CPA Full Grant Application FY26

Project Name: VIDA REAL BROADWAY ROOF PRESERVATION

Project Location: 404 BROADWAY SOMERVILLE

PART II: CONDITIONS ASSESSMENT & TREATMENT RECOMMENDATIONS

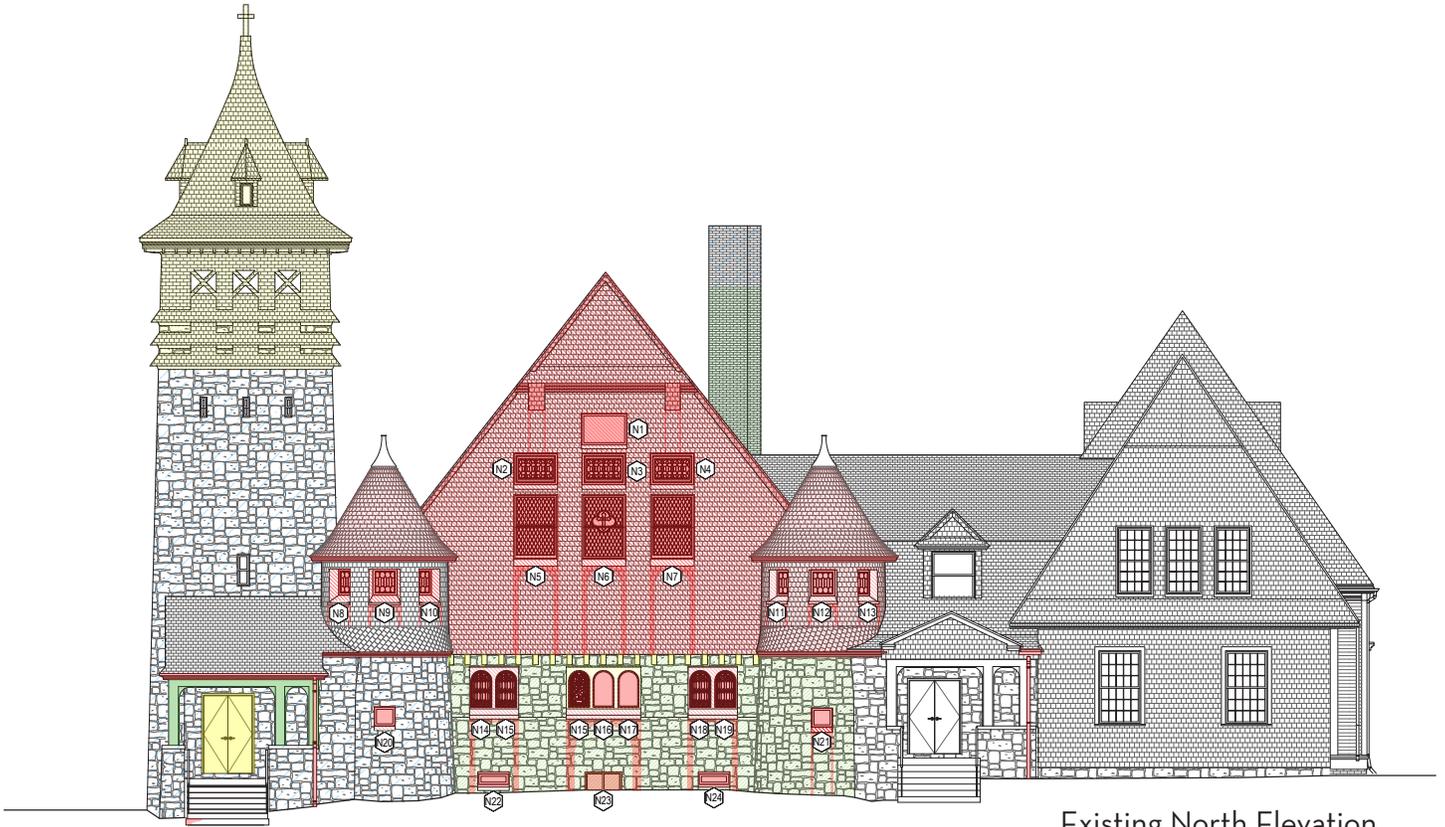
Existing North Elevation

The locations of each photograph are called out on the elevations included on pp. 20-21, which are color-coded according to the conditions' severity (urgent, high priority, and low priority).

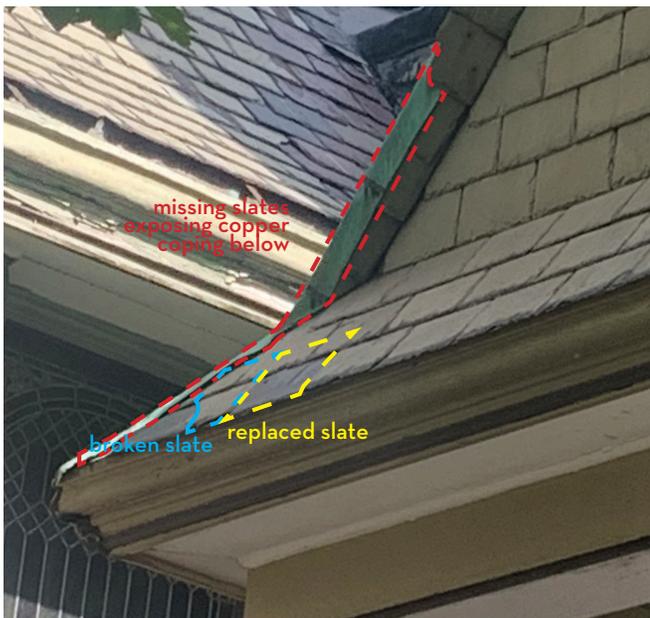
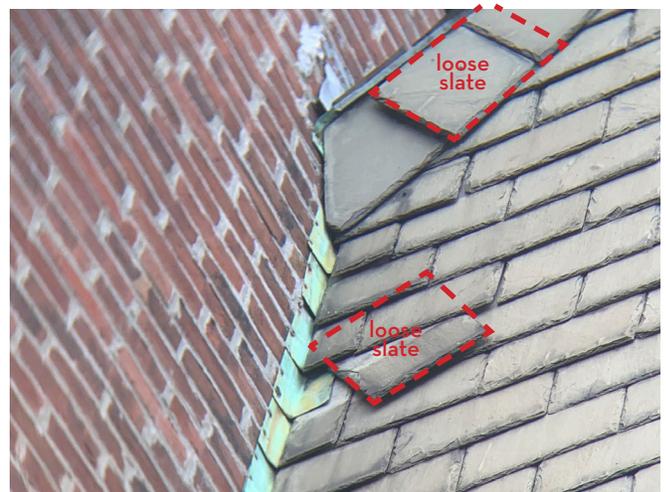
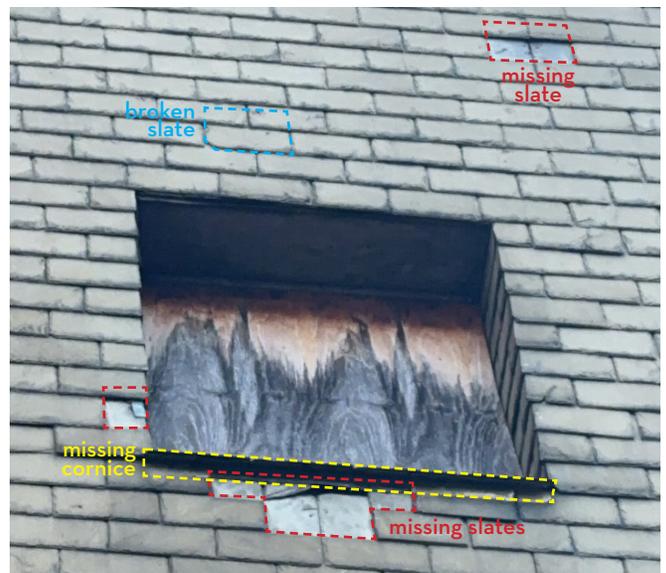
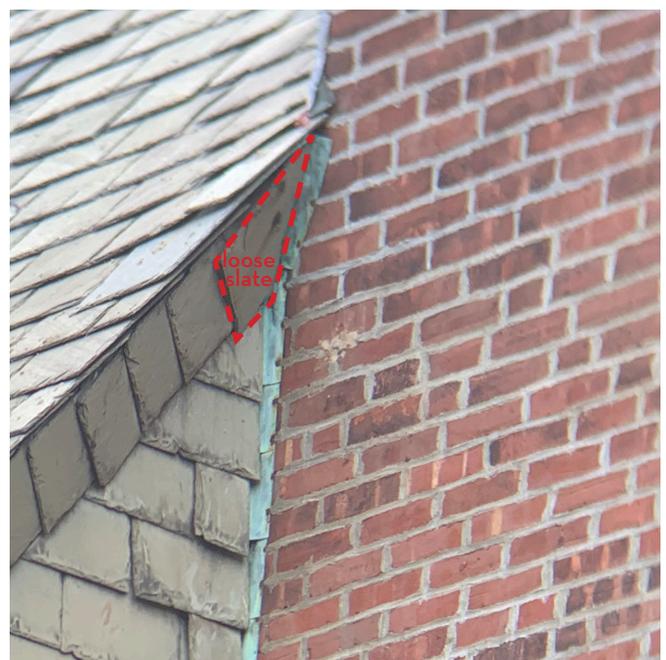
The most widespread symptom of aging, but not necessarily the most severe, is organic growth (Img. 1). This is very typical on roofs of all types, whether with slates, wood shingles, asphalt shingles, and even sometimes rubber; it results from the accumulation of organic debris, which almost always carries spores from moss and lichen and, over time, provides a substrate on which they can germinate. This condition accelerates with time, as the accumulated debris and growth take on residual moisture more readily than clean, bare slates. In fact, this is one of several reasons why metal copings are often fabricated in copper: the metal has antimicrobial properties and alters the pH of water with which it comes in contact, effectively killing or otherwise prohibiting growth of plant, algae, and

There are some loose, broken, and missing slates (Imgs. 3-4). Many such instances have already been repaired (Img. 2), but others have evidently arisen in the time since. No more than 10% of slates are loose, broken, or missing, mostly at intersections of the roof and dormers or otherwise adjacent to copper assemblies. Unsurprisingly, this condition is more readily observed at vertical faces, where slates are met with less resistance in loosening due to the steeper angle and, by extension, increased gravitational pull. The south gable end has been most obviously affected by this condition, particularly adjacent to window S1 (Img. 4), where it appears that wind has carried moisture into the open joint between vertical and horizontal slates, due to a missing cornice. Other areas where slates intersect at an angle of ninety degrees or less (Img. 2) are also likely to be affected by this condition, due to their being less secure in general. Nails used to hang slates are typically , and as such can rust and even disintegrate with repeated or consistent exposure to water. Such appears to be the case here. Loose, broken, and missing slates disrupt the waterproof barrier formed by overlapping courses of slate. Much like the above-discussed organic growth, this problem only accelerates with time as moisture is allowed to infiltrate the secure envelope, rusting nails, being absorbed into subroofing and structural timbers, and eventually damaging interior finishes like plaster, paint, and fine carpentry. What is more: loose and falling slates present a serious life safety risk in that they could seriously harm passersby below. *Loose slates should be secured with new stainless steel slate hooks and nails (Img. 6). Missing slates should be replaced in-kind, also with stainless steel hardware.*

There exist a handful of solutions for this condition, the most immediate of which is pressure washing. This can sometimes be challenging if access to the roofs is limited. An alternate treatment is chemical cleaning, usually with a solution including bleach or other chemical solvents. Notwithstanding, cleaning in either form is a relatively minor expense, especially if scaffolding is already in place apparent at mansards are in 'moderate' condition because for slate replacements, which will most likely be the case on this project, as discussed below.

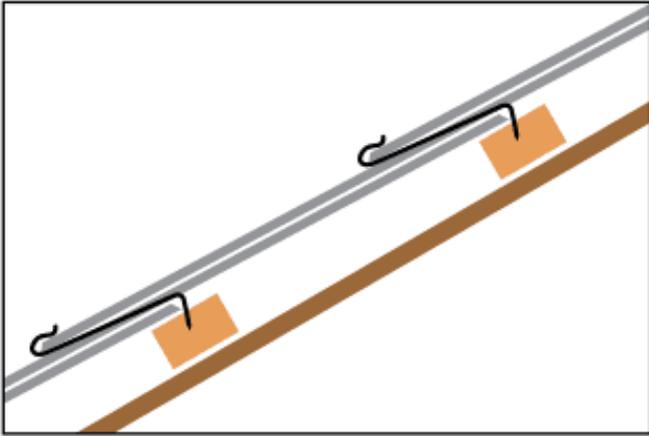
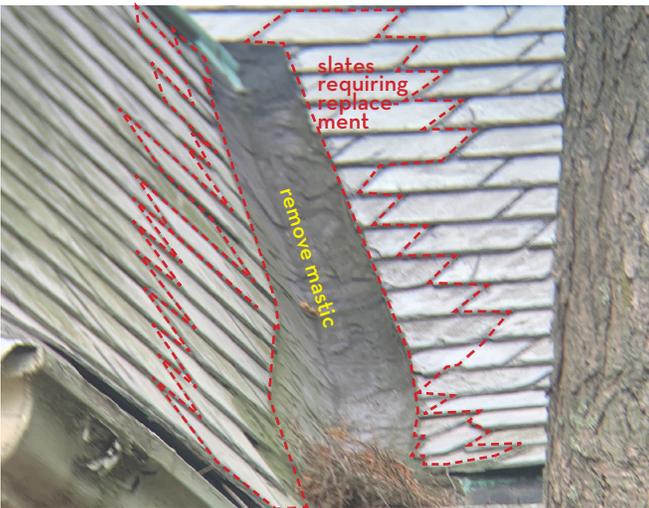
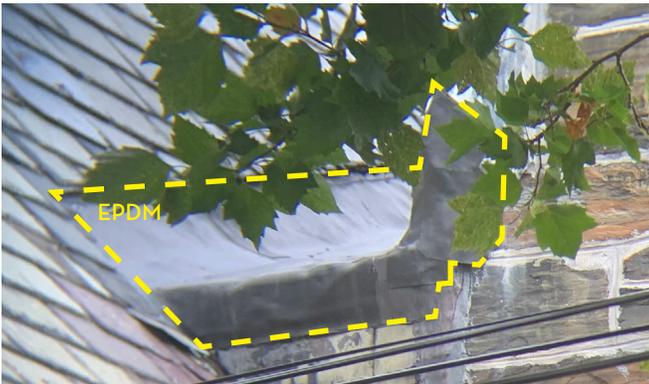
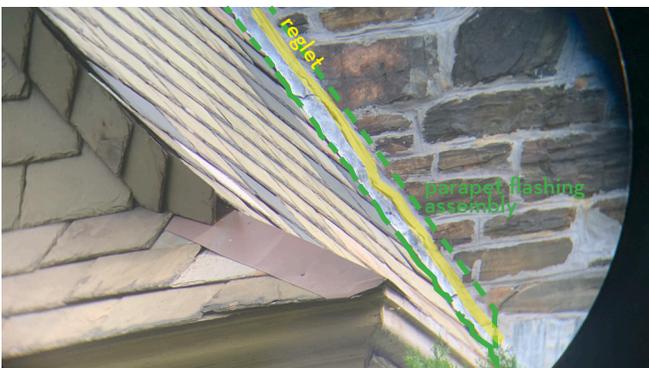
gable roof's east slope with the rear dormer (Imgs. 2 and 6). The presence of lead-coated sheet metal at other valleys throughout the building suggest that there was once a similar assembly here, which may or may not be concealed under the thick layer of black mastic by which this valley is currently characterized. However, the original valley's present or absence has no bearing on the simple fact that it has failed. While the existing mastic shows no leaks, at least outwardly, it is unsightly and fails to adhere to the structure's overall historic character. *It is our firm recommendation that this joint be reworked. Such will require removal of the mastic, the adjacent slates, and any sheet metal that may remain underneath. A new aluminum or copper valley assembly should be installed, with slates cut parallel to the joint (as can be observed at other valleys). Given that an entire column of slates will be replaced on either side of the valley, slate hooks should not be required. Notwithstanding, stainless steel nails should be used. An alternate approach could replicate what appears to have been done fairly recently at the opposite end of the same gable face, at its intersection with the turret roof and tower masonry. Here, EPDM membrane was installed in place of a metal flashing. Such is obviously not historically accurate (which may not be a concern given the relative inconspicuousness of the location) but is far more cost effective. At the other location, it appears that existing slates were salvaged and reused, though this may not be possible here depending on the contractor's ability to fully remove mastic residue. In either case, the section of the coping disrupted by this assembly (see image), should be bent back to its original profile and tacked down.*

Lead-coated copper stepped flashings and counter flashings at intersections of the slate roofs with masonry, such as at the bell tower, appear to have held up relatively well, despite their appearance of being somewhat bent and dented. Replacing assemblies like this can be challenging and costly, given that it almost always requires cutting and repointing the mortar joint into which the sheet metal is inserted (the 'reglet'). It is apparent that the masons who recently repaired the clock tower saw no need to replace these flashings, as the joint appears to be freshly pointed (Img. 9). As such, given the projected expense and low apparent need for replacement, *we recommend hammering bent areas back into place with a mallet and, for larger open joints, applying a small amount of mastic or caulk to hold it in place.*

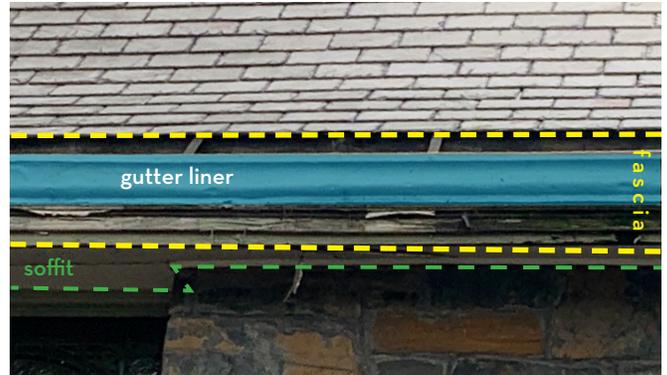
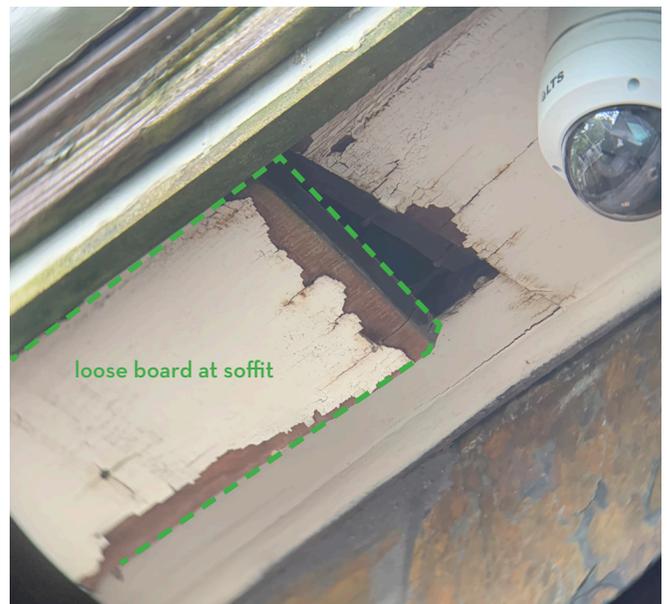
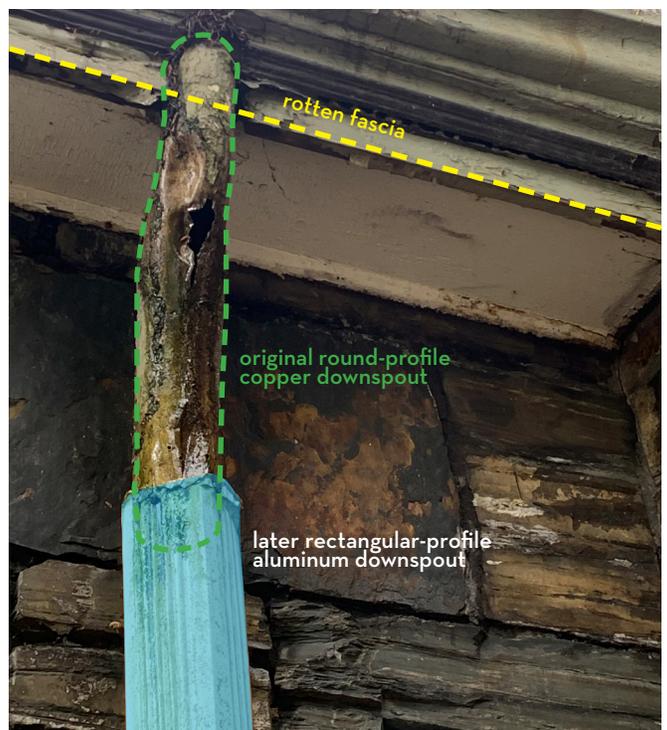
gable roof, the north and south faces of the rear portico, and the north face of the front bell tower portico. Despite the condition of the fascias on which they are mounted (discussed below), the gutters themselves have held up moderately well, likely due to their being painted and, as such, better protected from corrosion. Notwithstanding, these will need to be removed for access to the fascias, which are among the most severely damaged facets of the building (Img. 10). For the purposes of this assessment, it can be assumed that the condition of fascias is consistent throughout, though there are areas – particularly at the east elevation – where they are more visibly in distress. Sometimes wood can be salvaged via epoxy consolidation, a process by which a self-hardening adhesive is applied to spongy or rotted areas and planed to recreate the original profile of the trim. While there are areas of trim at the building exterior that can be salvaged through these means, fascias are far beyond repair. Their accelerated deterioration, paired with their relative unimportance to the building’s historic character (they are scarcely visible under gutter liners), suggests that *all fascias should be replaced with new wood. As mentioned above, such will necessitate removal of the gutter liners. These could be retained but good practice dictates replacement with new aluminum gutters matching the profile on the originals.* Related soffits vary in condition, but generally have not weathered to the same extent as the fascias (Img. 11). *Securing loose boards with new hardware and/or epoxy consolidation where necessary could sidestep complications that might arise when trying to remove soffits at their intersection with window casings (refer to image). Between removal and reinstallation of fascias, the condition of rafters underneath should be assessed. The entire assembly should be painted to match the existing following reinstallation. Given the presence of large trees around the property, gutters and downspouts should be monitored annually for clogs and cleaned when necessary.*

Further, the existing downspouts have a standard, rectangular profile. Some are damaged while others are in working condition. Notwithstanding, they are somewhat disruptive to the building’s historical appearance. *Round-profile aluminum downspouts similar in size to that at the north elevation of the rear portico (which, notably, has a large hole and is in need of replacement) would be more appropriate and are recommended. Doing so comprehensively would be good practice, especially in the event that gutters are replaced.*

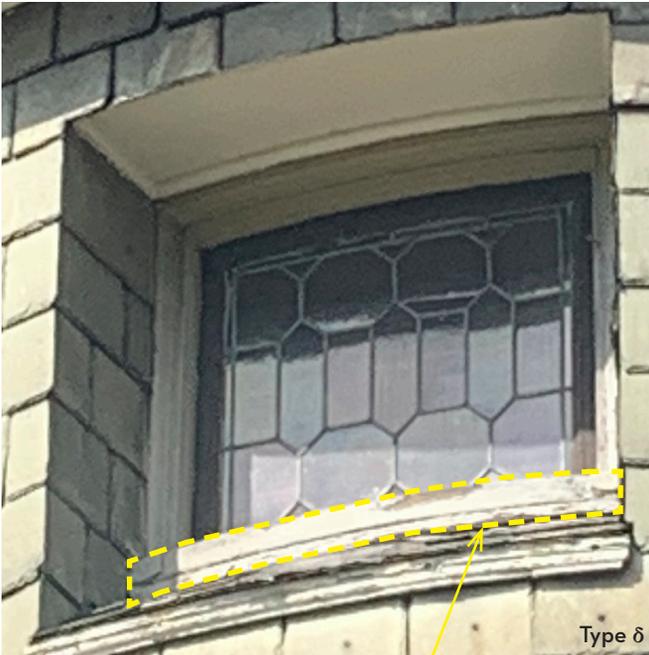
deteriorated sills from absorption of standing water – Type δ

δ – For one reason or another, turret windows are in significantly worse condition than many of the building's other leaded-glass windows. This could be due to difficulties with access, more complicated installation detailing, or some combination thereof. *That said, these windows are in need of comprehensive restoration, according to the recommendations provided earlier.*

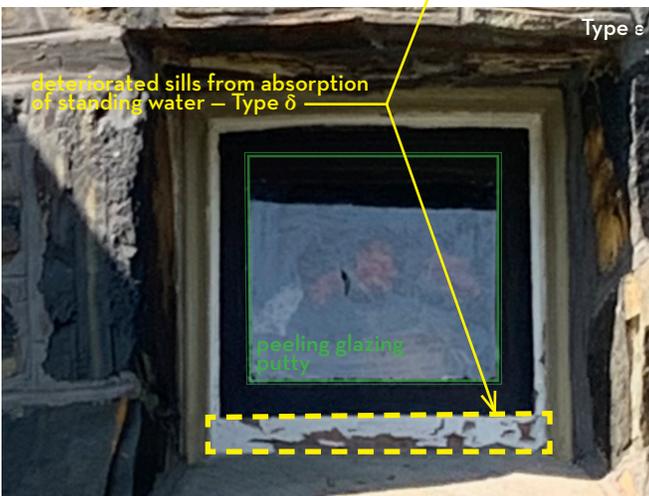
Type ε

ε and ζ – Water here has been allowed to pool on deep sills; this exacerbates the condition of windows during freeze-thaw cycles, when ice expands in the wood and splits its fibers. Given that these windows are largely compromised, and that they are relatively unimportant to the historic character of the structure, *they should be replaced with new clad-wood windows from Allied, Pella, or equivalent. These should match the profile(s) of the originals. Storm panels are not here required.*

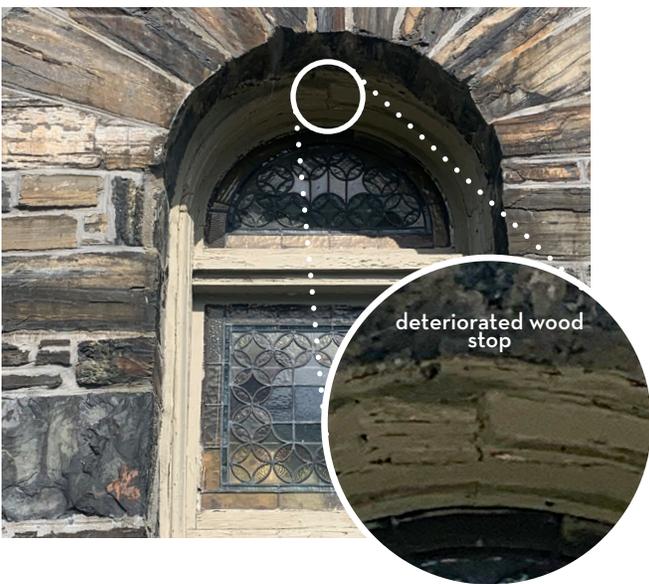
deteriorated wood stop
