# 2013 Pedestrian Accessibility Study

Somerville, Massachusetts

**May, 2013**

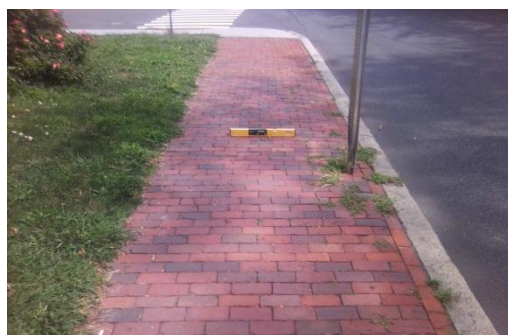
**Brick sidewalk on Central St.**

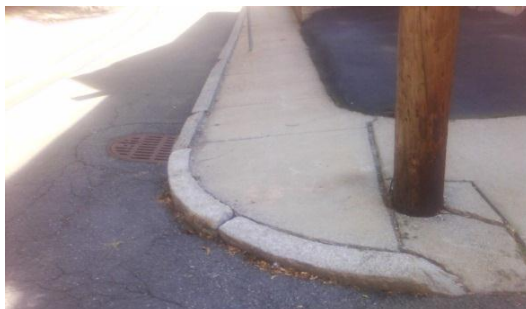
**Ramp is missing with no crosswalk**

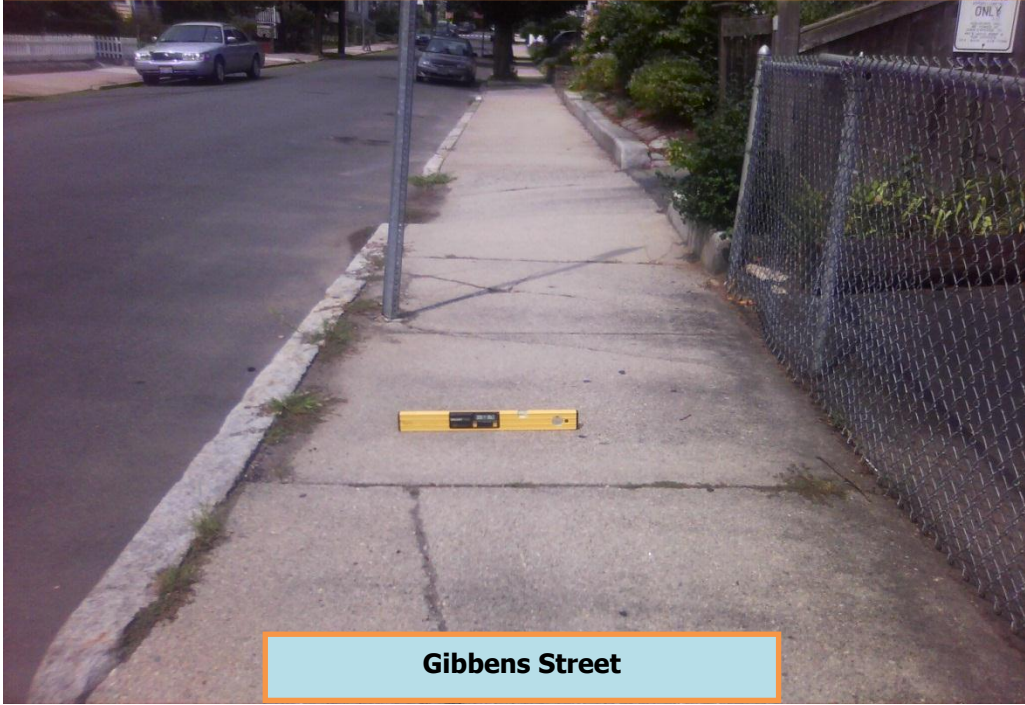
**Gibbens Street**

**DO NOTHING**
