2013 Pedestrian Accessibility Study

Somerville, Massachusetts

Prepared by

FAY, SPOFFORD & THORNDIKE

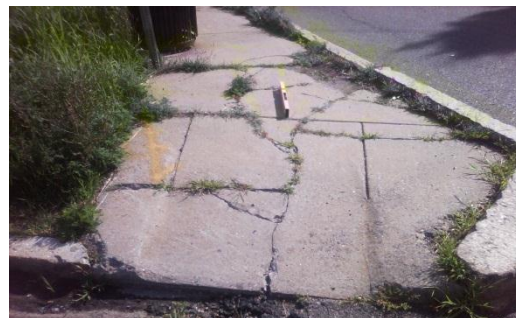
Poor ramp in need of Full Replacement

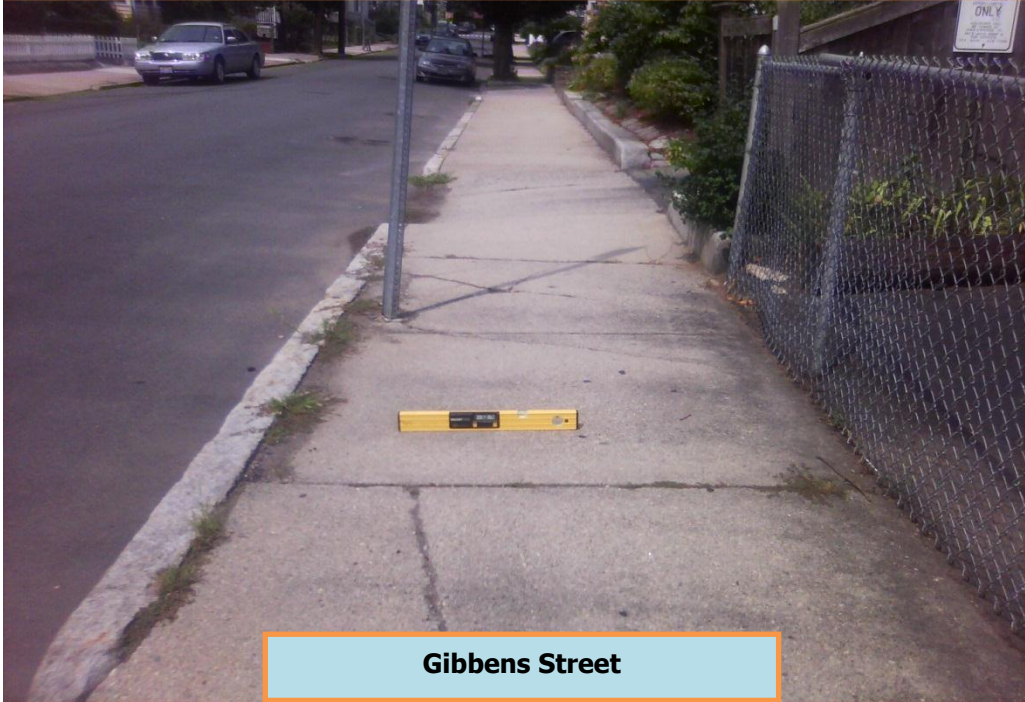
Gibbens Street

LOCALIZED REPAIRS

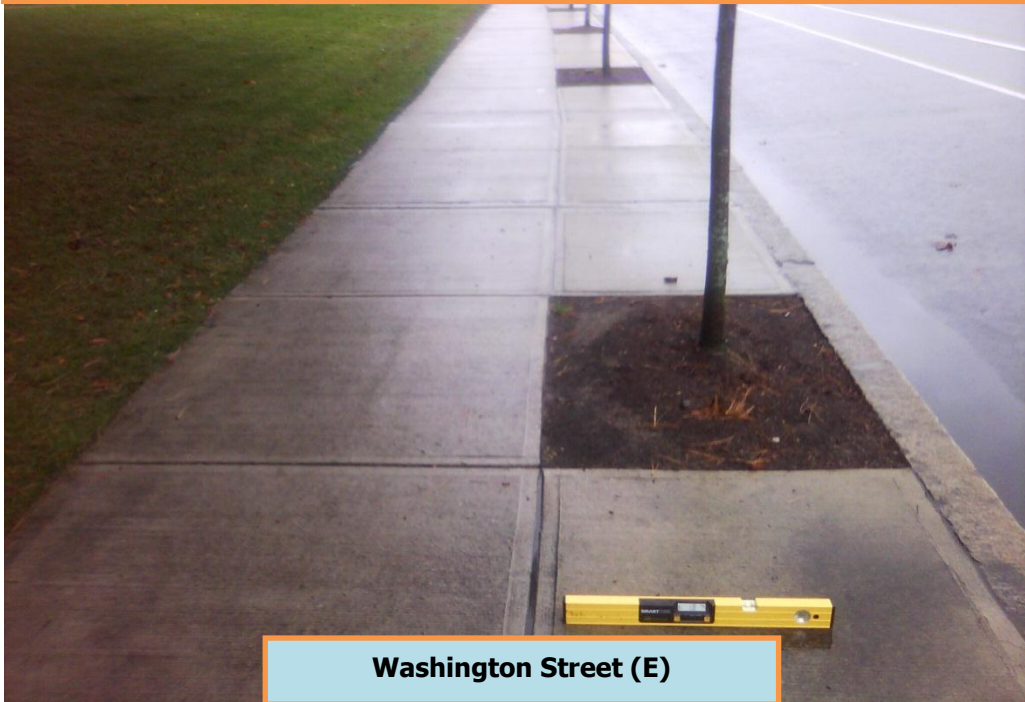
Washington Street (E)

DO NOTHING
