**Claim to the City of Somerville  
for repairs to a residential sewer line blocked by a city sub-contractor.**

John Glyphis/Gillian Puttick  
22 Elmwood Street  
Somerville, MA 02144  
Ph 617-797-5858

March 8, 2021

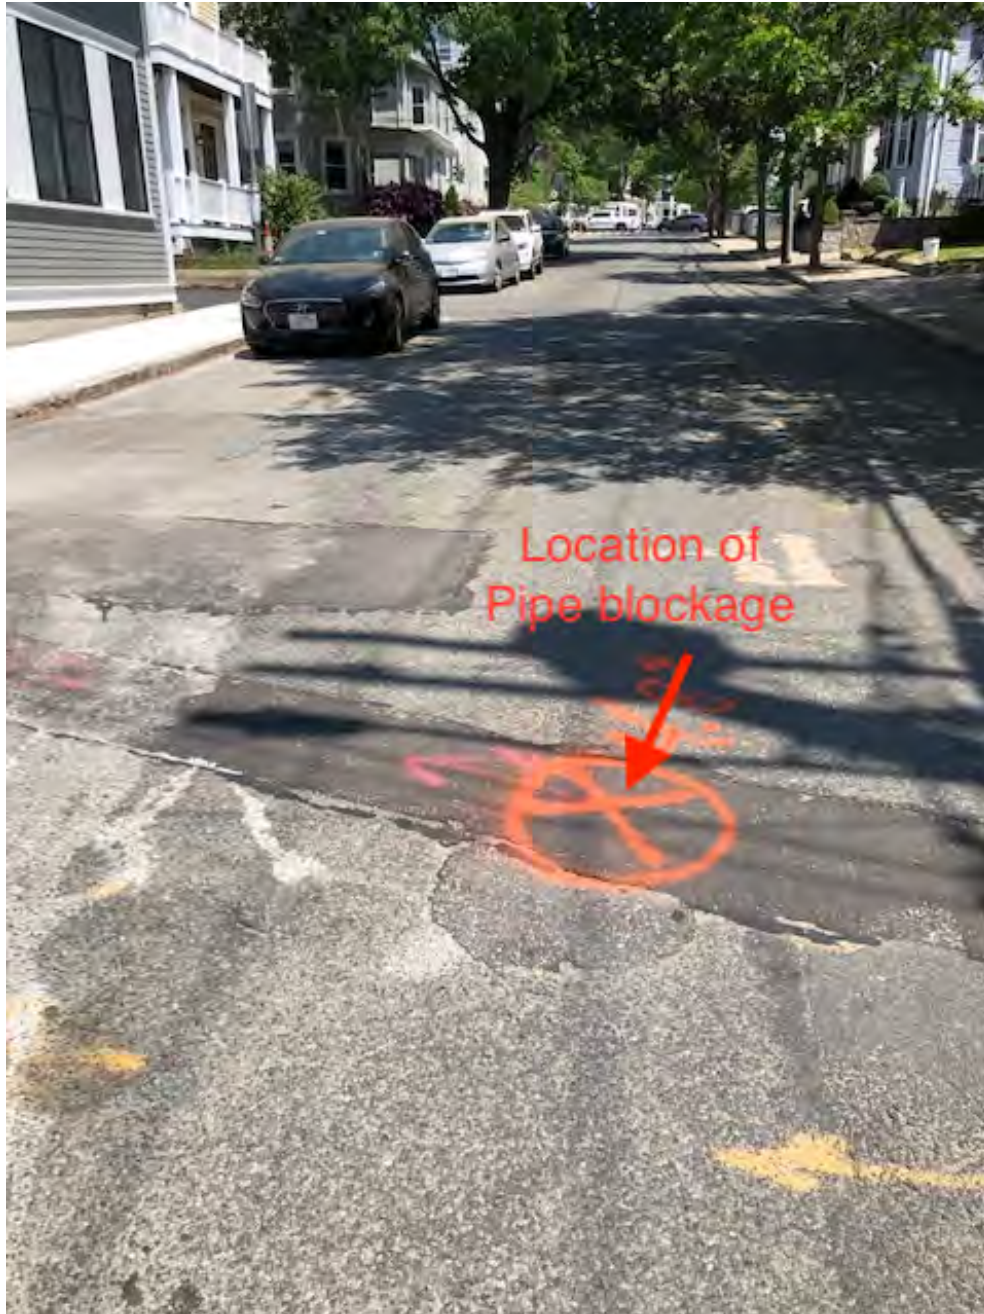
#### Attachment 4

- 2) Drains by James returned 2 days later with the necessary camera equipment to do this examination and to determine the blockage location using GPS (Attachment 2). This examination confirmed a solid blockage at 40 feet from the cleanout in the basement of 22 Elmwood. This exact location was marked in the street (See Attachment 4)).

Location of the sewer line blockage marked (red circle with cross) in the middle of Elmwood St after the camera and GPS inspection (26 May 2021).

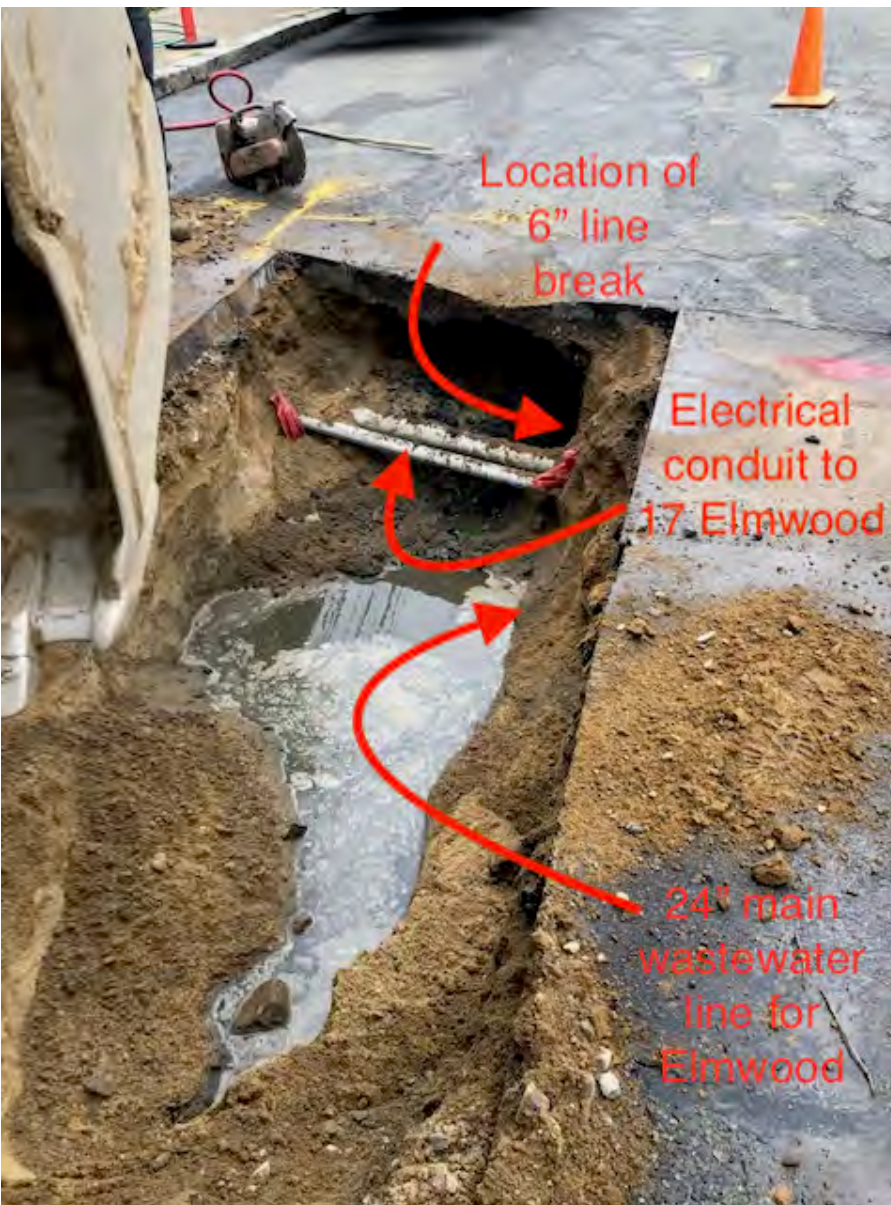
## Attachment 5

- 5) Borges commenced work on Wednesday, 9 June 2021. With a relatively shallow excavation (approx. 30 – 36 inches deep), the electrical connection between the utility pole and 17 Elmwood was uncovered, and about 12" lower and parallel to this was the 6" clay pipe sewer line feeding to the 24" main line in the middle of Elmwood street. As soon as the dirt substrate was removed with hand shoveling, the residential sewer line was visibly broken from the main line at the junction (Attachment 5). In this photo, sewage effluent can be seen running from the cracked pipe into the open excavation hole.

First photo of broken 6" sewer pipe in relation to 24" main street pipe. The new electrical connections are also shown running from the utility pole (not visible in the left side of photo) across the street to 17 Elmwood. The visible waste water drained out of the 6" residential line as soon as that was exposed by hand shovel digging.

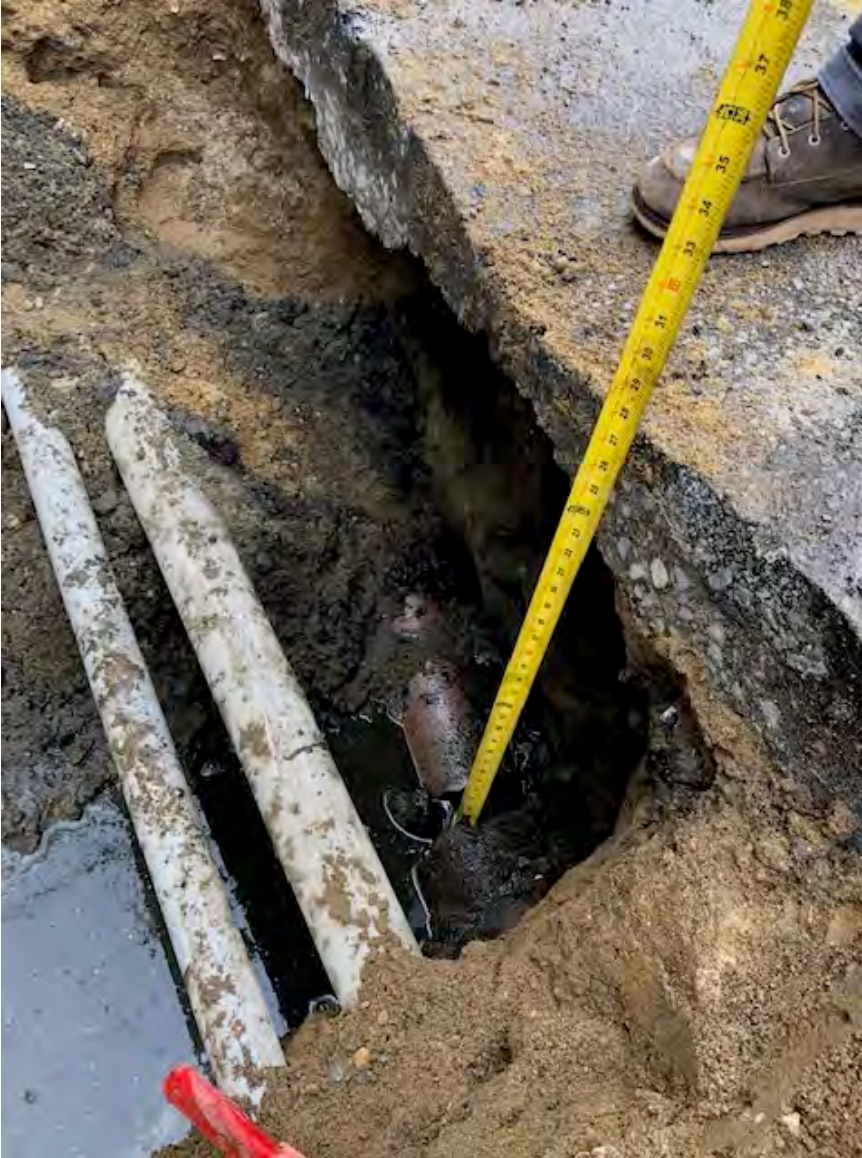
### Attachment 6a

Photo showing the broken 6" sewer pipe at 28" below the asphalt surface and less than 12" from the location of the electrical connections to 17 Elmwood.

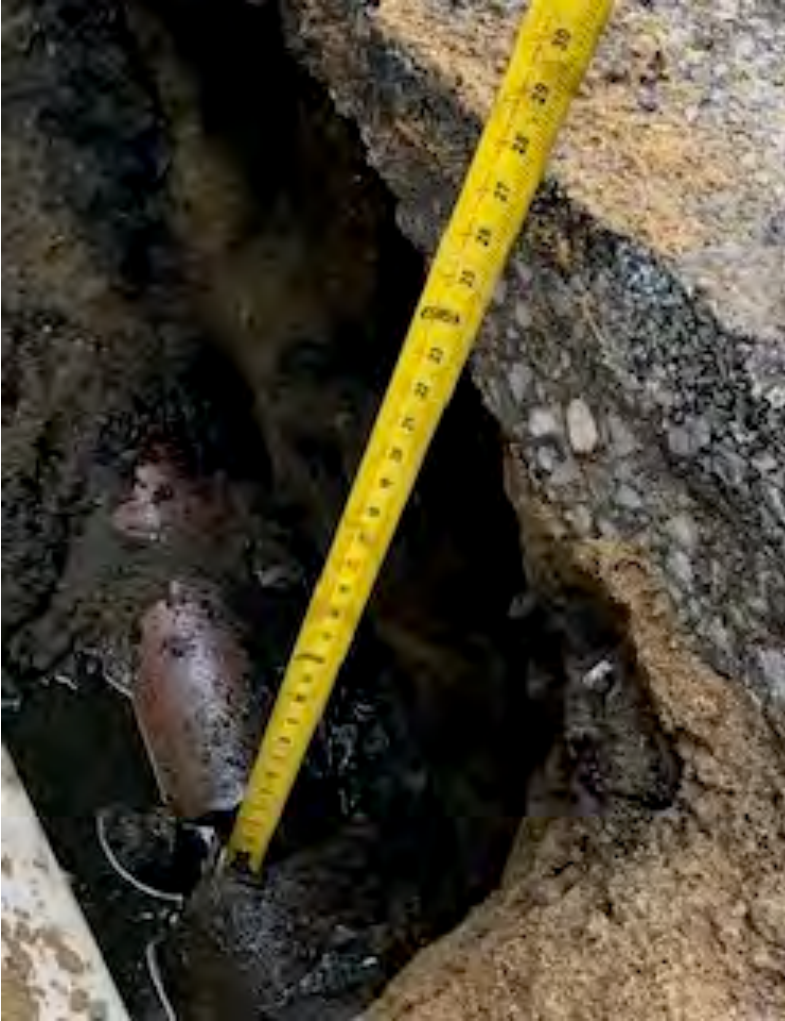
### Attachment 6b

Enlarged view of photo in 6a above to show the tape measurement of break in pipe at 28" below the asphalt surface.

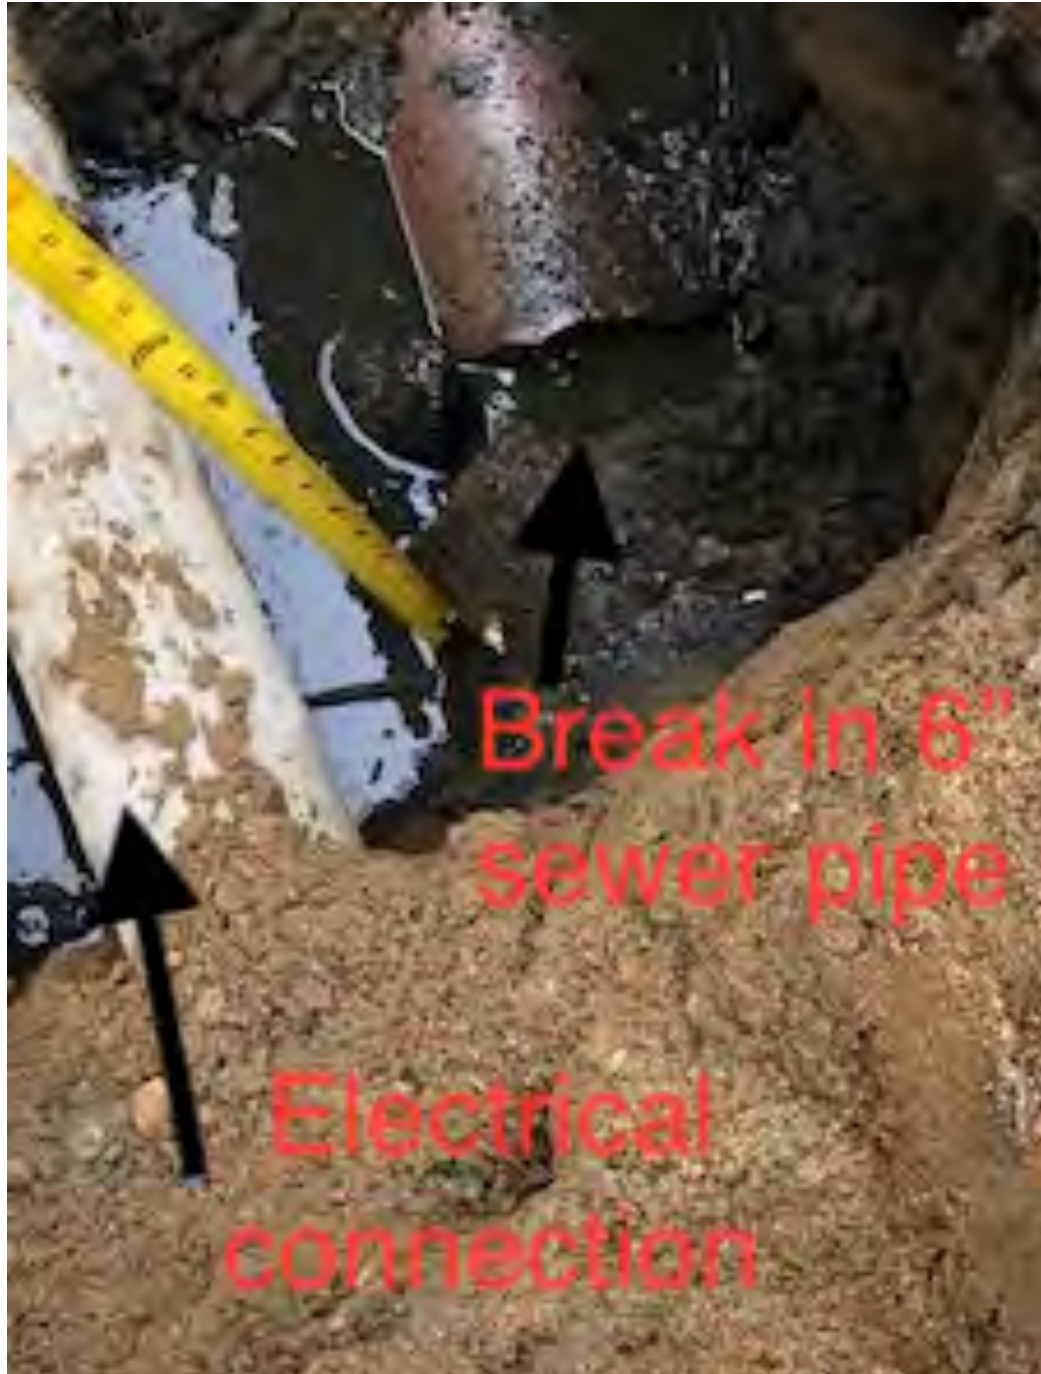
## Attachment 7

Close up view of break in 6" sewer pipe to show proximity of less than 12" below electrical connection as shown by tape measure. The main 24" sewer line is buried an inch below the sandy colored dirt in the lower part of the photo.

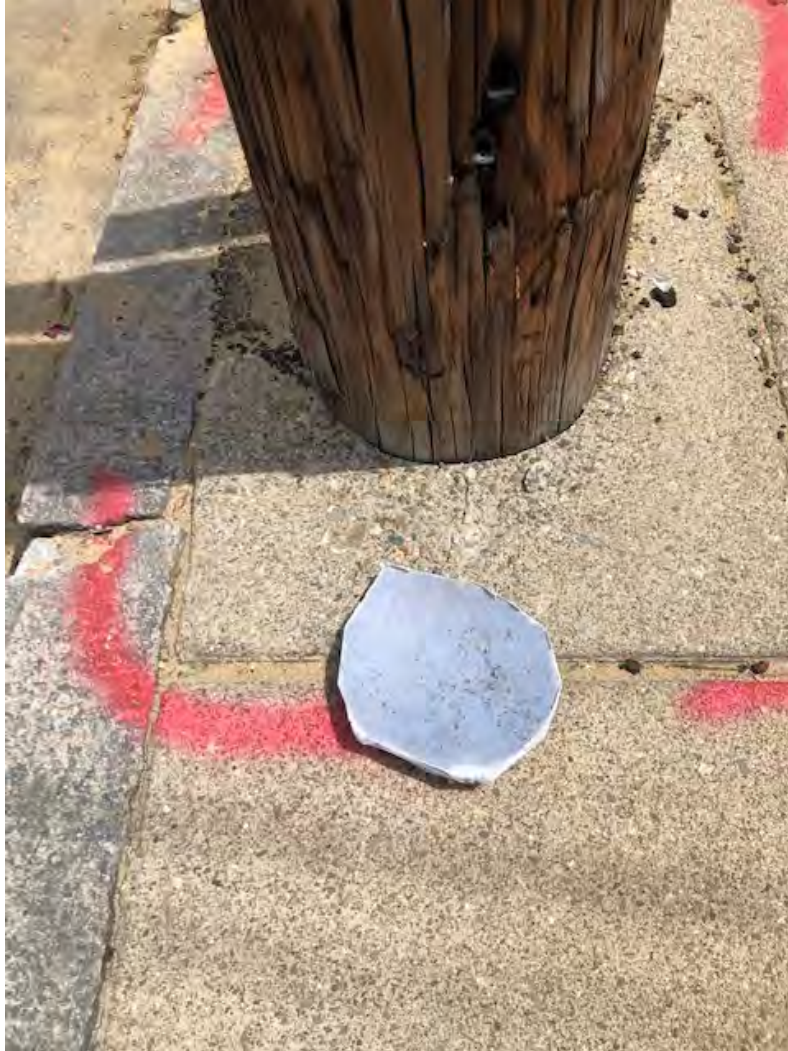
## Attachment 10

A subcontractor to the city, National Watermain, was contracted to re-sleeve the main 24" waste water/sewage pipe in the middle of Elmwood Street. In the process of re-sleeving, the opening of the 6" residential sewer pipe from 22 Elmwood was not cut open.

- 7) In attempting to attach the new PVC section into the mainline they then discovered that the sleeve material installed in March 2021 had completely covered the opening for the residential pipe, having never been cut out by National Watermain. It was necessary to remove a 6" round section of this sleeve to seat the replacement PVC. This sleeve disc is shown in Attachment 10.

Photo of the sleeve disc that had to be removed to enable a re-connection of the 6" pipe with the 24" pipe. During the re-sleeving in early March 2021 of the 24" pipe this disc should have been cut out internally by the contractors installing the sleeve in the 24" pipe.

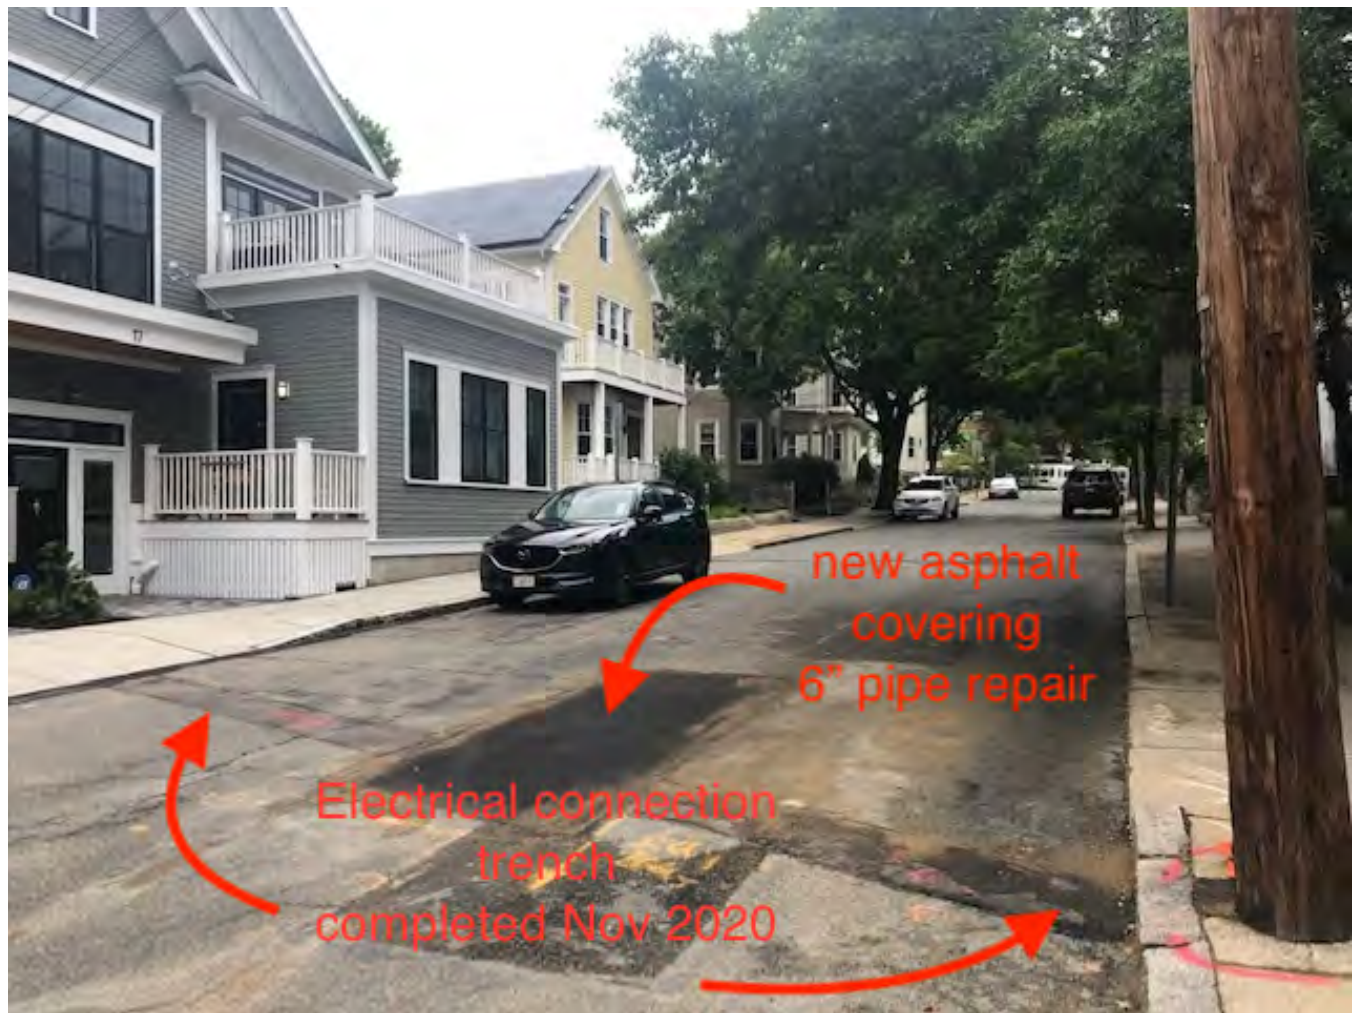
## Attachment 11

Photo showing the location of the completed excavation for the 6" pipe repair relative to the electrical connection completed by Eversource for 17 Elmwood in November 2020.
