SD|LYONS

VEHICLE ANALYSIS – SDL# 10744.1

INSURED Somerville DPW
VEHICLE 2017 Ford F550 Super-Duty
VIN 1FDUF5HY1HED35804
ODOMETER Unknown
DATE OF LOSS April 13, 2018

Inspect the 2017 Ford F550 Super-Duty aerial bucket truck. Determine the origin and cause of the fire.

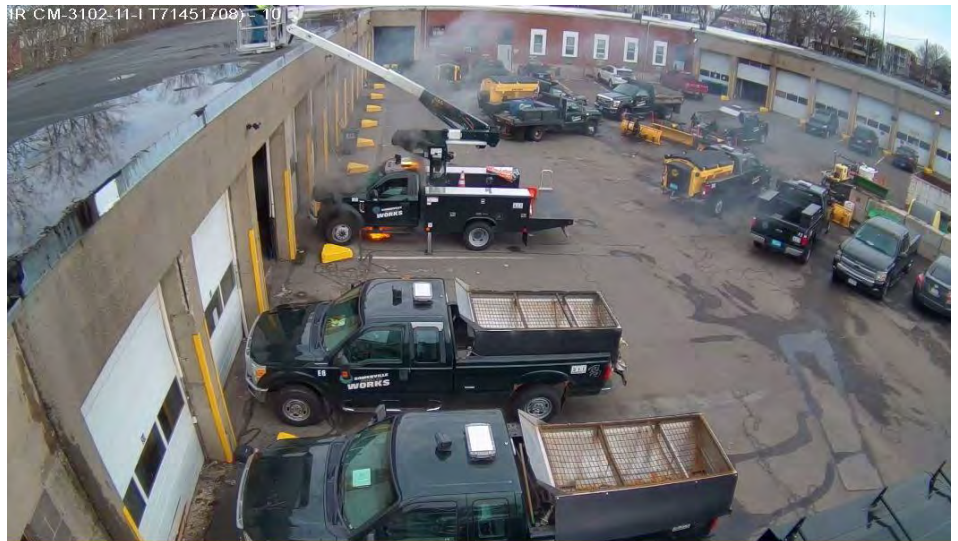
7

View of more intense fire on the ground under the left side of the transmission and coming up from behind the cab. Workers are still in the bucket.

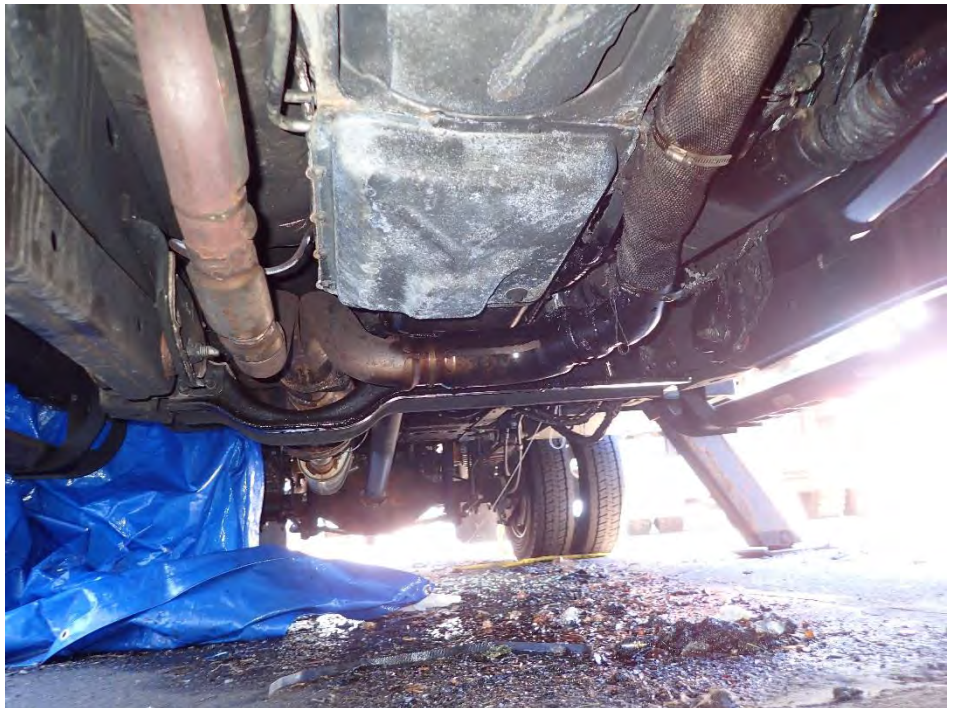
21

View of the underside of the automatic transmission and exhaust pipes looking from the front toward the rear. The left side (driver's side) exhaust pipe had been wrapped with heat tape. The exhaust pipe, the tape, and the crossmembers were dipping wet with transmission fluid.

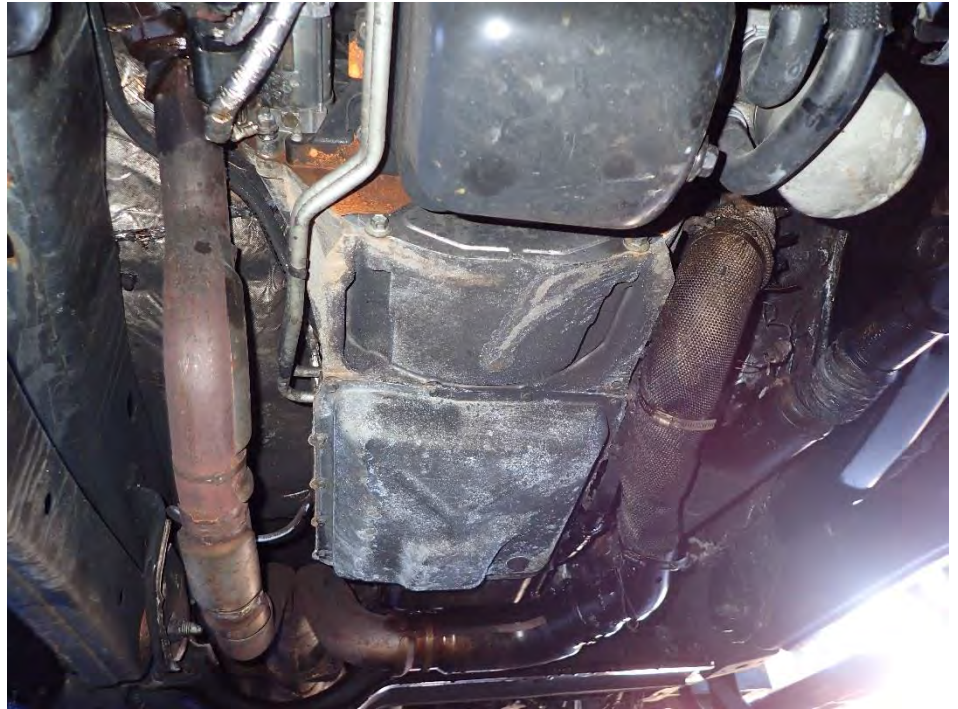
22

Closer view of the underside of the engine and transmission. Only the left side was burned.

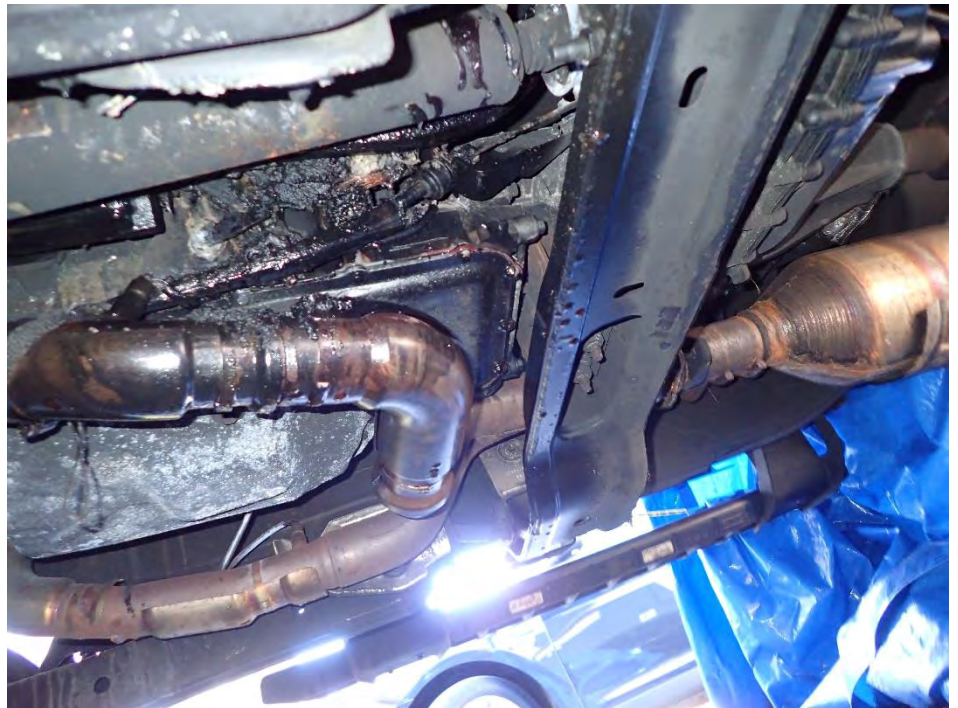
Another view showing the left side of the transmission and the transmission crossmember. Transmission fluid was dripping from the pipe and the crossmember.

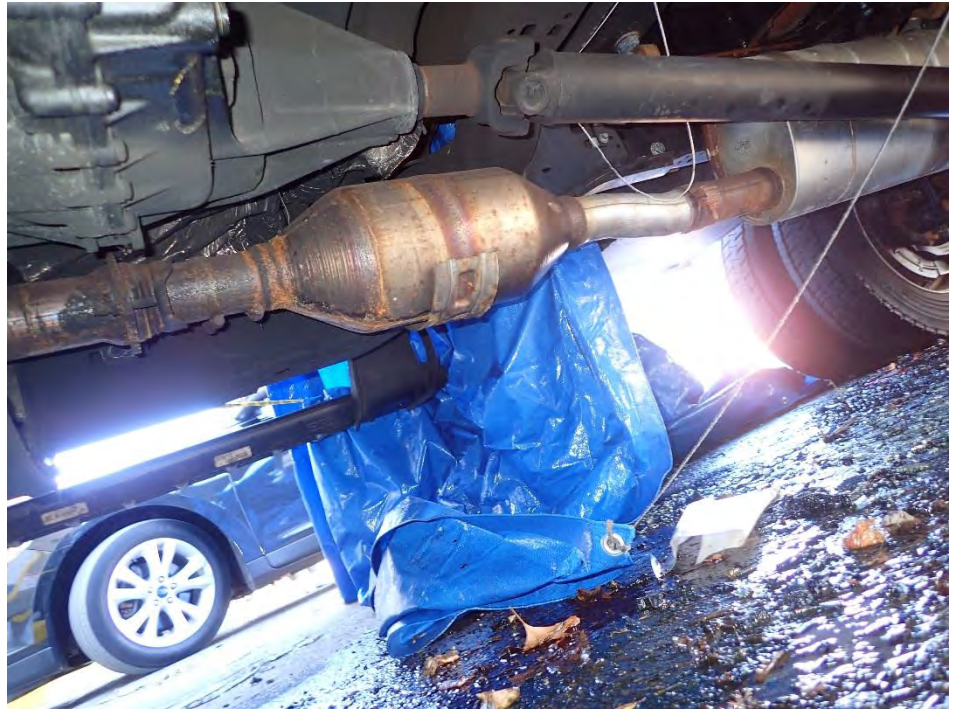
26

View of the exhaust system located rearward of the transmission and the 4-wheel drive transfer case. There was no fluid present and this area was not burned..

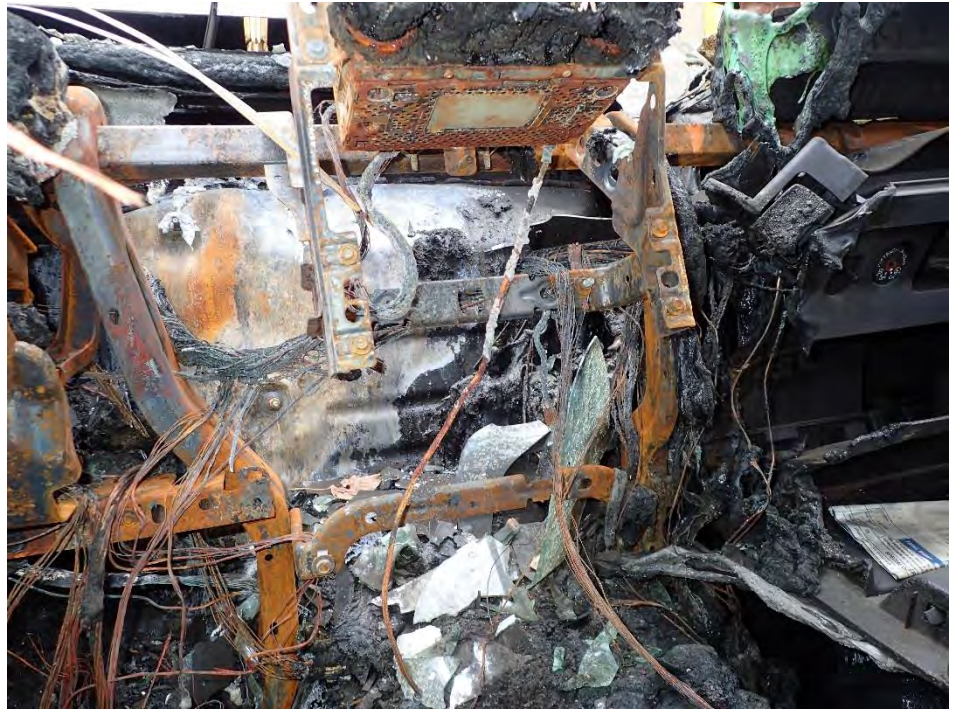
The fire extended up through the opening in the floor and traveled through the center of the dash where it breached the windshield.

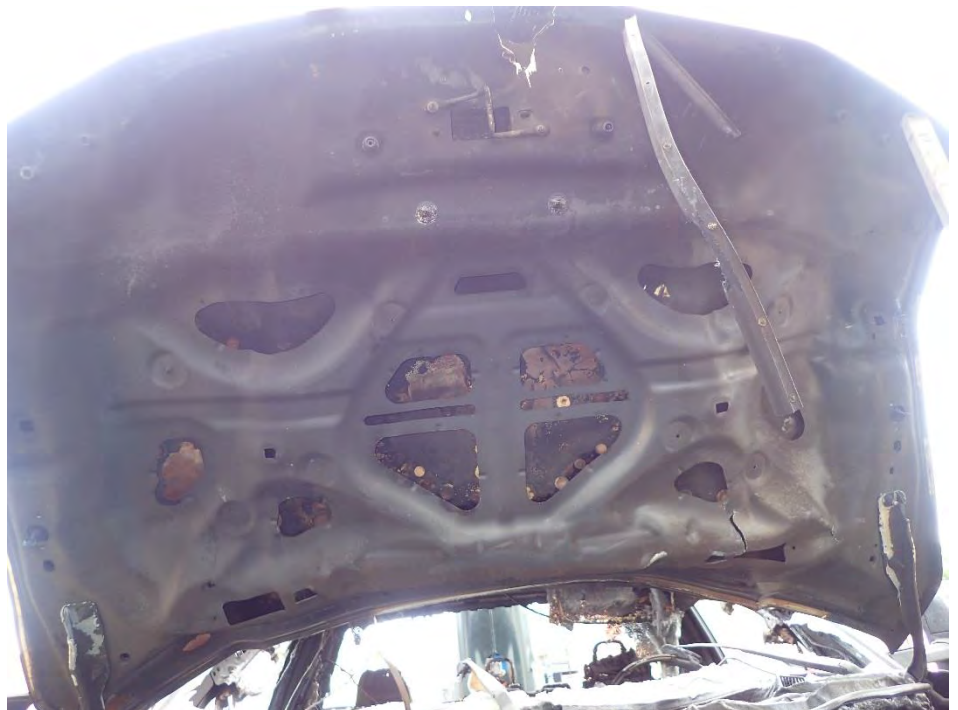
54

View of the underside of the hood. The aluminum hood began to melt above the left rear of the engine compartment as the fire progressed from underneath the cab and into the rear of the engine compartment at a later stage.

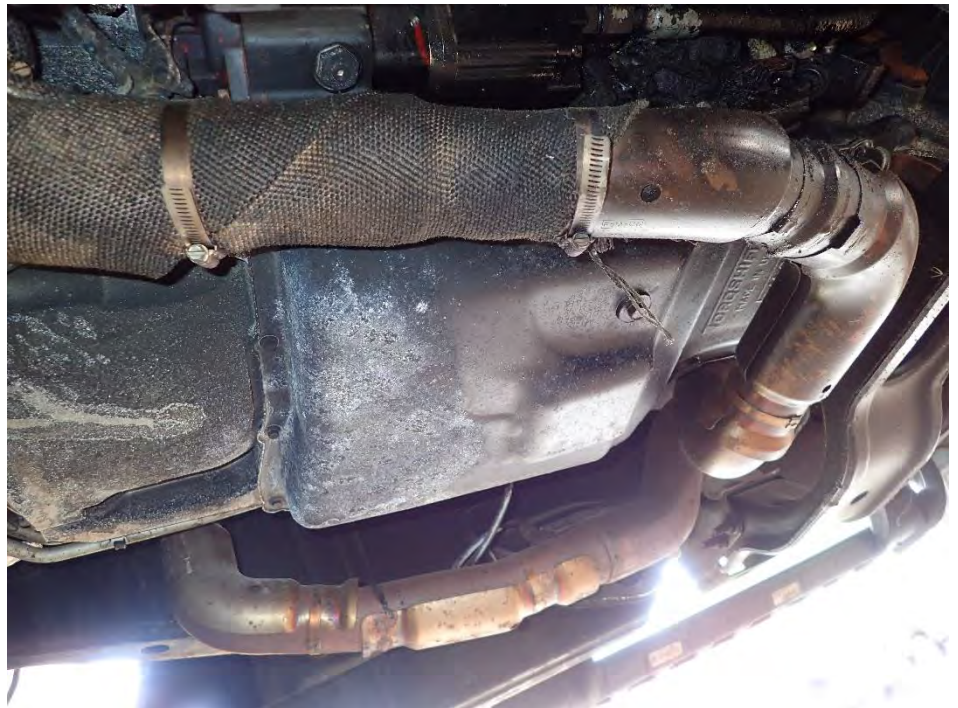
62

View of the left side pipe and the exhaust crossover located behind the transmission. Only the left side of the transmission and the left side exhaust pipe were wet with fluid and burned.

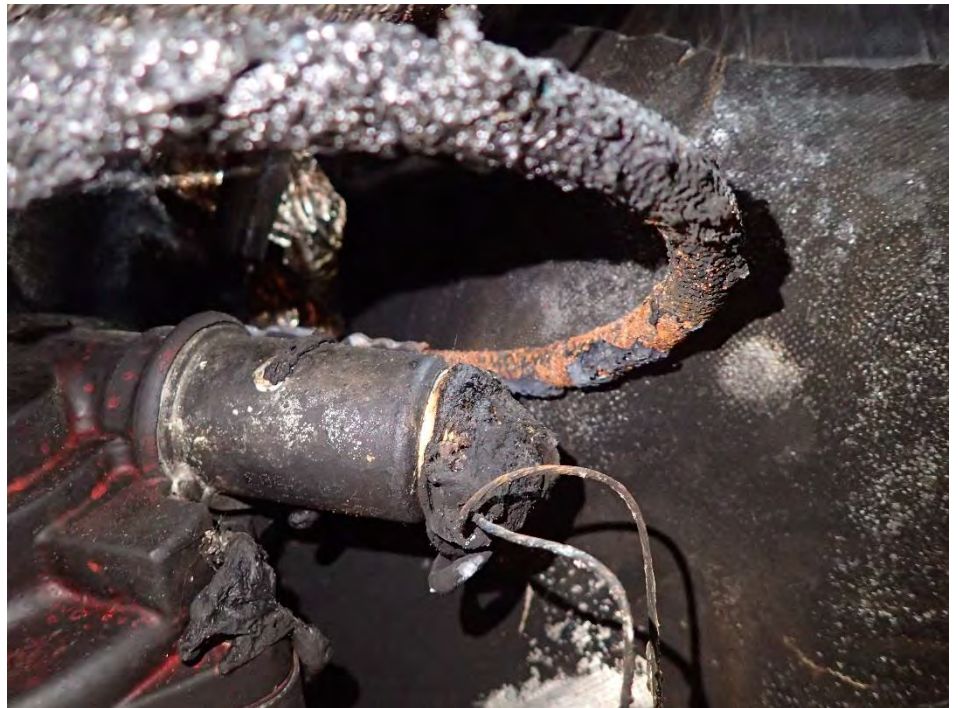
68

Closer view of the pressurized control switch for the PTO and the burned transmission line. As noted, there is continuous fluid pressure in this line when the engine is running. The transmission pressure and the engine RPM elevate when the PTO is activated by the remote control in the bucket. The line was rubbing against the floor of the truck.

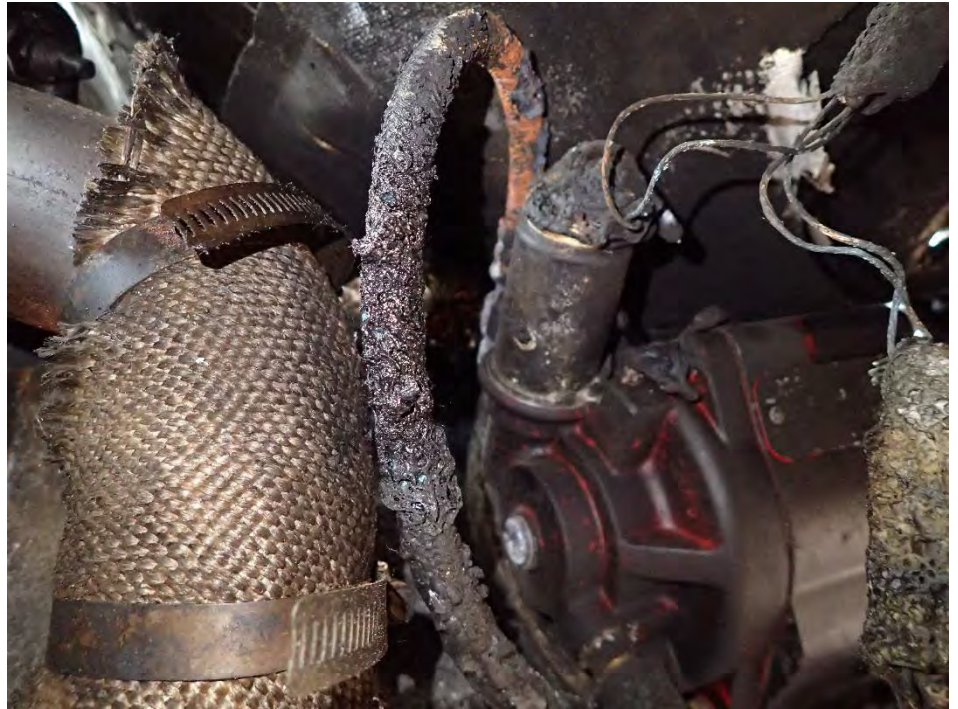
69

View of the transmission pressure line extending from the transmission test port to the activation valve. The transmission line was up against the exhaust pipe which had been wrapped with heat tape.

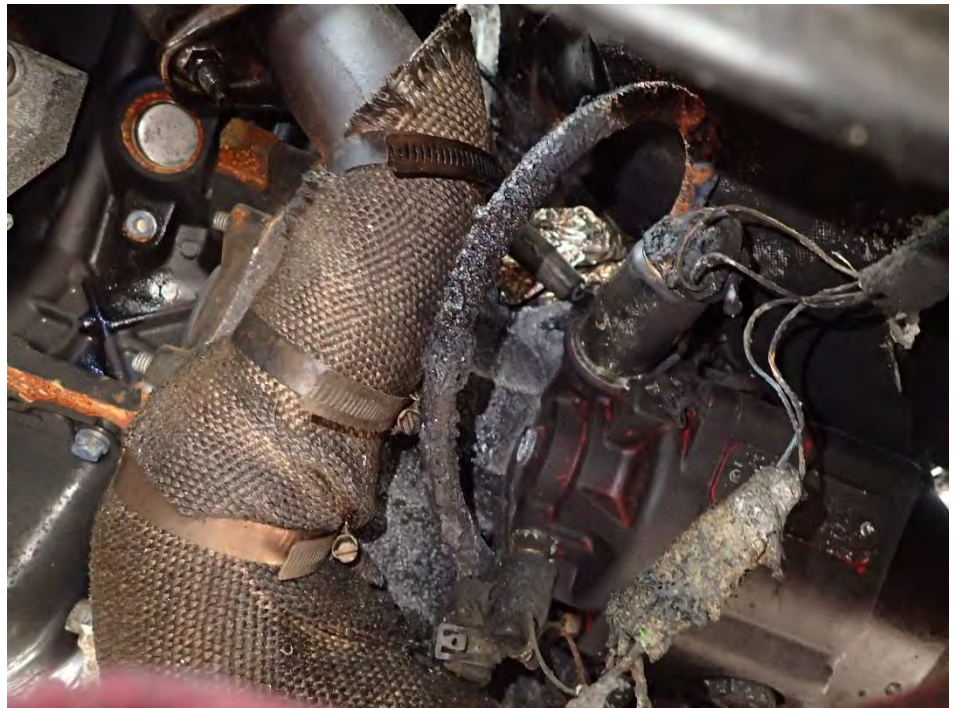
70

Another view showing the transmission line near the exhaust pipe. This transmission line may have been damaged prior to the installation of the exhaust heat wrapping.

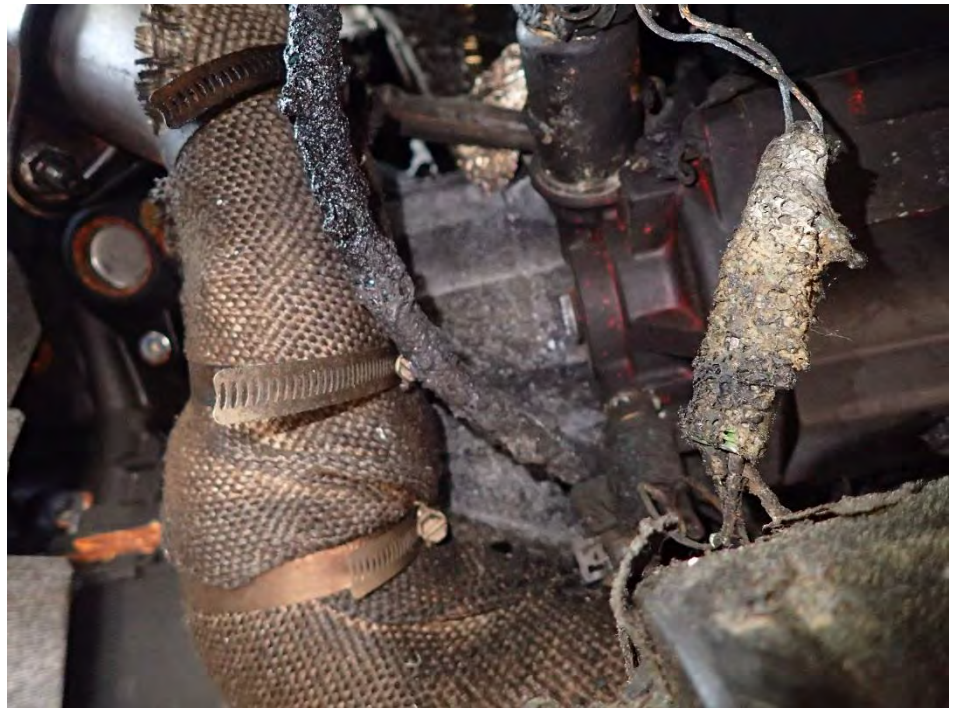
Another view showing the exhaust pipe and the transmission pressure line. This transmission pressure line could have been run in a different location where it would not be in close proximity to the exhaust pipe.

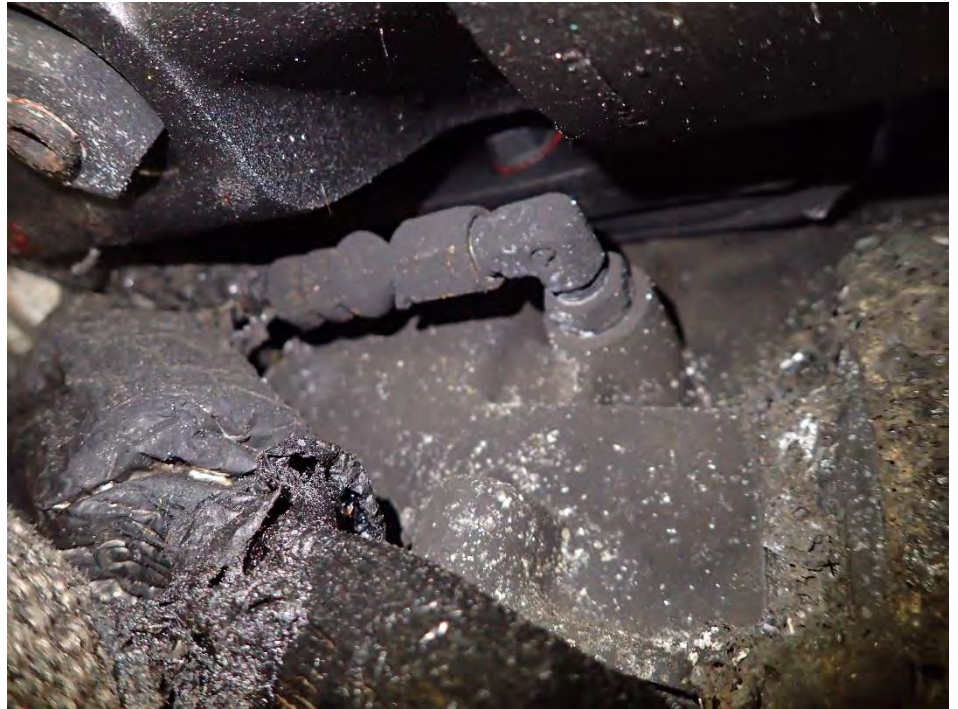
Closer view of the transmission line where it was inserted into the pressure test port on the transmission. This is an aftermarket installation and not installed by Ford during the manufacturing of the truck.

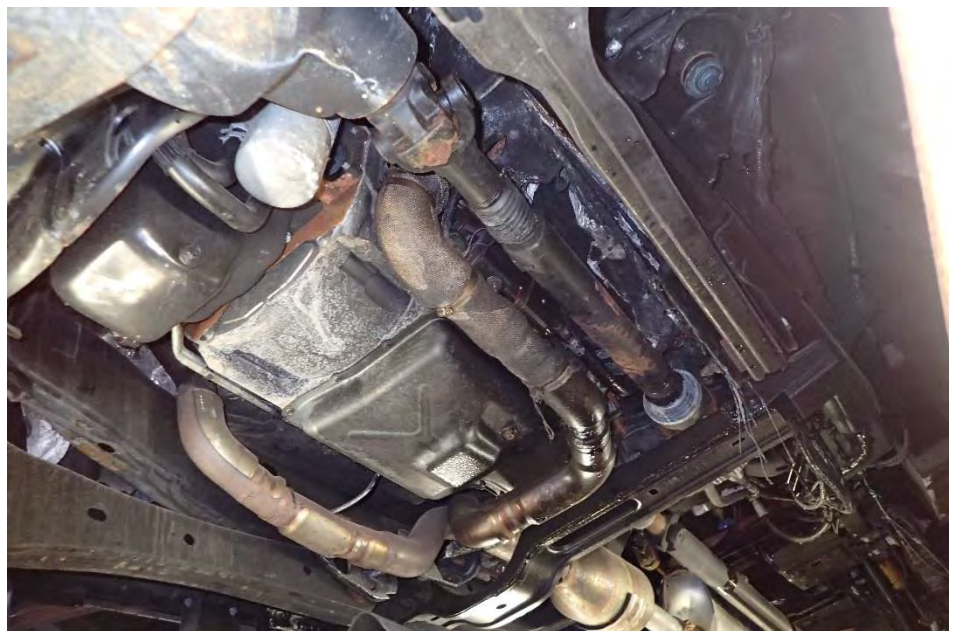
90

Overview of the automatic transmission and the exhaust pipes. The fire originated under the left side of the transmission. It represented the area of origin and the highest mass loss of material. The video surveillance shows the area of origin was on the left side of the transmission, which was consistent with the physical evidence.

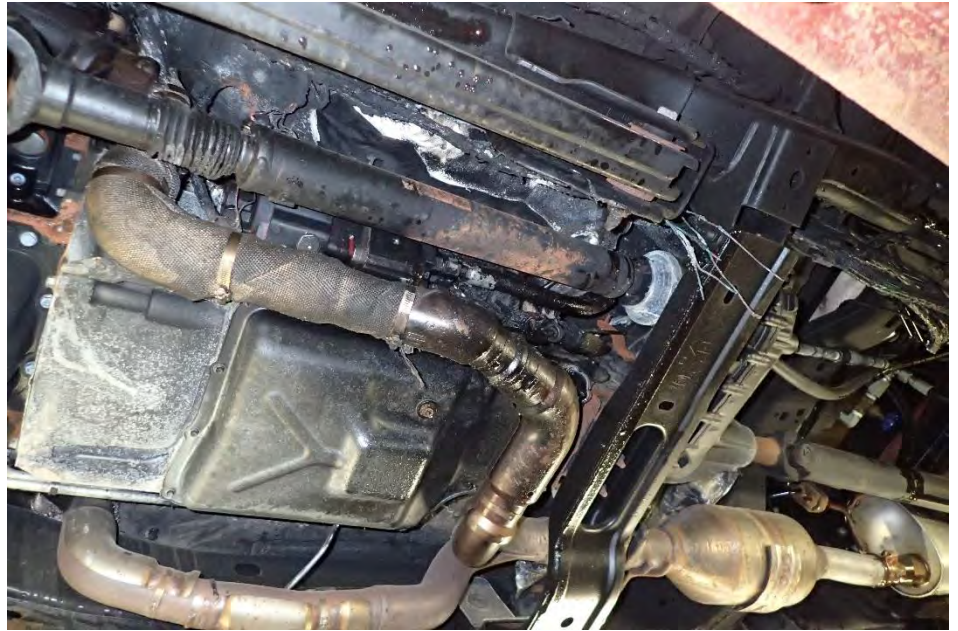
91

Closer view of the fire-related damage under the left side of the truck cab. The heat wrapping on the exhaust pipe was saturated with transmission fluid.

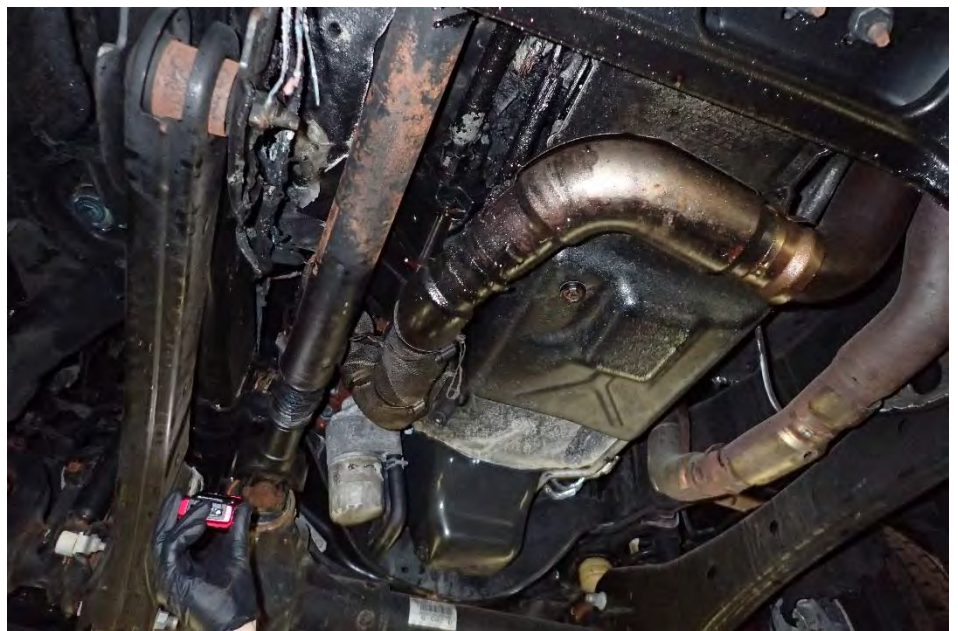
92

Rear view showing the left side of the transmission. The area of origin is clearly defined by the fire patterns.

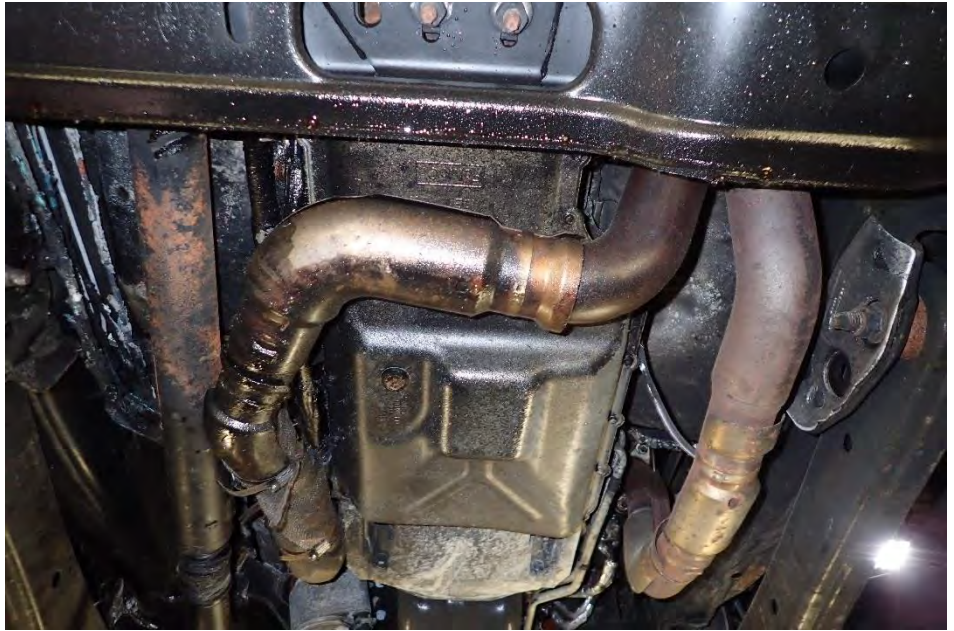
95

View looking at the rear of the automatic transmission oil pan. Burned oil could be seen on the exhaust pipe and underneath the left side of the floor pan. There was a defined fire pattern on the left side of the transmission pan.

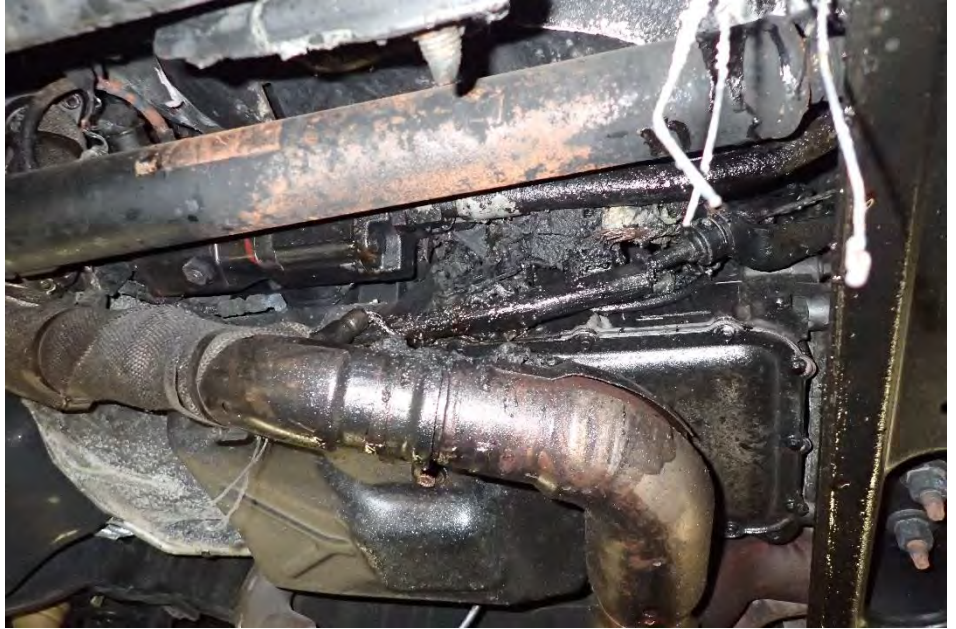
Closer view of the left side of the transmission. The exhaust pipe was soaked with fluid. The PTO pump and the reservoir line can be seen directly above the exhaust pipe.

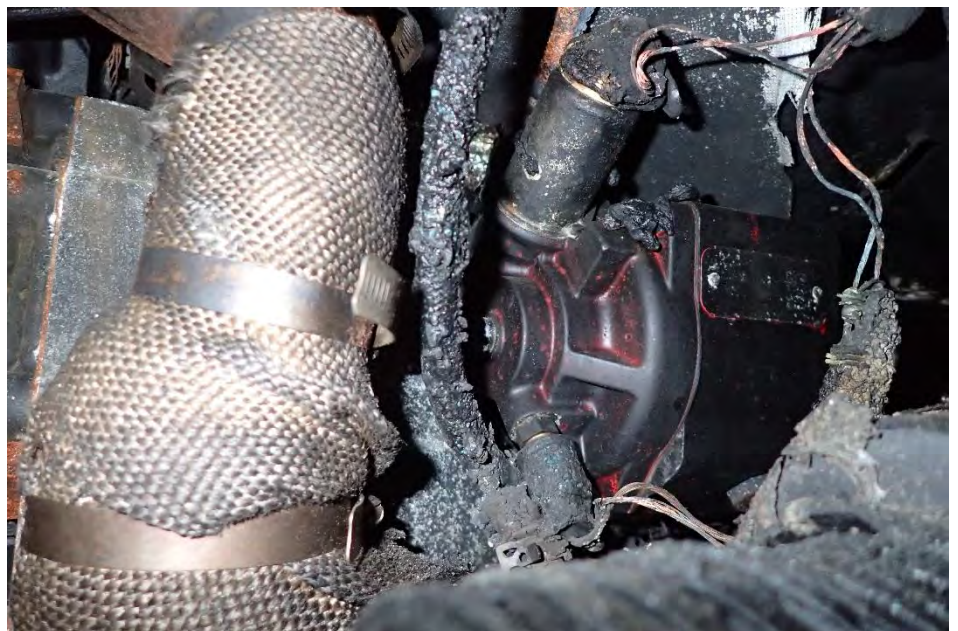
104

Closer view showing the burned transmission line located between the PTO pump and the exhaust. The PTO line should have been run in a different route where it would not come in close proximity to the exhaust pipe.

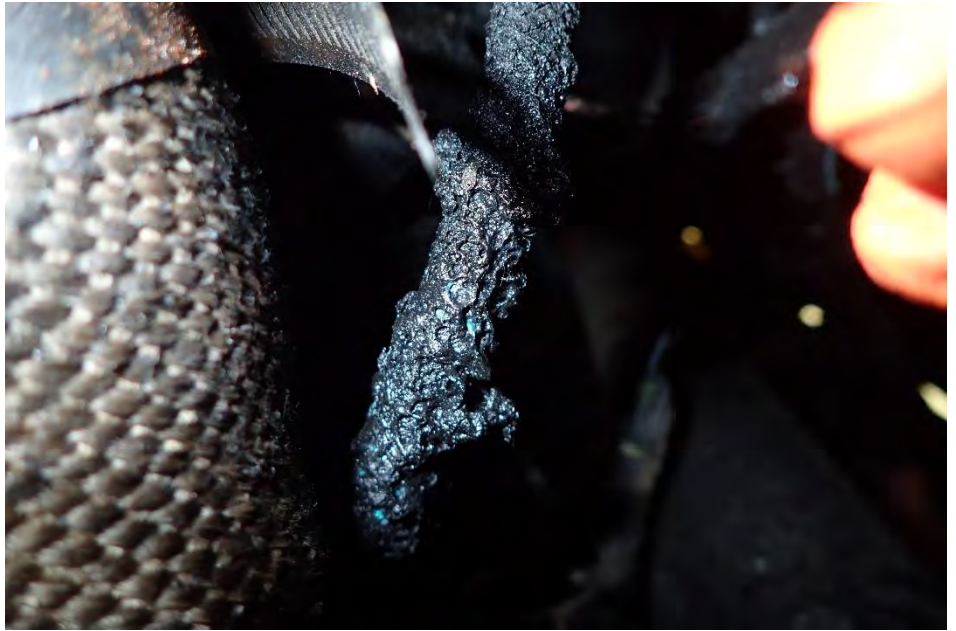
105

View of the burned pressurized transmission line extending from the transmission to the PTO switch. It was in close proximity to the exhaust pipe.

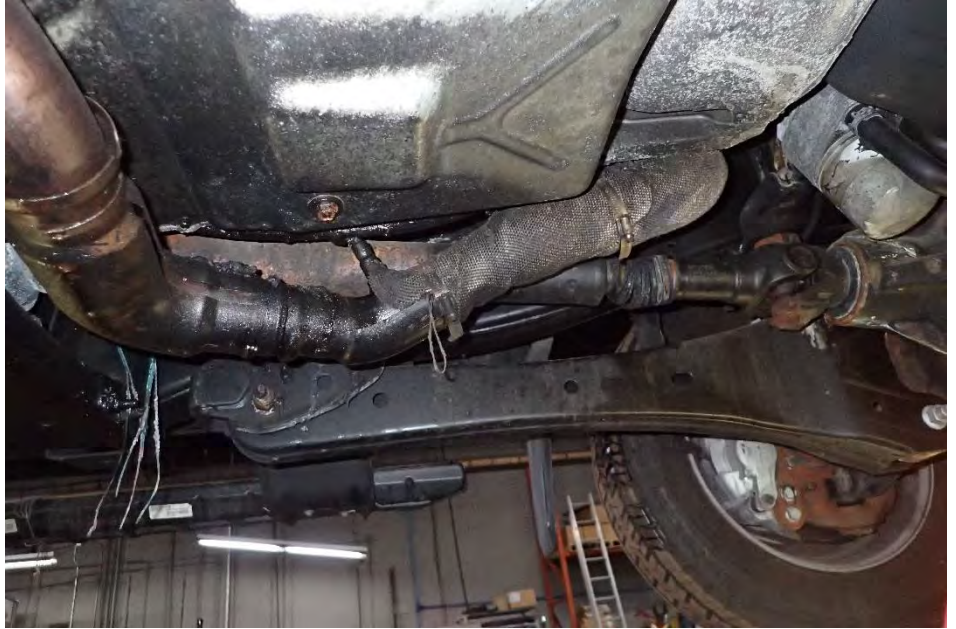
107

View of the left side framerail of the truck. The left side exhaust pipe and the crossover can be seen below the transmission. The wrapping was soaked with transmission fluid and fluid was burned onto the surface of the pipe.

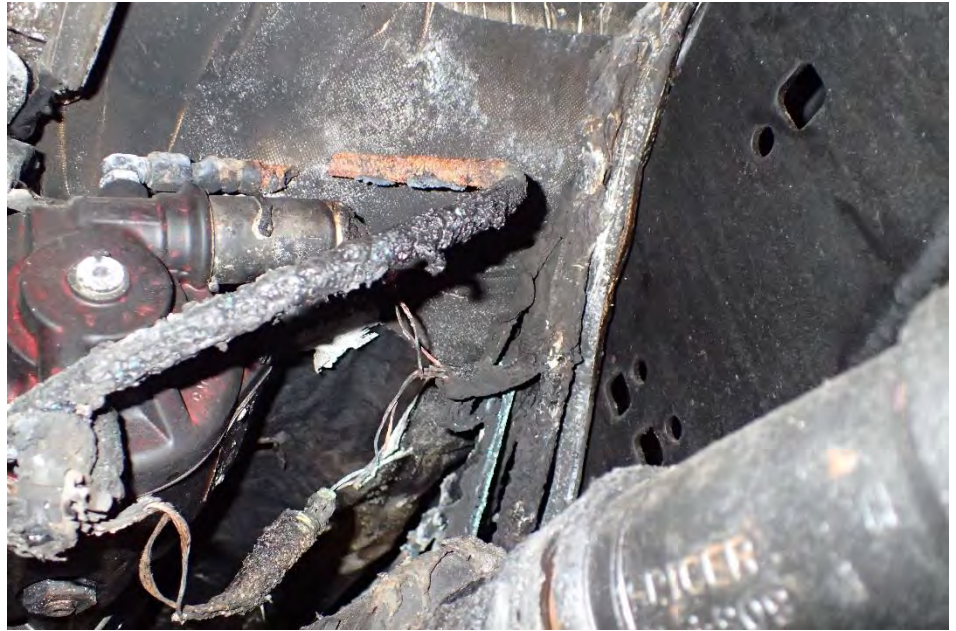
121

View of the pressurized transmission line where it extends to the activation switch on the PTO. When the exhaust pipe was removed, the upper portion of the pressurized transmission line was found to be fractured.

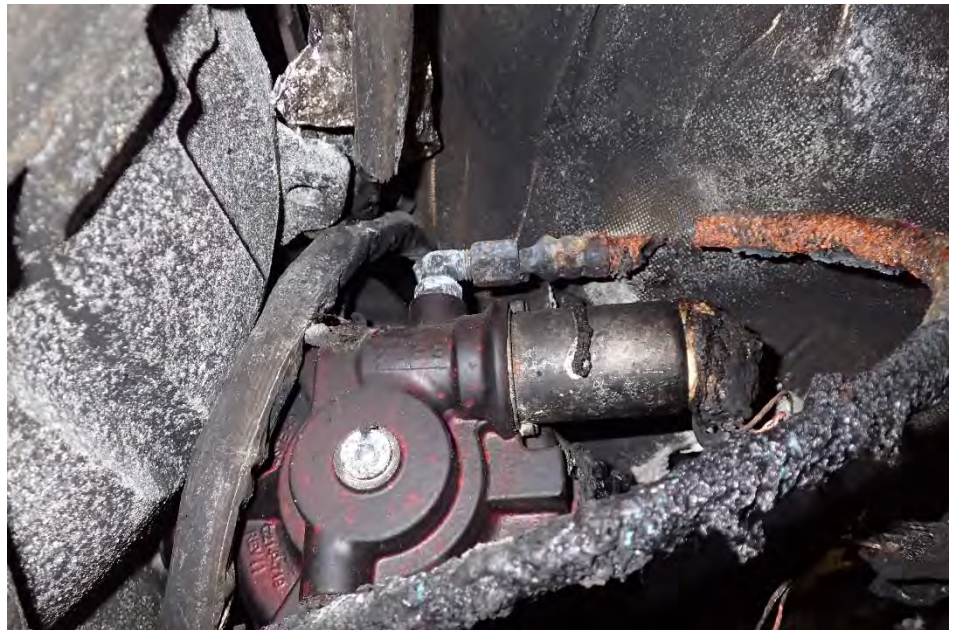
126

The hose was fractured where it had been up against the floor of the truck.

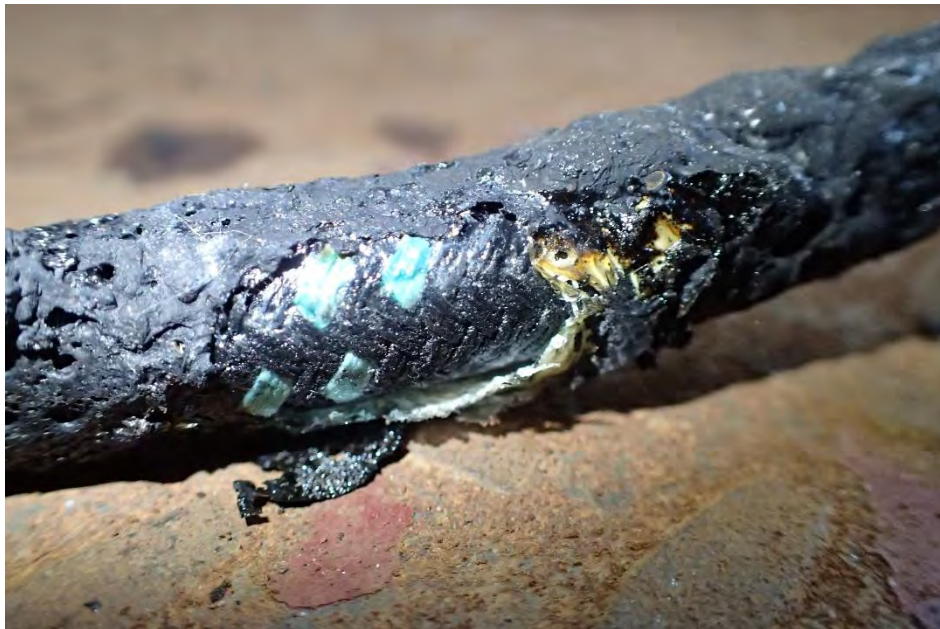
141

We separated the transmission line from the gearshift cable and found that it was not rubbed through.
