CITY OF SOMERVILLE, MASSACHUSETTS
DEPARTMENT of ENGINEERING
JOSEPH A. CURTATONE
MAYOR

**BOARD ORDER #203947 - ELMWOOD FLOODING
ENGINEER'S REPORT**

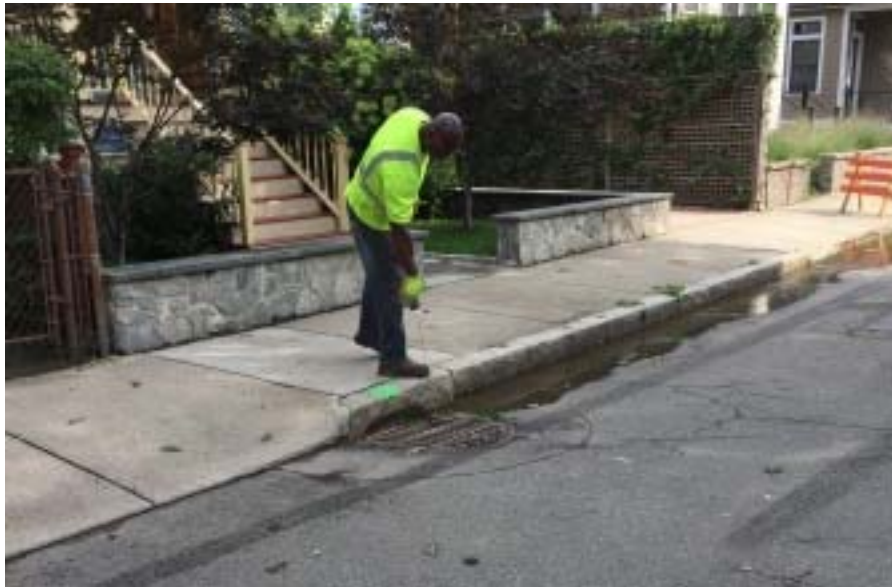
The roadway is generally in good condition, and localized flooding due to roadway grading is not evident. There are catch basins in the public right of way at Elmwood Street's intersections with Holland Street, Elmwood Terrace, and Tannery Brook Row. Catch basins also exist on private property for the condo complex at 39-41 Elmwood / 40 Cameron.

Figure 2 Catch Basin near Elmwood Terrace

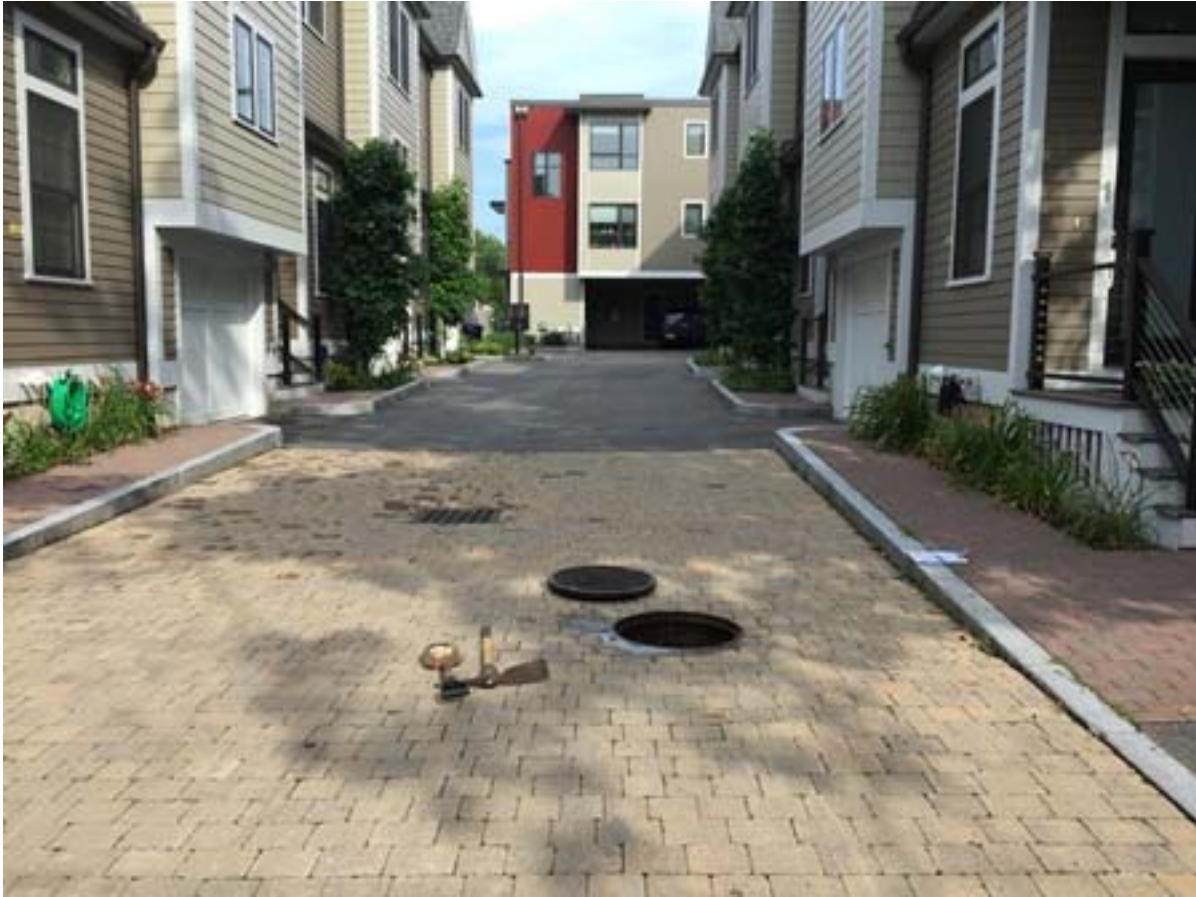
Figure 3 Private Subsystem for 39-41 Elmwood / 40 Cameron Condo

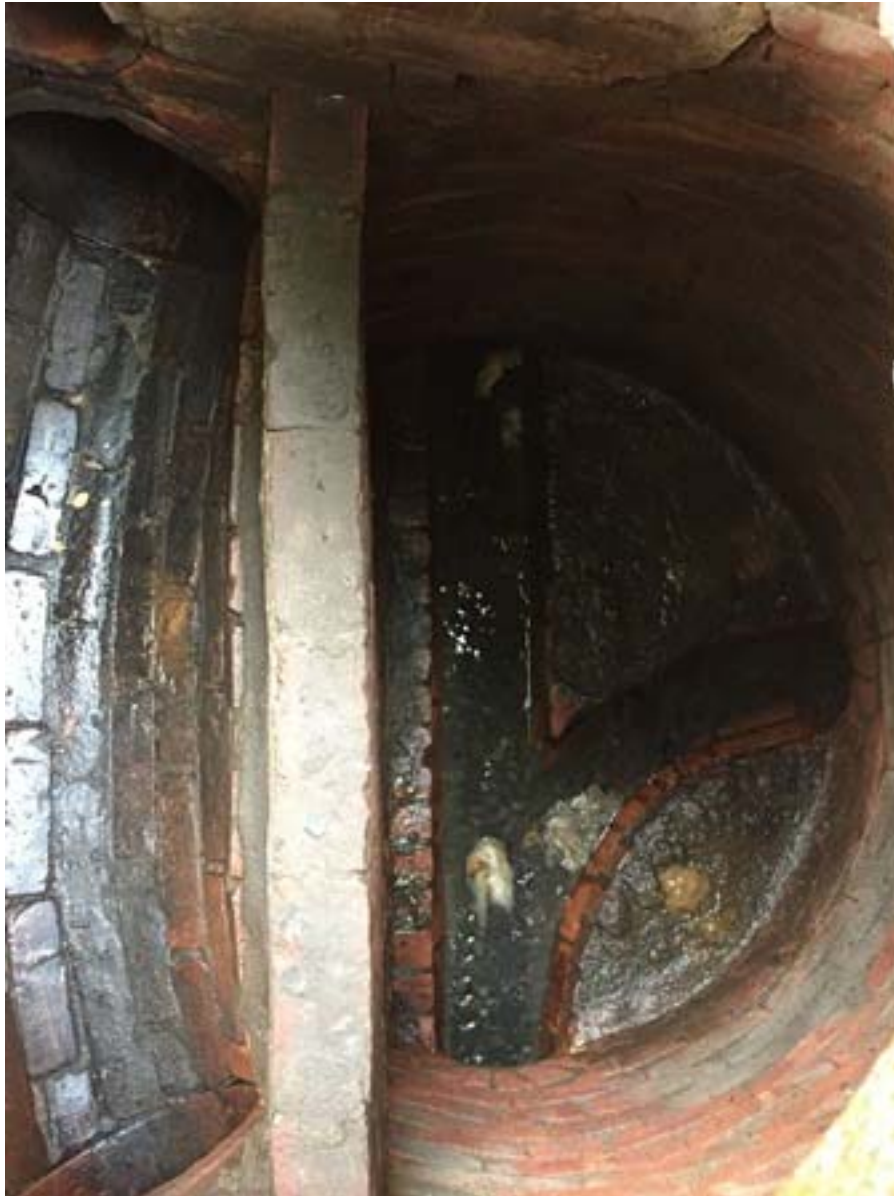
Dye testing in the area between 39 and 51 Elmwood Street confirmed that system connectivity is correct. The sanitary service for 47 Elmwood is connected to the deeper sanitary system. The public catch basins near Elmwood Terrace are connected to the shallower drain system. The common manhole near Elmwood Terrace; however, can create cross-communication between the two systems during surcharge conditions.

Figure 4 Sanitary in Common Manhole

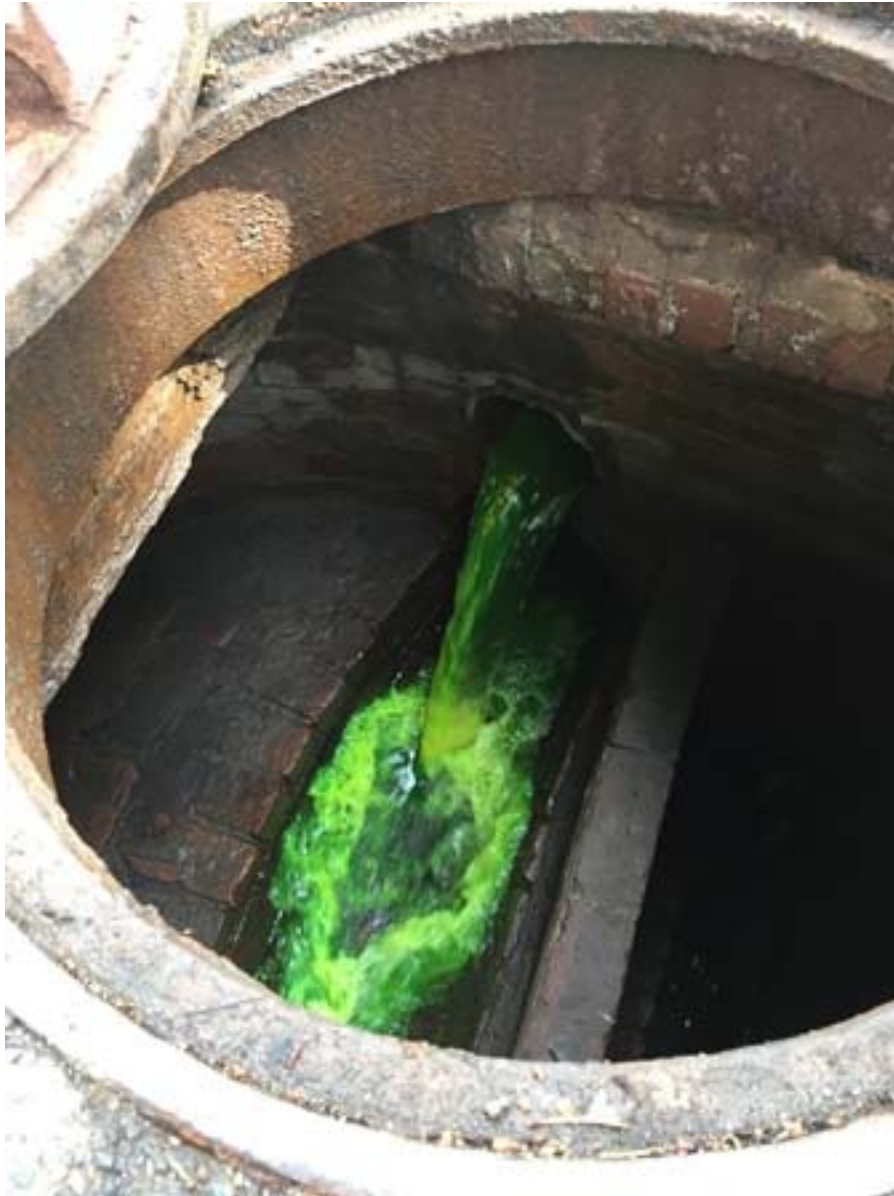
Figure 5 Stormwater in Common Manhole

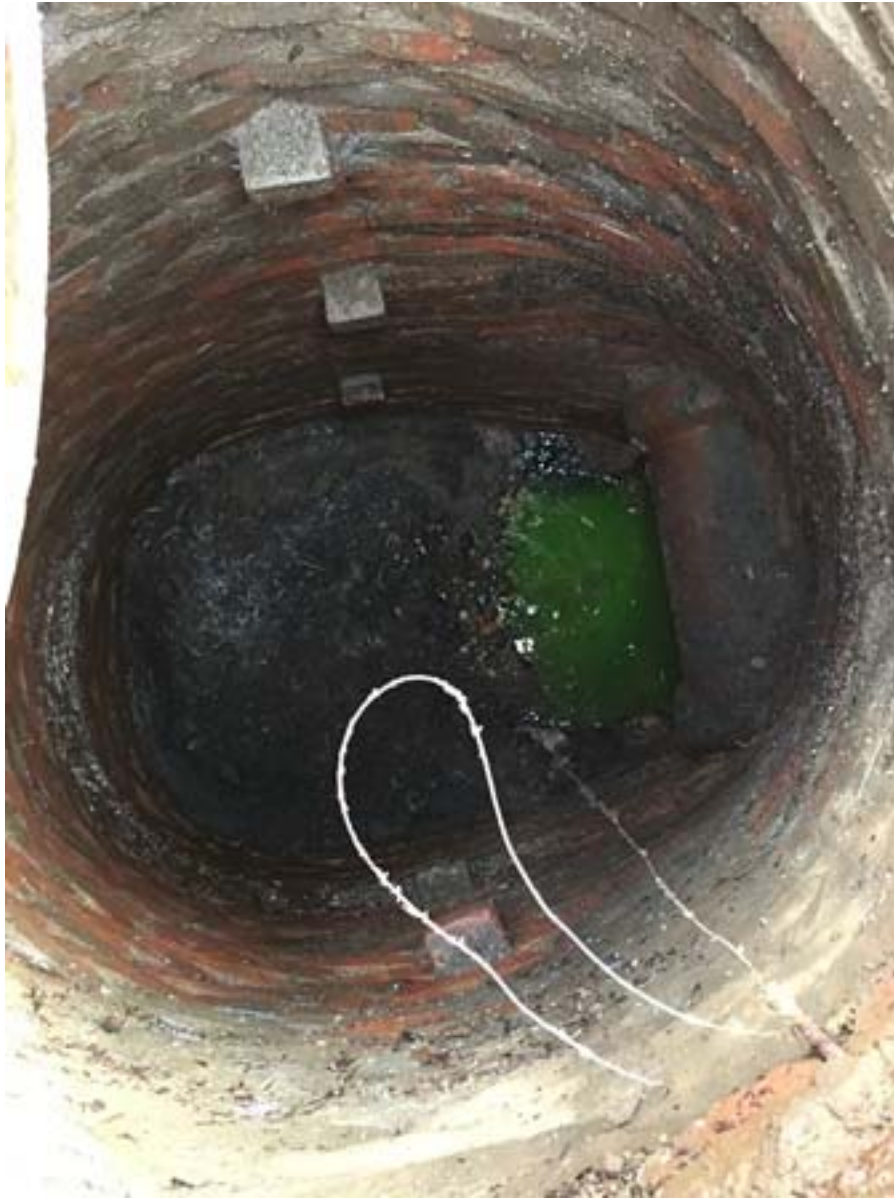
At the manhole at the intersection of Harrison Road, the storm drain line is hard-piped through the manhole eliminating the potential for cross-communication. However, that piping arrangement limits the hydraulic capacity of the sanitary sewer. Despite the Sewer Department's efforts to clean the system, a clearly defined channel for sanitary flow is lacking. Dye testing confirmed the connectivity of Harrison Road, but flow moves slowly. There is also evidence that the system surcharges regularly, which is consistent with reported problems along this region of the Tannery Brook system.

Figure 6 Obstructed Flow near Harrison Road

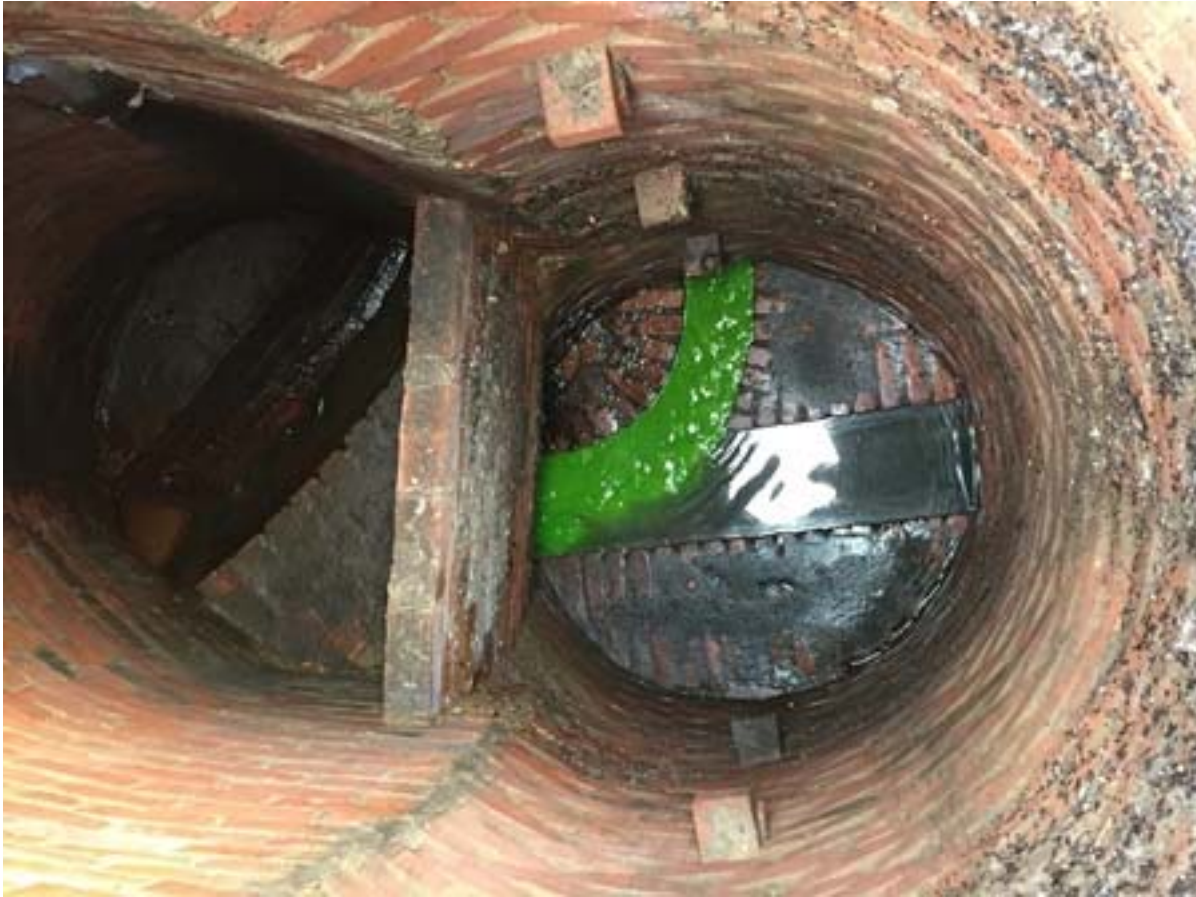
At the Elmwood Street system's connection to the Tannery Brook interceptor, dye tests again confirmed that the 12" Elmwood drain and the 8" Elmwood sanitary sewer are connected to the appropriate portions of Tannery Brook system. However, those connections are in a common manhole; therefore surcharging of either system can create cross-communication between the systems. Moreover, this condition is present at many locations along the Tannery Brook system, so despite locally separate systems, all pipes act as combined sewers during large storm events.

Figure 7 Sanitary Connection to Tannery Brook System

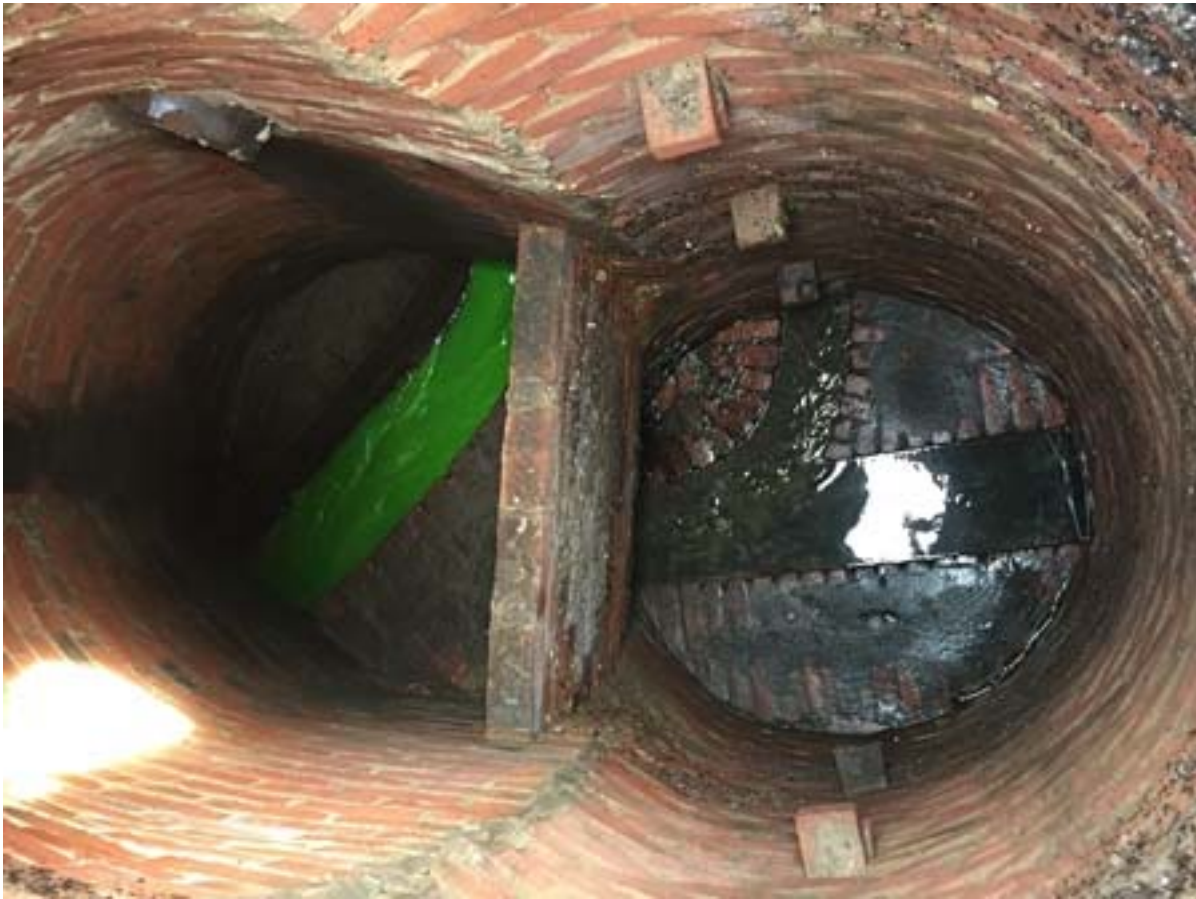
Figure 8 Storm Connection to Tannery Brook System
