Project Name: Structural Stabilization Project

Project Location: 277 Broadway, Somerville, MA 02145

Building Conditions Assessment

31 May 2019

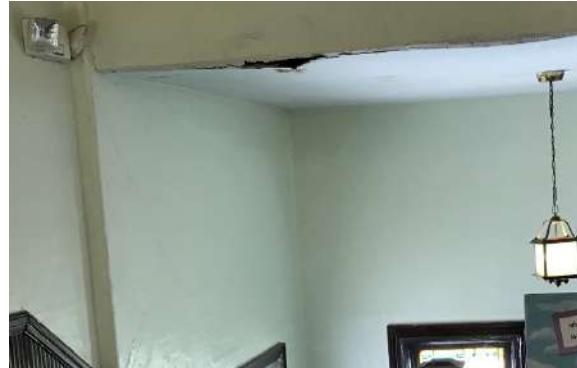
There appears to be active water infiltration where the low roof edges intersect the tower. This may be due to flashing not having been installed by the roofers, or other movement created by summer heat or winter ice. Damage from the water intrusion can be seen in the front stairs. See photos to the right.

3 Roof-wall intersection and possible leak above the north stair.

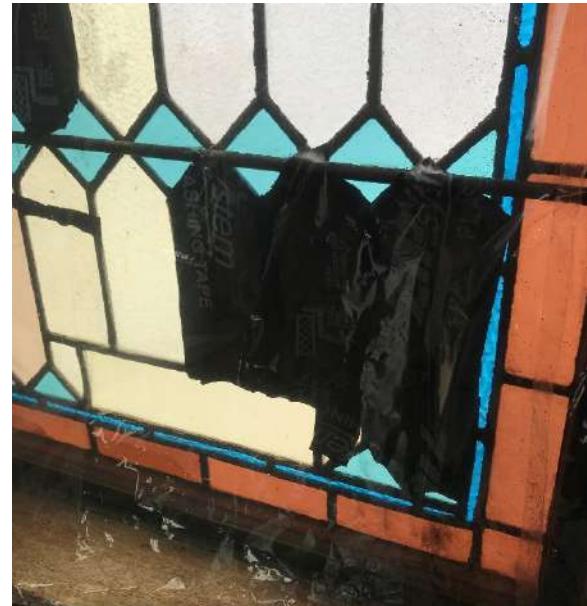
4 Patched stained-glass detail

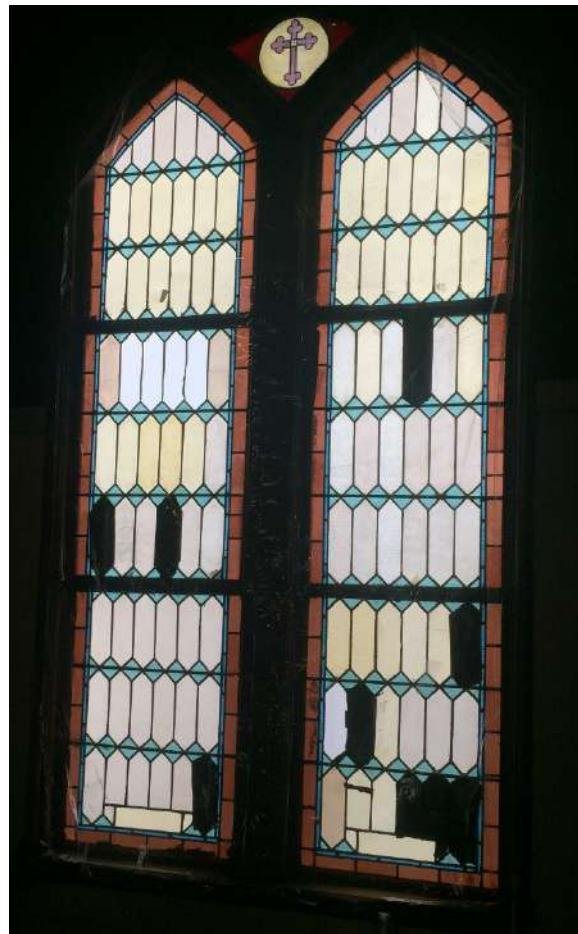
5 Patched stained-glass window

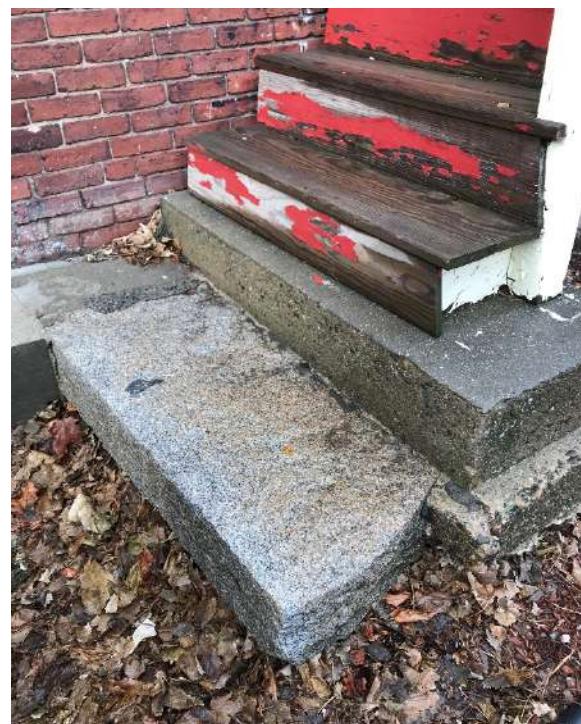
- Two exceptions to the above are:
 - The southeast exterior egress stair, is a dangerous condition and should be remediated as soon as feasible.
 - The electrical grounding is inadequate. It should be upgraded as soon as feasible

1Bottom risers of southeast egress stair

The egress stair on the south east is open to the large area and includes winders on the stair. This stair also leads to the southeast exterior stair described above.

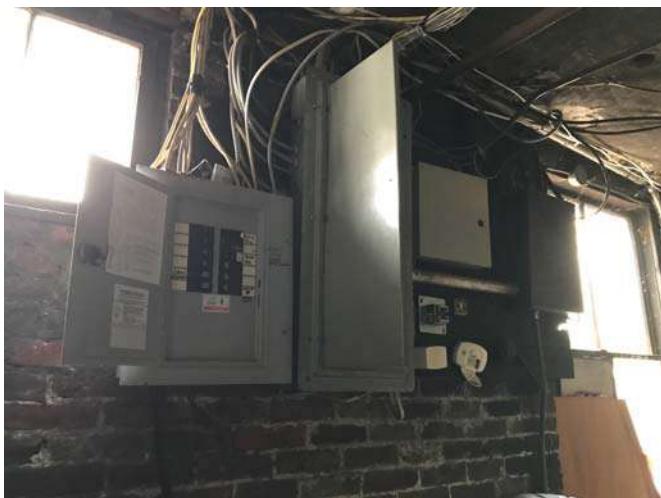
Photo #1

It was noticed that the main load center and the adjacent supplemental load center was mounted at a height that does not comply with accessibility requirements dictated in the NEC. Article 240.22 states; "Circuit breakers and fuses must be readily accessible, and they must be installed so the center of the grip of the operating handle of the fuse switch or circuit breaker, when in its highest position, isn't more than **6 feet, 7 inches** above the floor or working platform". The main load center in boiler room does not comply with this requirement. The main circuit breaker and number of the branch circuit breakers are located above the 6'-7" requirement. When renovations take place the existing arrangement will need to be corrected. See Photo 1.

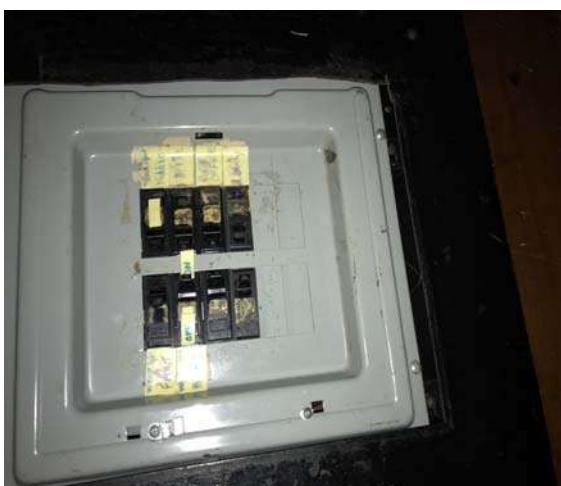
Photo #2 (Stair)

There are two other load centers within the facility. There is one on the second floor located on the stairs leading to the mezzanine and another one at the mezzanine level. The load center on the second floor is recessed in the wall of the stairs and is a 12 circuit load center with 4 spaces for future circuit breakers. The load center at the mezzanine level is 20 circuit load center and primarily serves the theatre lighting and equipment. These load centers are showing signs of wear and should be upgraded if renovations are being considered. See Photos #2 & #3.

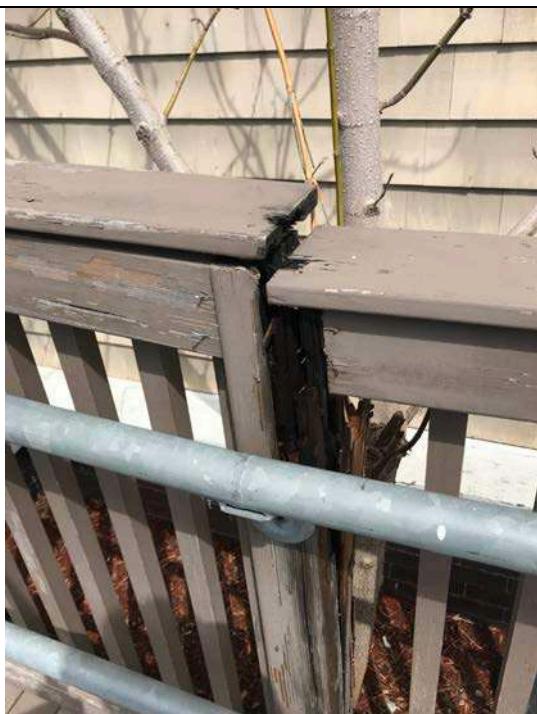
5. Front Ramp Rail Deterioration

- *Determine and remediate the water condition that has created the rot in some railings and posts.*
- *Replace rotted railing posts and hand rails.*
- *Replace rotted or splintered floor boards.*
- *See also recommendations in the Accessibility section of this report.*
- *Repair or replace the rear trash enclosure.*
- *Grounds need to be cleaned up and replanted with shrubs and trees and mulched.*

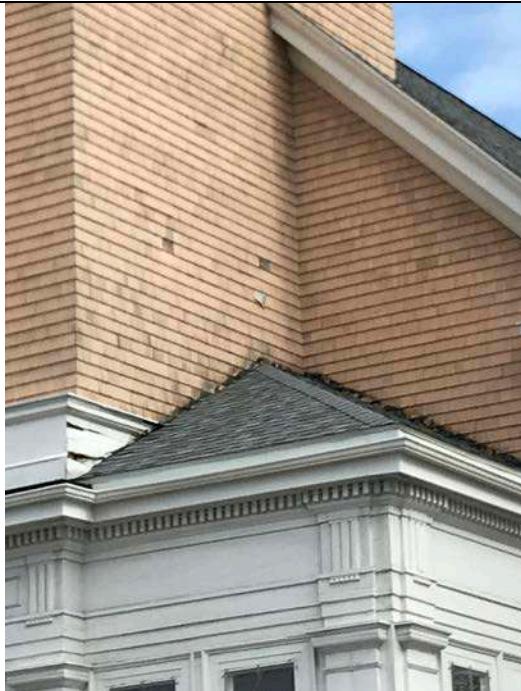
6. Flawed cheek wall flashing

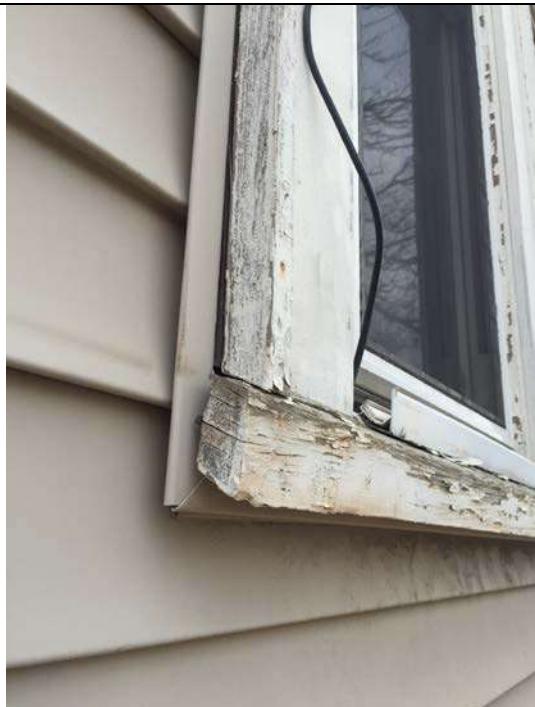
11. Condition of Exterior Window Trim and Sill.

- *Scrape, paint and replace as required the:*
 - *First floor window trim*
 - *Wooden spandrels between the first floor and upper level windows.*
- *Survey all other windows for thermal failure and create a schedule for restoration or replacement on a case-by-case basis.*
- *Repair the basement windows and screens.*
- *Create a capital reserve to restore and protect the stained-glass windows. Alternate proposals and prices should be solicited. Alternatively, this and other exterior restoration may qualify for CPA funding*

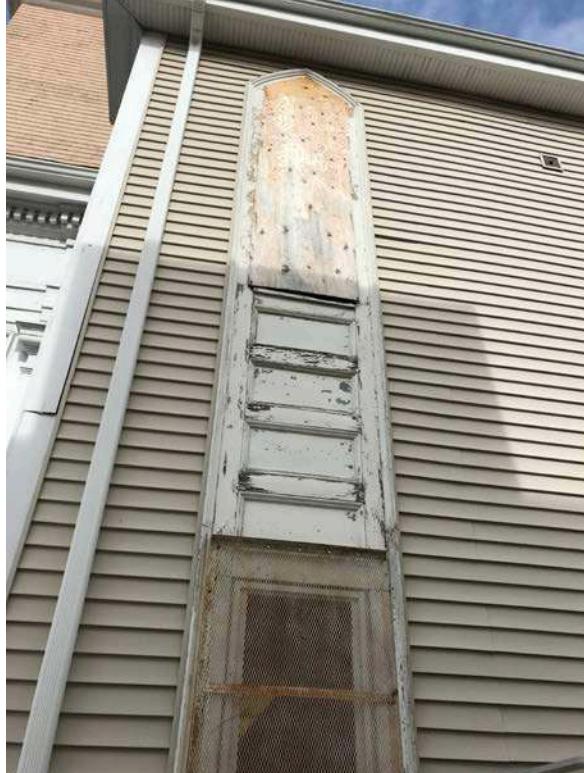
12. Condition of East Side Windows and Trim

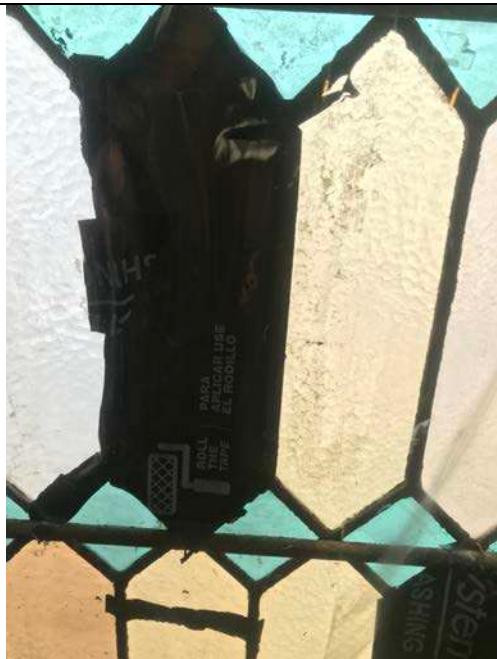
18.Temporary patches on broken Stained Glass Windows

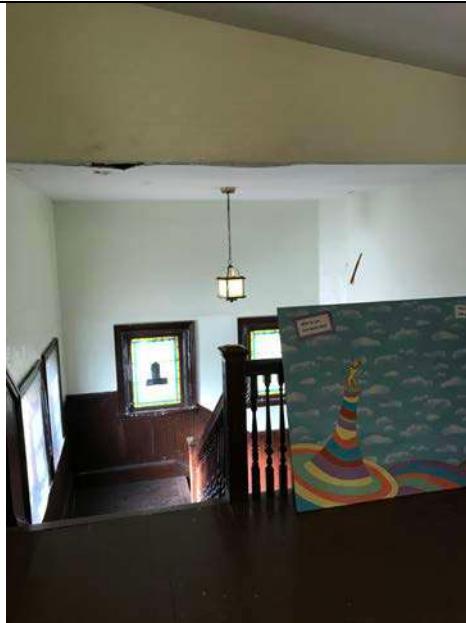
19. Front Hall Stair showing plaster damage from water intrusion.

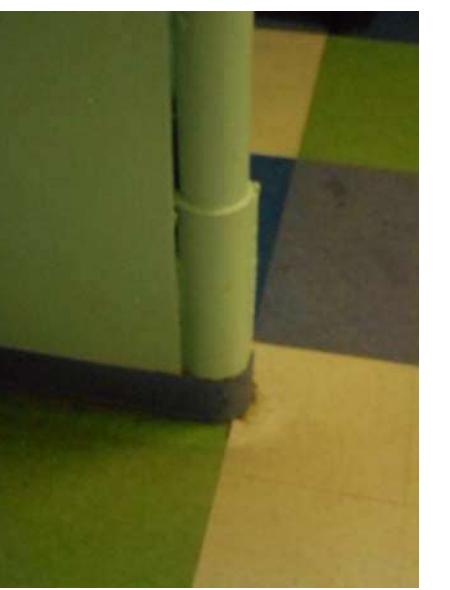
REINFORCED PIPE COLUMN REPAIRS

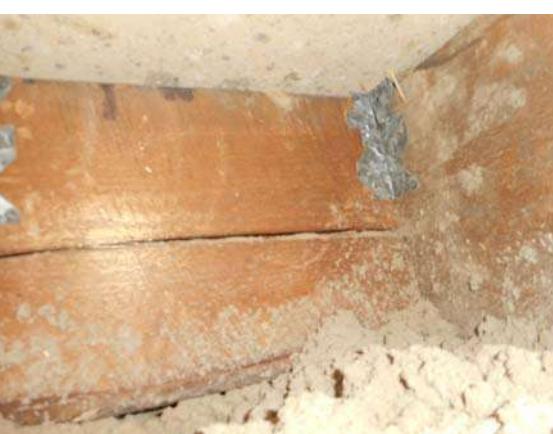
SECOND FLOOR JOIST WITH MODERN LIGHT STEEL ANGLES INDICATING RECENT FLOOR REPAIRS.
