City Of Somerville – 42 Cross

42 Cross Street, Somerville, MA 02145

Phase 1 - Two Year Planning

February 29, 2024

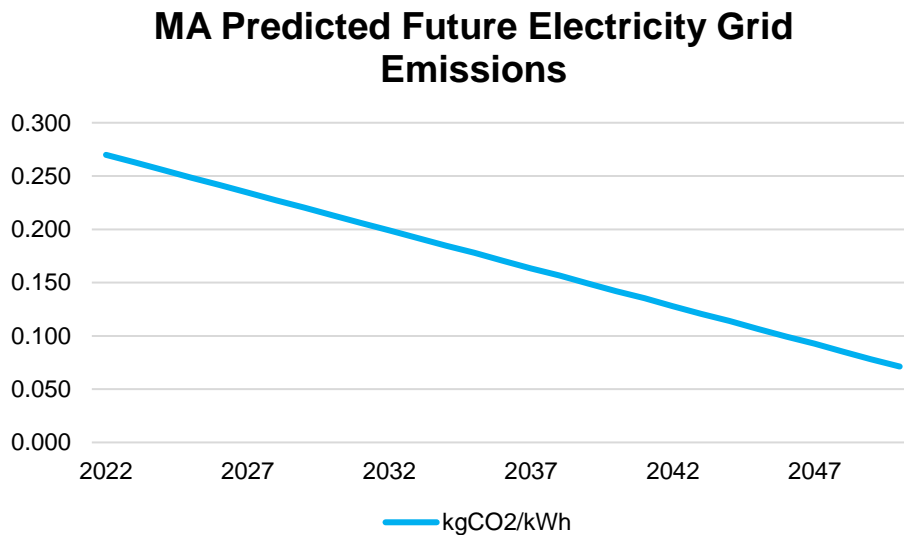
Figure 2 Future Electricity Grid Emissions

Carbon emission rates are calculated using rates provided by City of Boston published Projected Grid Emission Factors (see Figure 2 below) and Energy Star Portfolio Manager Building Emissions Calculator Technical Reference Document.

> Electricity Carbon Emissions Rates (MA 2023):	0.263 kgCO ₂ e/kWh
> Electricity Carbon Emissions Rates (MA 2024):	0.256 kgCO ₂ e/kWh
> Electricity Carbon Emissions Rates (MA 2026):	0.242 kgCO ₂ e/kWh
> Electricity Carbon Emissions Rates (MA 2030):	0.213 kgCO ₂ e/kWh
> Electricity Carbon Emissions Rates (MA 2040):	0.142 kgCO ₂ e/kWh
> Electricity Carbon Emissions Rates (MA 2050):	0.071 kgCO ₂ e/kWh
> Natural Gas Carbon Emissions Rates (USA):	53.11 kgCO ₂ e/MMBTU

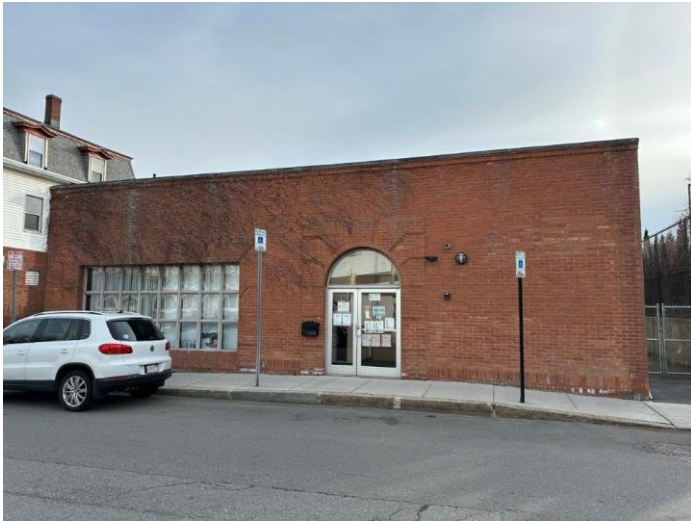
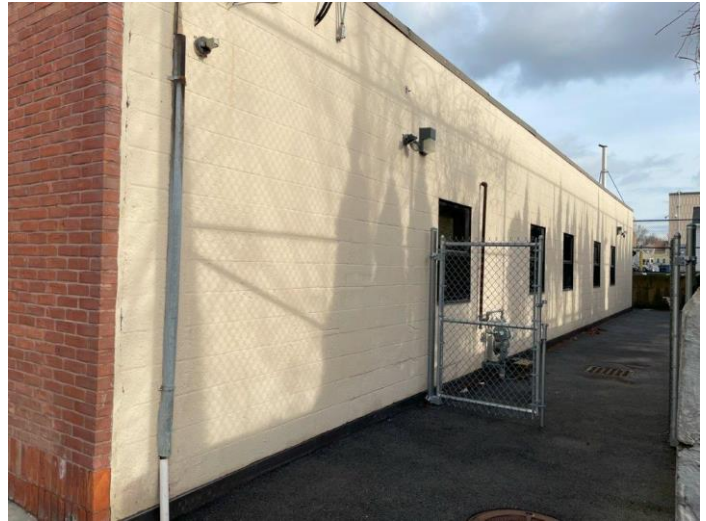
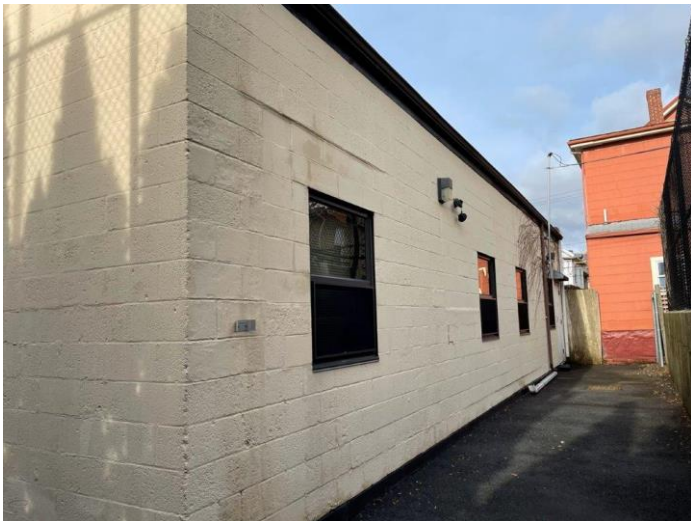
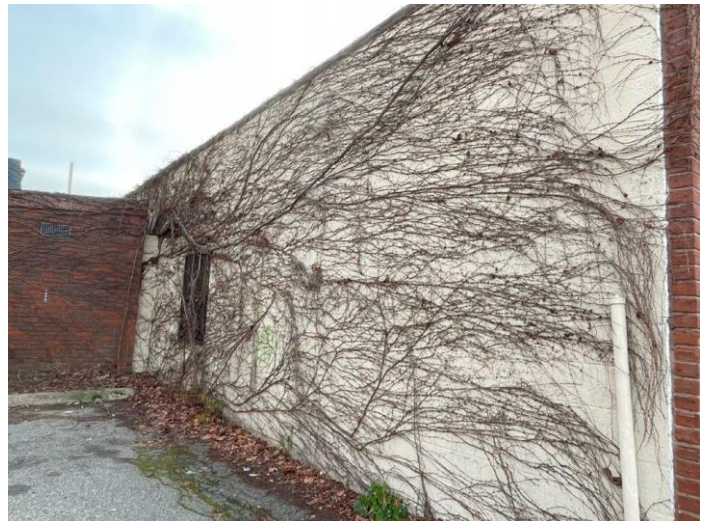
Photo 1 - West (top-left), South (top-right), East (bottom-left), and North (bottom-right) building elevations. Triple-wythe brick masonry wall on West elevation, and single-wythe CMU construction on other elevations. Vines need to be removed prior to roof replacement for roof edge access.

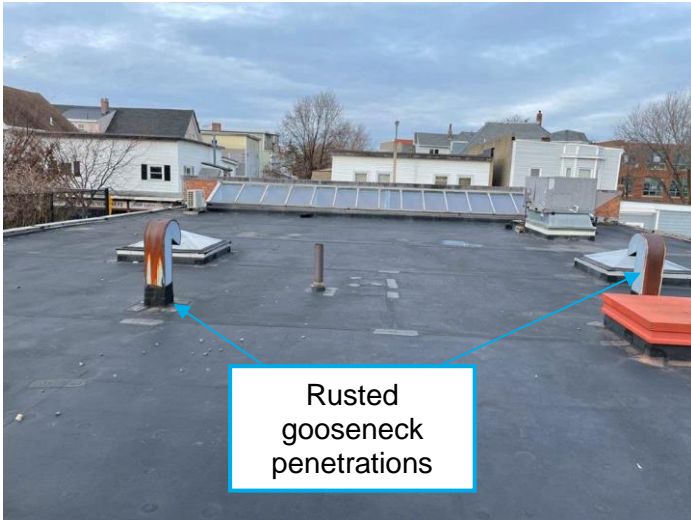
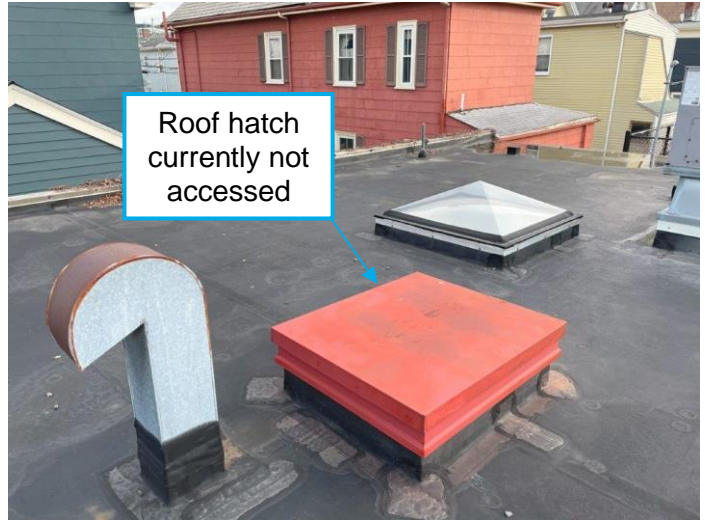
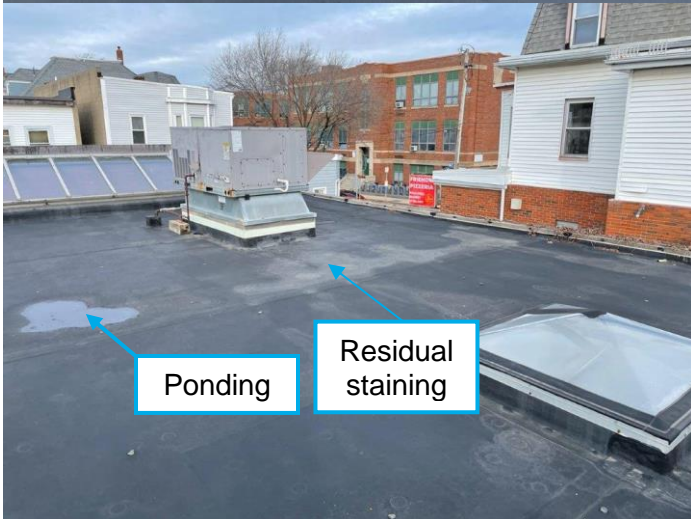
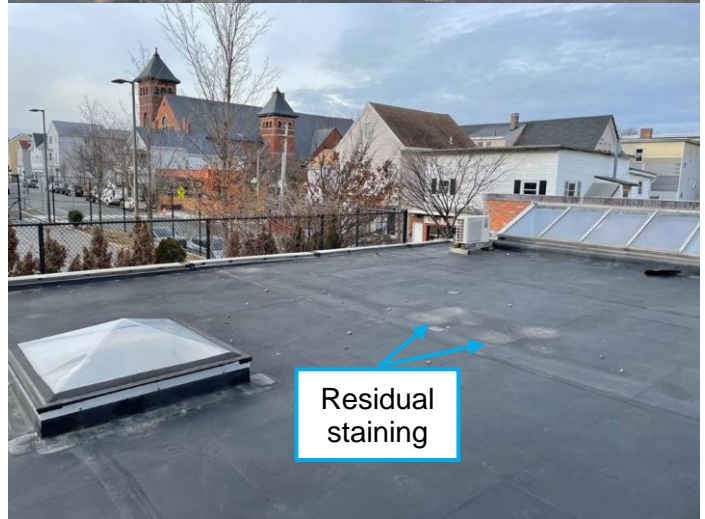
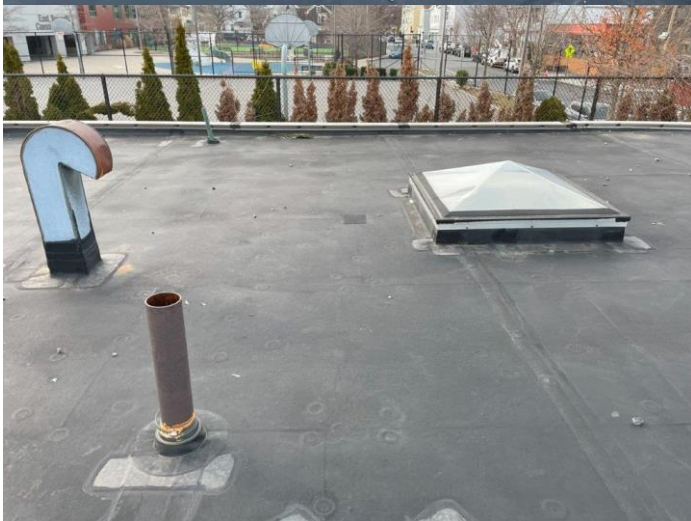
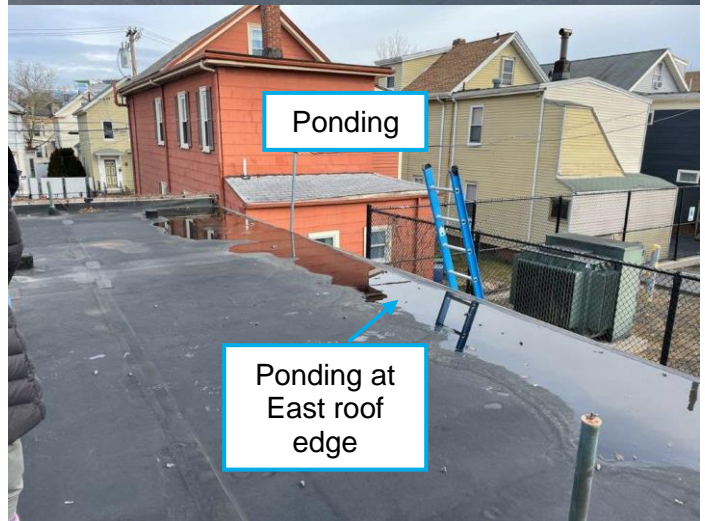
From our on-site visual observations, there were areas of ponding water and residual dirt staining at the roof membrane (Photo 2). Ponding water for short durations is unavoidable and typically considered acceptable by roof manufacturers, however water that stagnates on a roof for more than 48-hours is considered detrimental to the roofing assembly. Ponding water typically occurs because the roofing drainage system is not adequate for the structure, or because of high-low variations within the roofing assembly. Test cuts taken on February 12, 2024 revealed that the flutes in the steel deck are filled with gravel surfacing, which can cause the deck to deflect, along with roofing paper, which may be asbestos-containing. Ponding at the East edge of the building is occurring because the roof blocking is too high, and not allowing water to drain; we noted on our February 12, 2024 site visit that the roof has a 1/8" slope

to the East side of the building. The gooseneck penetrations are rusted, and the roof hatch does not have interior access or exterior safety railing.

Photo 2 – Overview of Roof with Carlisle EPDM FR membrane. There is active ponding and residual dirt staining on the center of the roof, as well as areas of active ponding on the East roof edge. Rusted gooseneck penetrations should be wire-brushed and painted. The roof hatch has no interior access or exterior safety railing.

Dark roof membranes absorb heat and transfer it into the building, and do not reflect the UV rays responsible for membrane deterioration. A full roof replacement utilizing a “tear-off” application would improve the thermal performance and reflectivity of the roof. Refer to Section 3 Recommendations.

We recommend full roof replacement utilizing a “tear-off” application, which includes complete removal of all roofing down to the roof decking level followed by the installation of a new single-ply reflective roofing system. This work will require removal of the vines that are on the North and West elevations (Photo 1) for roof edge access. The gravel surfacing and roof paper installed in the steel flutes will also need to be removed, as they cause the deck to deflect.

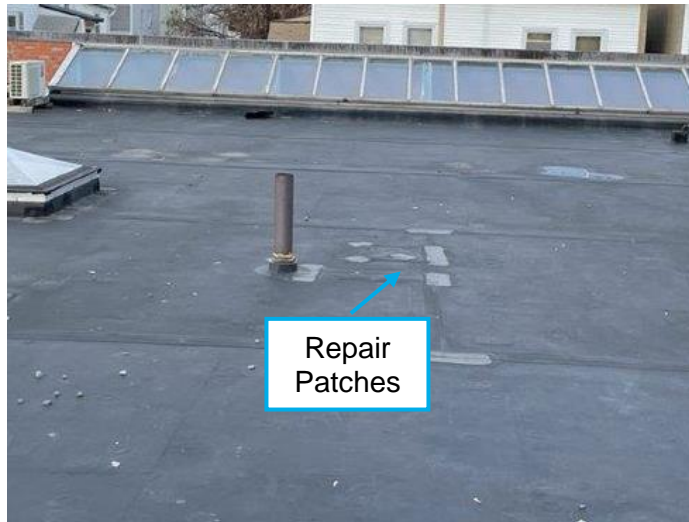
There are isolated areas repair patches throughout the roof areas, indicating that these repairs have been made to locate/stop leaks or seal punctures (Photo 3). At the brick parapet, the rough edges of the flashing are touching the roof, which can cause punctures in the EPDM membrane; the flashing is also not tied into the skylight assembly, relying only on sealant at the joint interface and creating potential for water penetration at the joint (Photo 4). At the sloped skylight curb, the EPDM appeared to be delaminating from the curb (Photo 8). The spray foam insulation installed at the underside of the roof deck, as viewed in the Electrical/IT room, is peeling in some locations and is not continuous (Photo 6).

Photo 3 - Isolated areas of repair patches on EPDM roof.

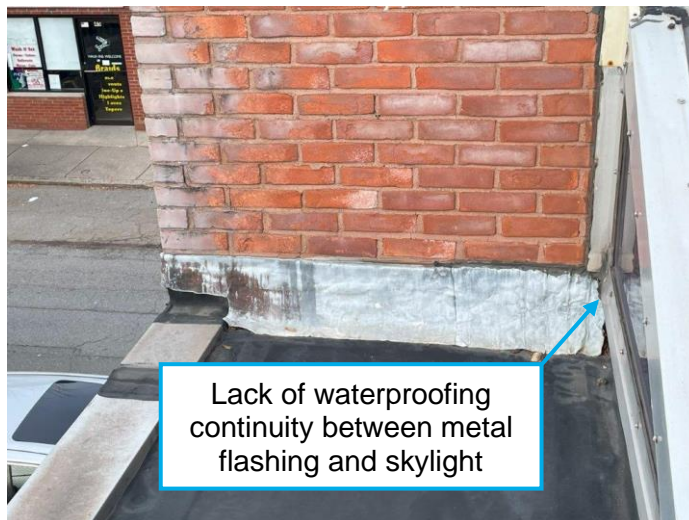
Photo 4 - Metal flashing at parapet. Low flashing height. Rough edges of flashing are touching the roof, which may cause punctures in the EPDM membrane. Flashing is not tied into skylight, relying only on sealant, and creating potential for water penetration at corner joint.

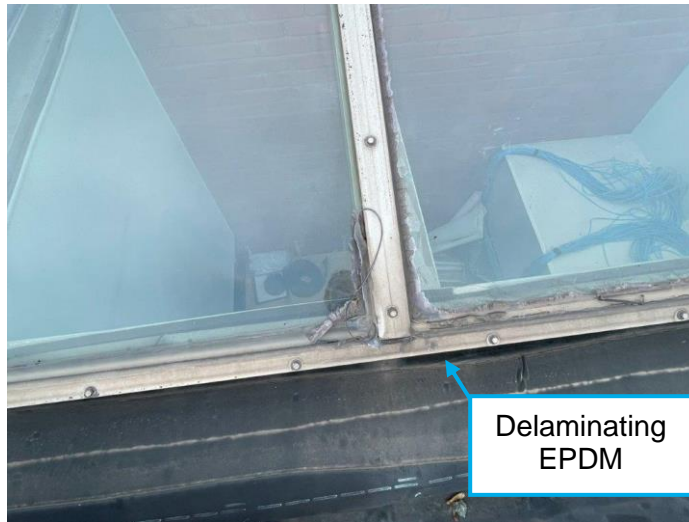
Photo 5 – Sloped skylight at West elevation. EPDM membrane is delaminating at skylight curb.

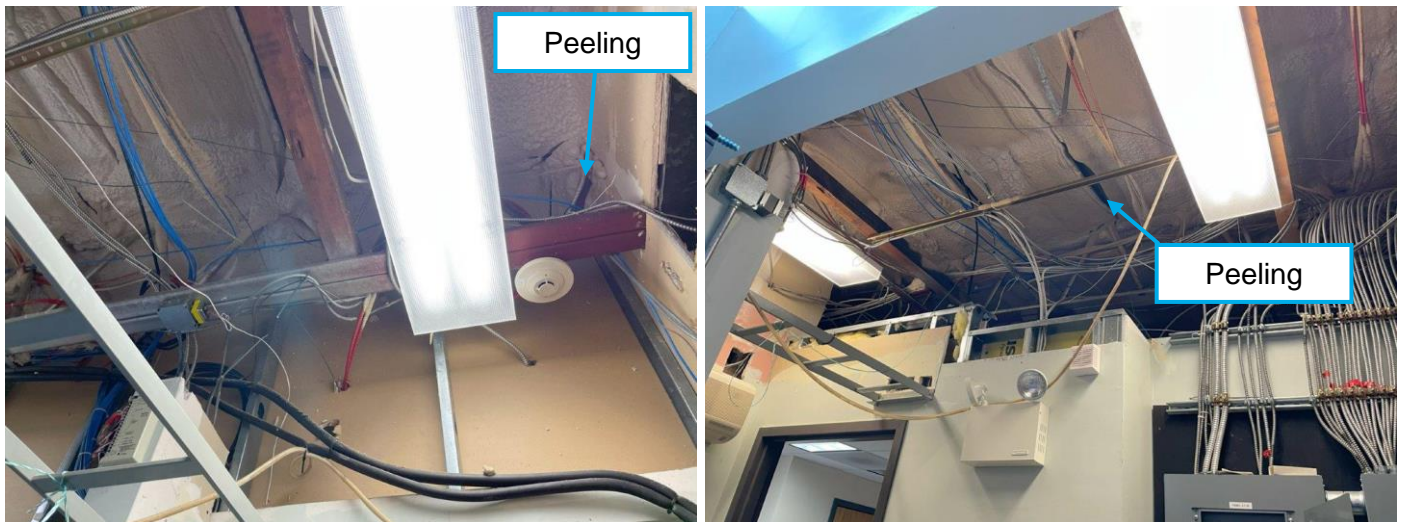
Photo 6 - Spray-foam insulation installed at underside of roof deck, as shown in the Electrical/IT room, is peeling and not continuous.

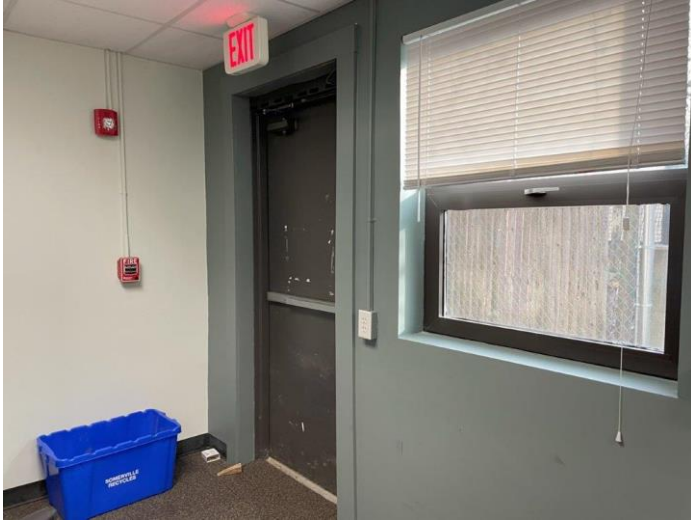
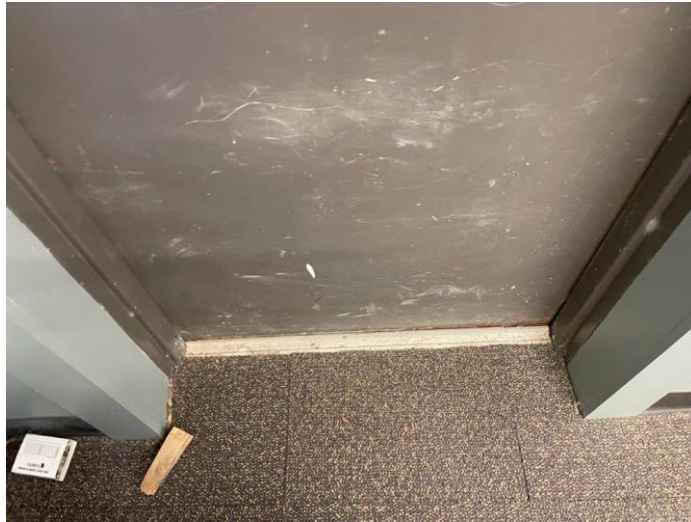
The occupant sitting near the East-facing egress door (Photo 9) noted draftiness in their work space. The blower door test showed a high amount of air leakage at this door, 123 CFM, when the building was depressurized to -50Pa – refer to Appendix D. There are no drawings available showing how this door is tied into its surrounding conditions, however it is likely not an airtight seal. Evidence of moisture damage at the door head indicates potential condensation within the wall cavity.

Photo 9 - Back egress door. Occupant seated near egress door has noted draftiness. Evidence of moisture damage is apparent at door head. Blower door test showed 123 CFM air leakage at egress door when tested at @-50Pa. Refer to Appendix D.

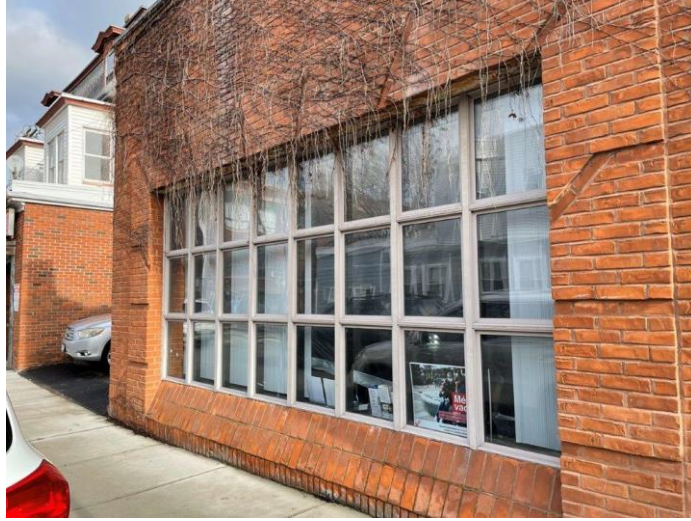
There is a large storefront window in the Community Room (Photo 10) on the street-facing West facade. The storefront is a muntin grid holding double-pane glazing. Using ASHRAE Appendix A, we estimate this system is U- 0.9 and SHGC-0.68. For comparison, MA Stretch Code requires maximum U-0.30 and minimum SHGC-0.38. From conversation with the Office of Immigrant Affairs, we understand the Community Room is always cold in the winter; this could be because of the lower insulative value of the glazing, or because of air infiltration at the window perimeter – small gaps were observed in the masonry at the window perimeter. The blower door test showed 68 CFM air leakage at the storefront when the building was depressurized to -50Pa. The infrared thermography photos taken during this test showed active air infiltration around the rough opening. Refer to Appendix D.

Photo 10 - Storefront window in Community Room. Blower door test showed 68 CFM air leakage at storefront when tested @-50Pa. Refer to Appendix D.

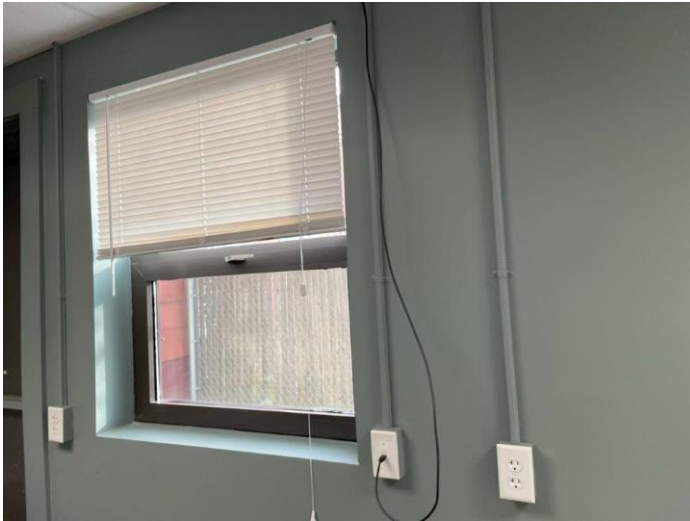
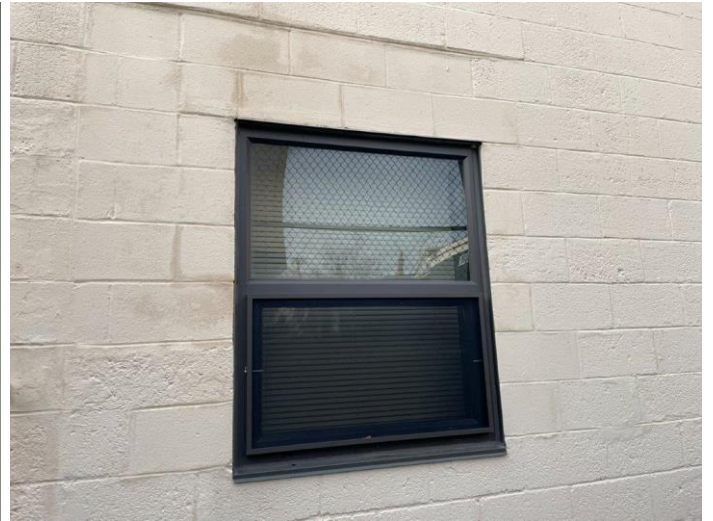
There are fifteen punched windows throughout the office space that were installed as part of the 2016-2017 Russo Barr renovations (Figure 5, Photo 11). These are thermally broken Winco 8250 operable windows with mesh security screens. They consist of, from outside to inside: 1/4-inch tempered exterior glass (PPG Solargray); 1/2-inch cavity with 90% argon-filled air space and warm-edge spacer; 1/4-inch interior tempered glass (with PPG Solarban 60 Low-e on #3 surface).

Photo 11 - Typical Winco window opening in open office area, installed in 2017. Blower door test showed 35 CFM air leakage across all punched windows (except for the windows located behind the archives storage, which remained sealed) when tested @-50Pa. Refer to Appendix D.

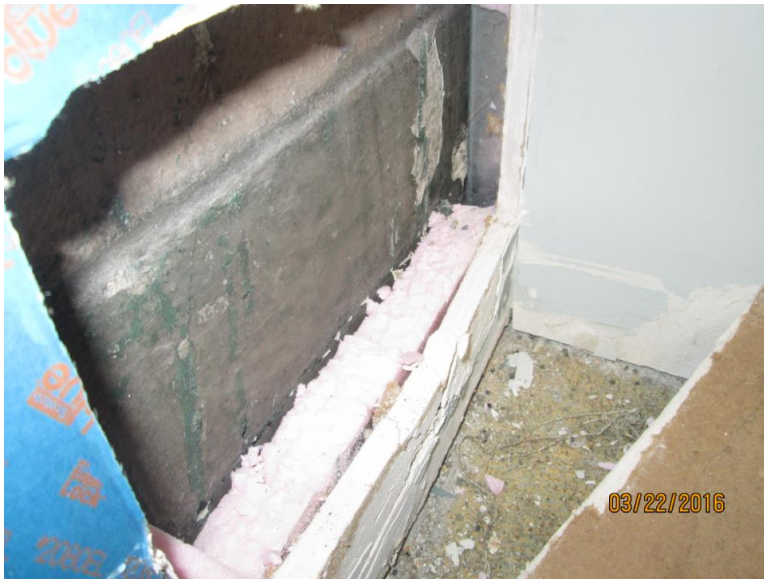
Photo 12 – Exterior wall composition, from Russo Barr records dated March 22, 2016.

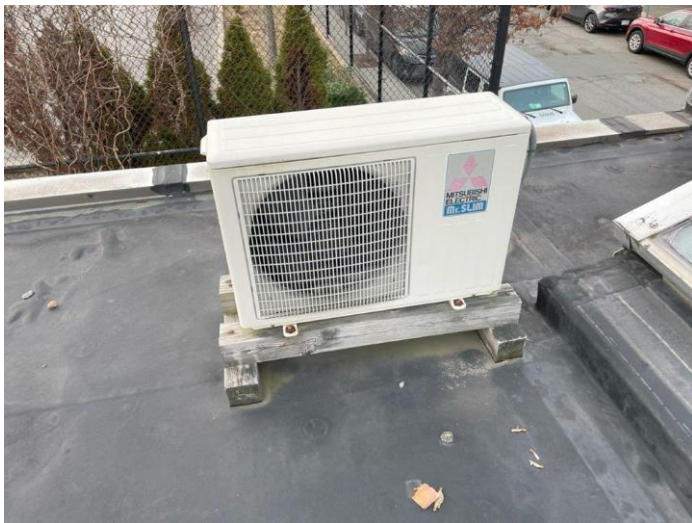
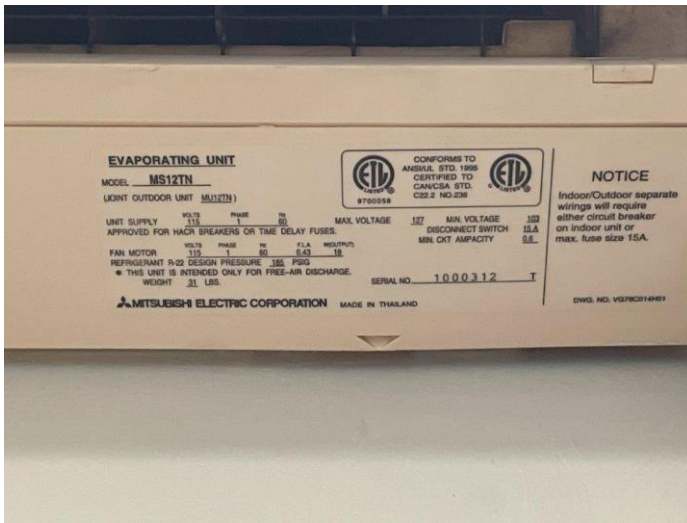
Photo 13 – Mitsubishi heat pump serving Electrical/IT Room.

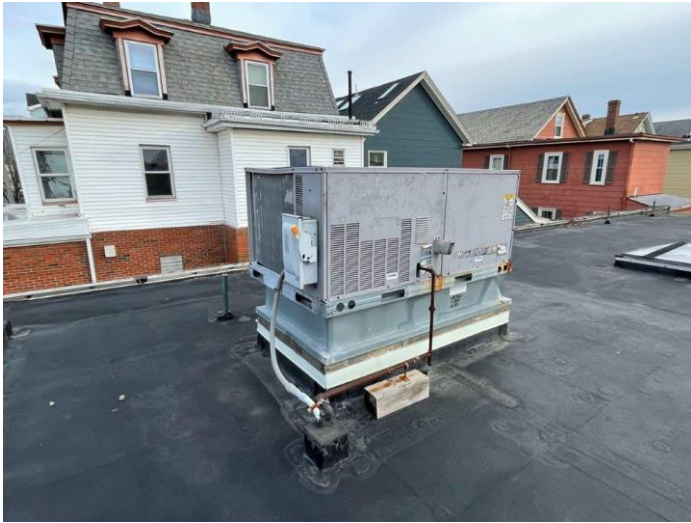
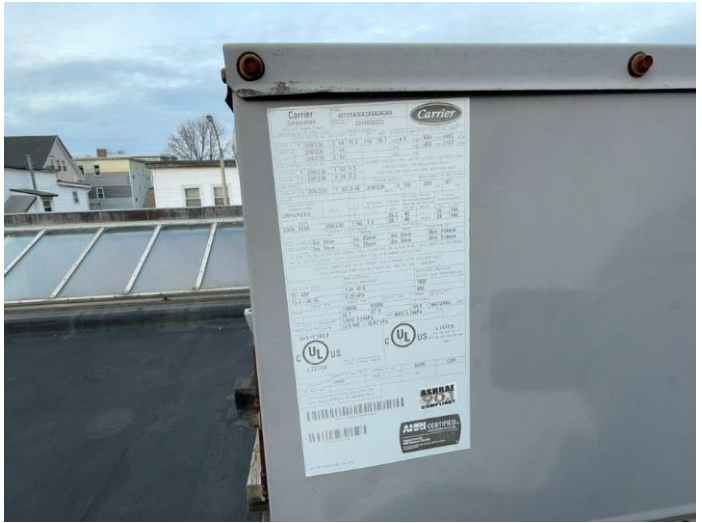
Photo 14 – Carrier RTU 2. Blower door test showed 460 CFM air leakage at both RTUs when tested @-50Pa. Refer to Appendix D.

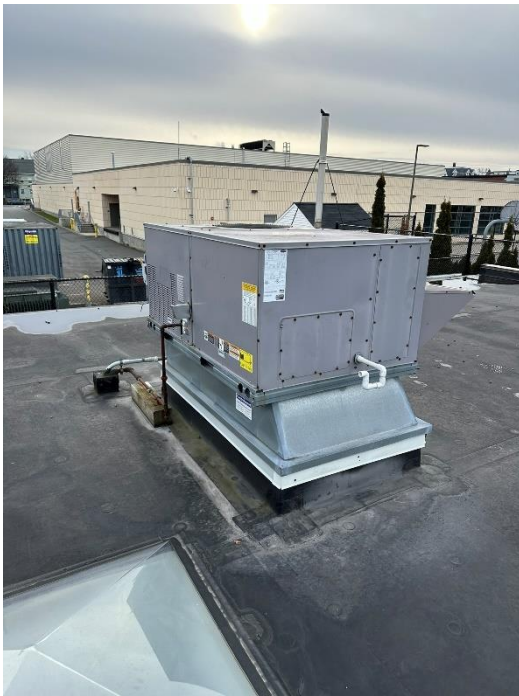
Photo 15 – Carrier RTU 2. Blower door test showed 460 CFM air leakage at both RTUs when tested @-50Pa. Refer to Appendix D.

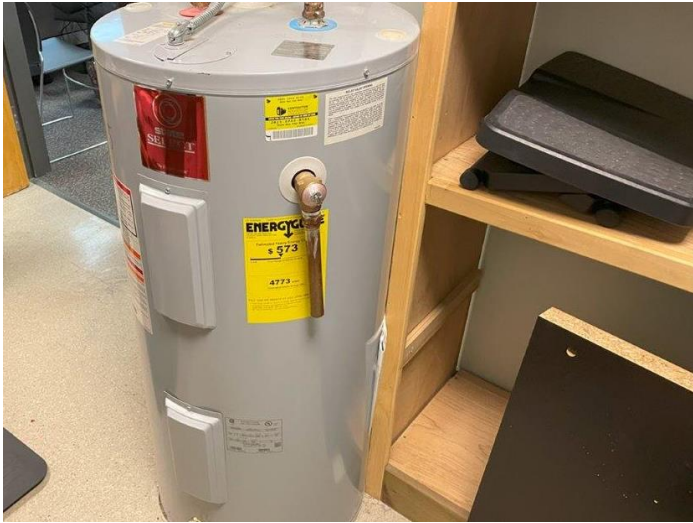
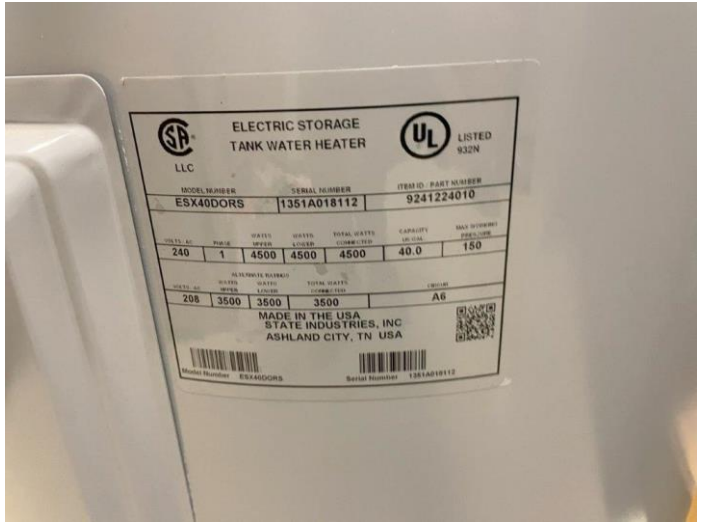
Photo 16 – State Select hot water heater in Storage D.

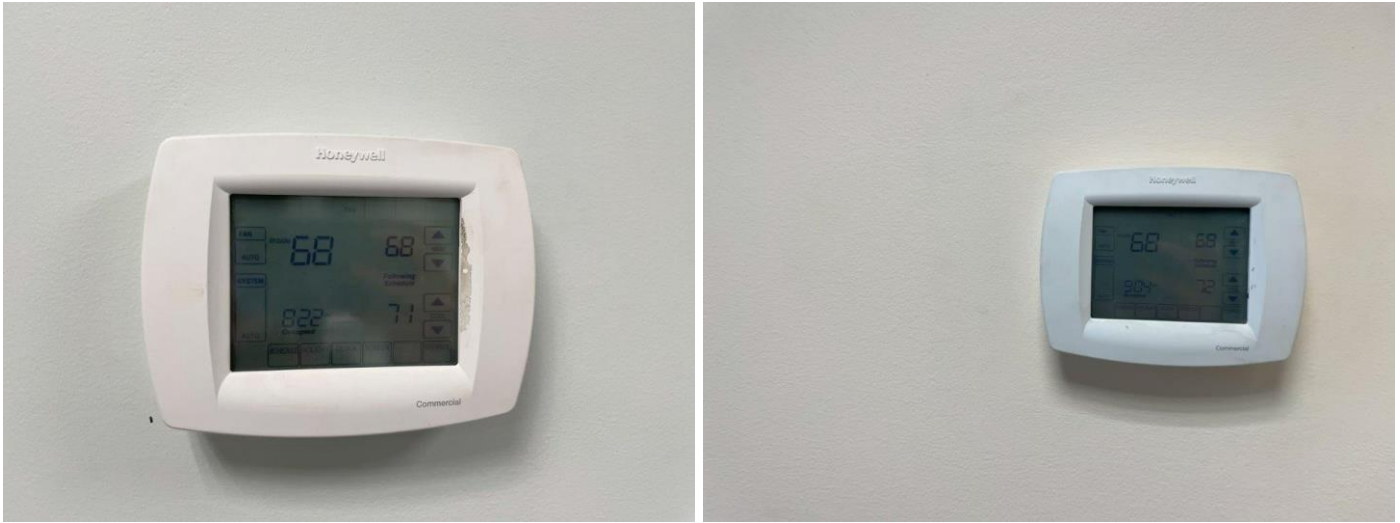
Photo 20 - Honeywell thermostats and settings at reception (left) and open office area (right).

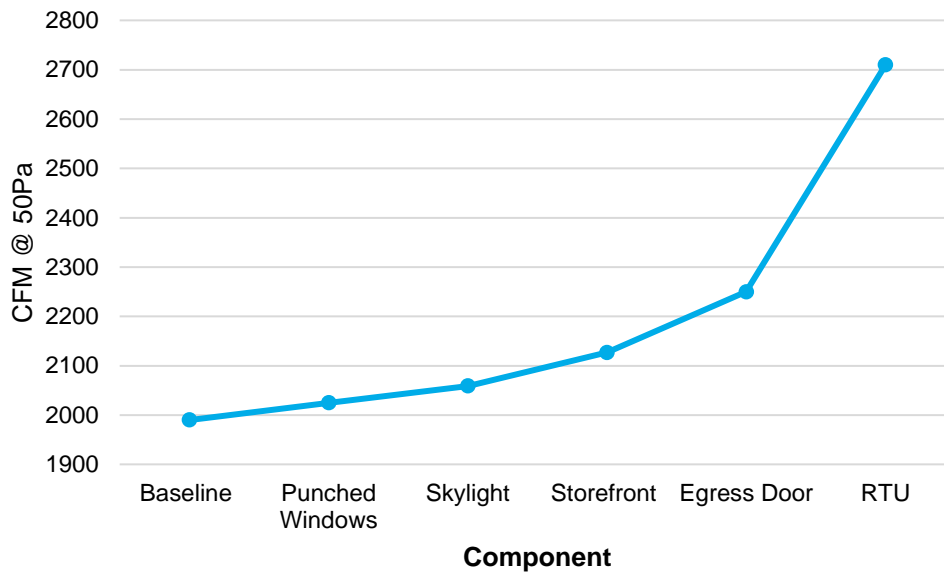
CFM @ -50Pa For Each Component

Difference in CFM between each component (displayed @ -50Pa):	
Punched window seals removed:	35 CFM
Skylight seals removed:	34 CFM
Storefront seal removed:	68 CFM
Egress door seal removed:	123 CFM
RTU seals removed:	460 CFM

Taking the difference from each test and the baseline shows the components with the most significant amount of air leakage are the **storefront, back egress door and RTU units**. This can also be seen through the infrared camera at the storefront and egress door where the cold air leaks around the rough opening (see Photos 6-7 and 10-13).
