## Preservation of Historic Collections and Resources

Project Name: Preservation of Historic Collections and Resources

Project Location: Somerville Museum

**Conservation Assessment for Preservation (CAP) Report  
Of the Collection and Building of the  
Somerville Museum, Somerville, MA**

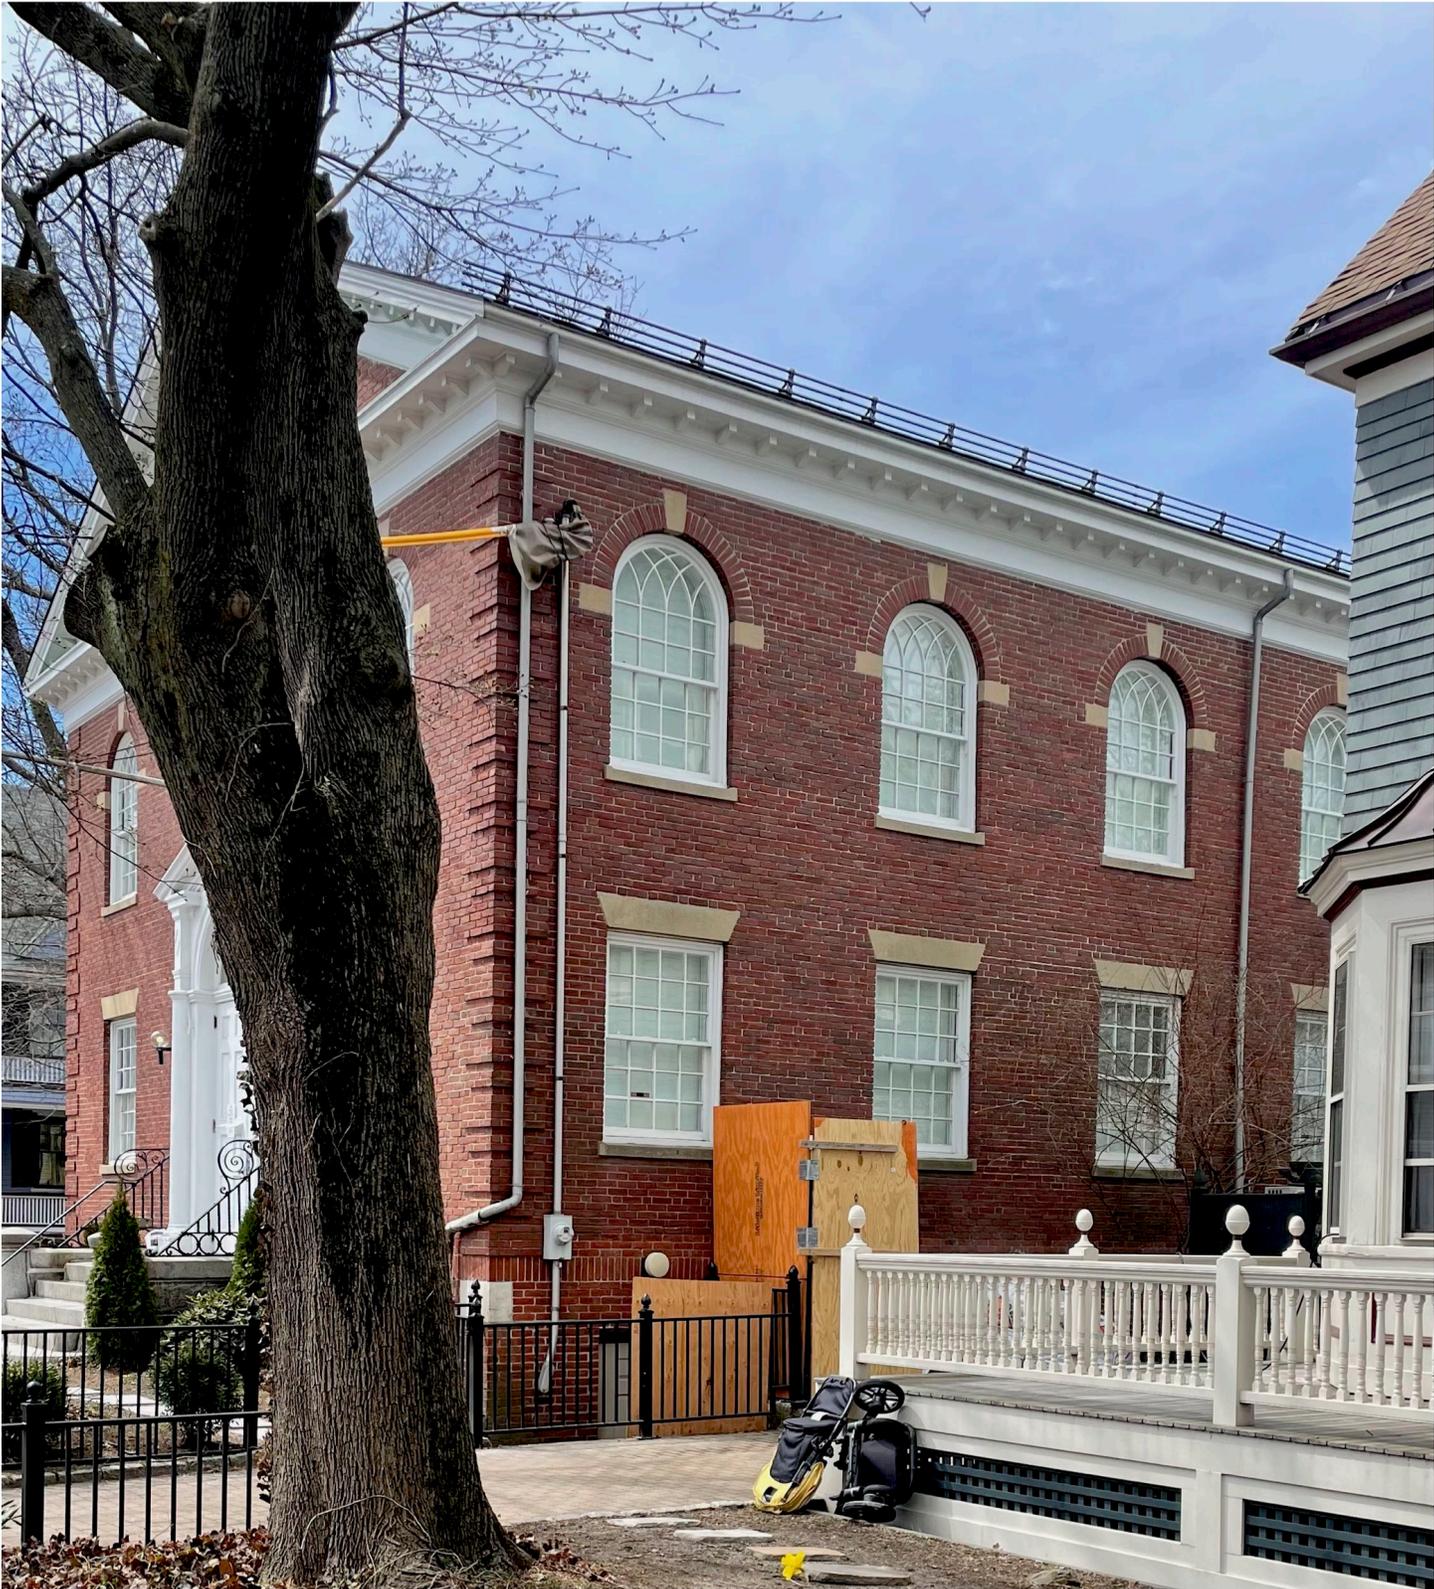
SKETCH PLAN SHOWING  
BOUNDARY CORNERS  
AT 54 CENTRAL STREET  
SOMERVILLE, MASSACHUSETTS

THE PURPOSE OF THIS PLAN IS TO SHOW THE BOUNDARY/LOT CORNERS FOUND OR SET AND IS THE RESULT OF AN ON-THE-GROUND INSTRUMENT SURVEY PERFORMED BETWEEN MARCH 7, 2007 AND DECEMBER 7, 2016, BY DESIGN CONSULTANTS, INC.

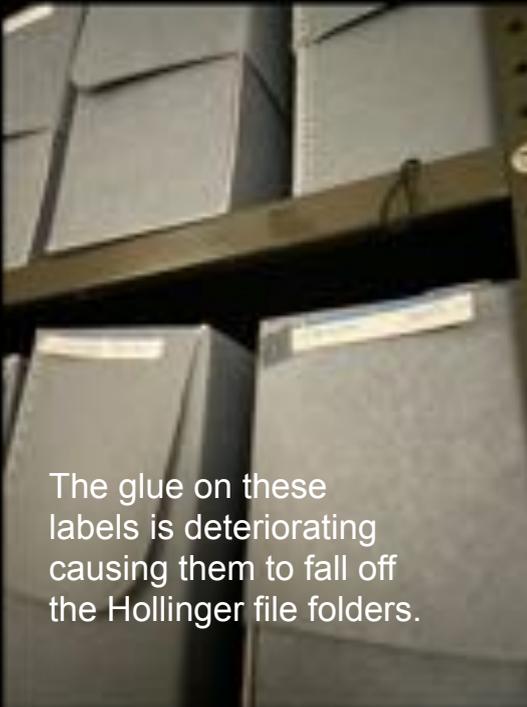
The glue on these labels is deteriorating causing them to fall off the Hollinger file folders.

The paint on the old shelving units and acidic cardboard boxes off-gas pollutants that are damage paper-based objects.

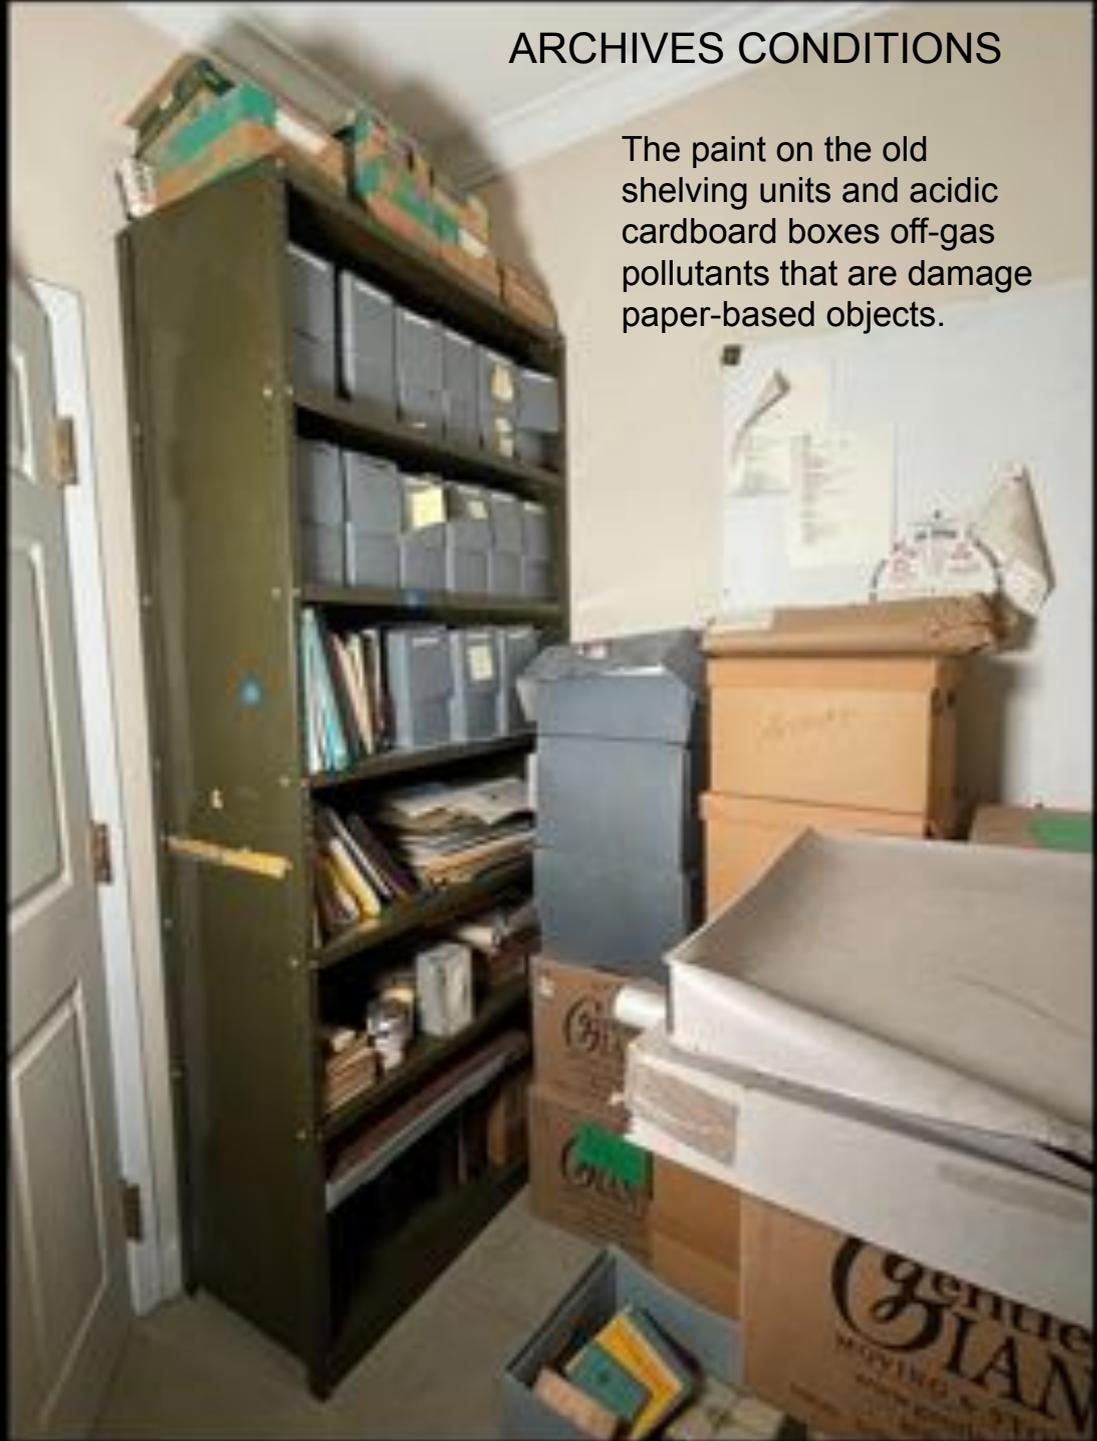
The finish has been abraded by wear and bleached by light in these areas.

These leaves were generally kept in the dark and were less used. They are closer to what the finish should be.

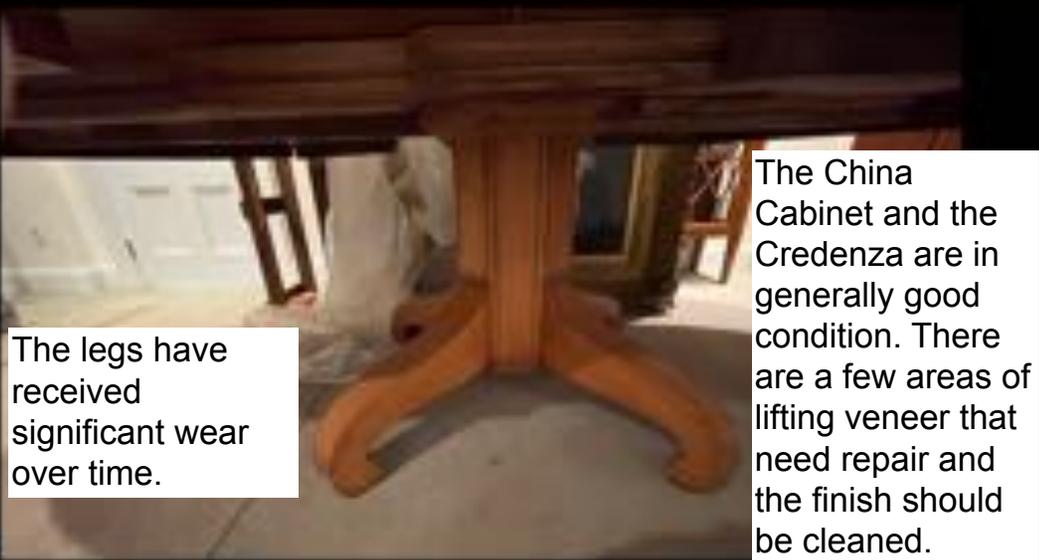
The legs have received significant wear over time.

The China Cabinet and the Credenza are in generally good condition. There are a few areas of lifting veneer that need repair and the finish should be cleaned.

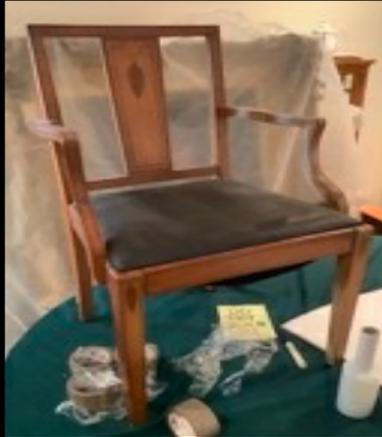
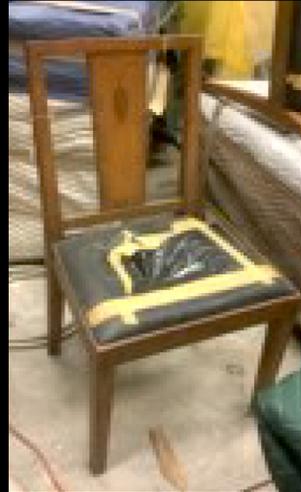
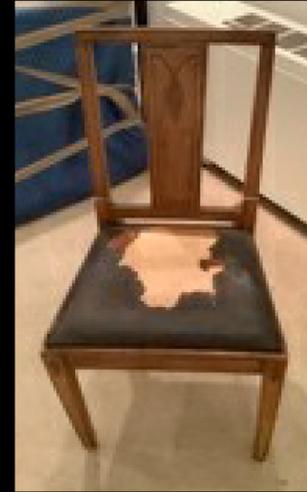
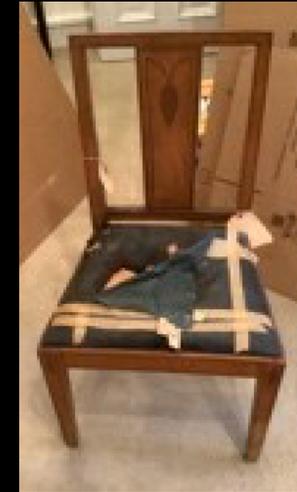
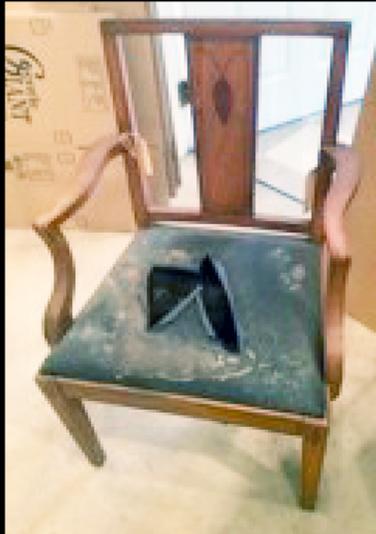
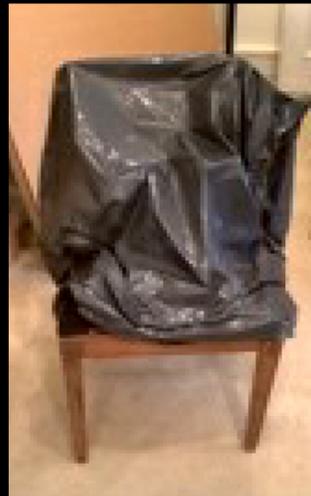
## Chairs from the Stone Family Dining Room set at the Somerville Museum

All the seats of the chairs need to be reupholstered in a manner that maintains their historic integrity. The finishes need to be restored and some veneers need to be repaired.

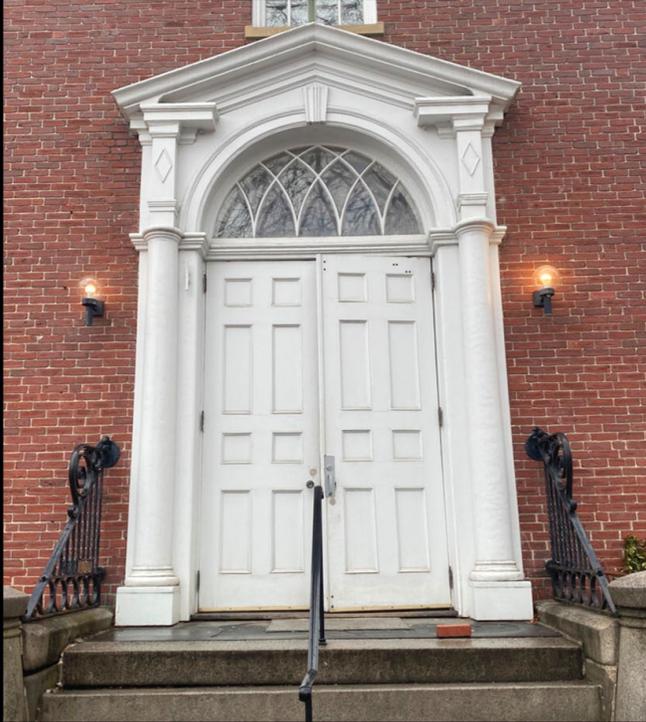
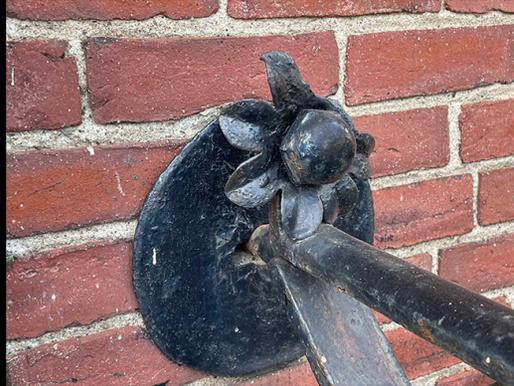
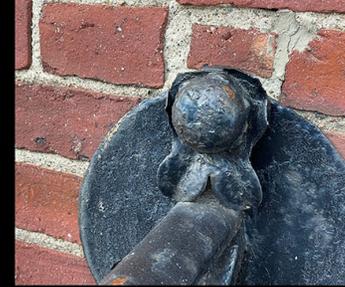
Simulation of the work after restoration

Status as of 7/24/2023

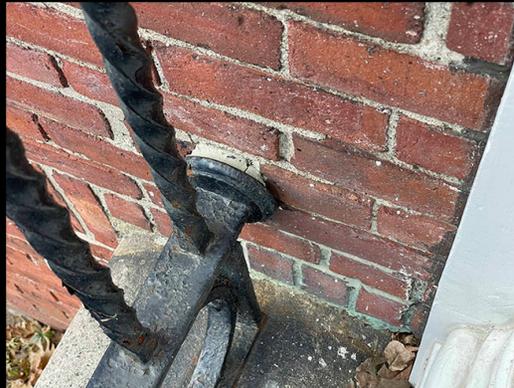
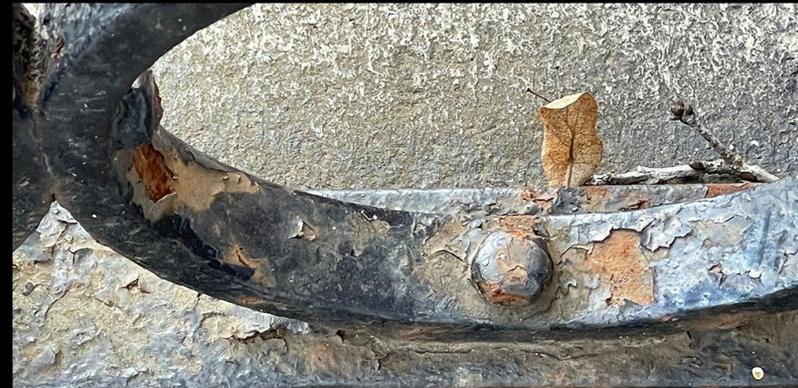
The paint degrades, letting water contact the metal and the iron rusts. This results in continuous damage and eventually loss of parts such as the leaves on the daisy fasteners.

- The rails will be photo-documented before and after treatment.
- Dismantle the rails from the landing and take the pieces back to their workshop in Rowley.
- The paint will be removed in a safe and secure manner in the event that lead paint was employed either in the paint or in the original primer. It often was.
- After paint and primer removal, the iron will be further cleaned to metal using as gentle a method as possible.
- Repairs to the wrought iron will be made and the leaves and other decorative elements restored.
- The entire piece will be degreased, primed and painted with a marine paint within a controlled relative humidity environment. The piece will be allowed to completely cure.
- The sections of the rail will be reassembled mechanically, as in the original, and reinstalled at the Museum

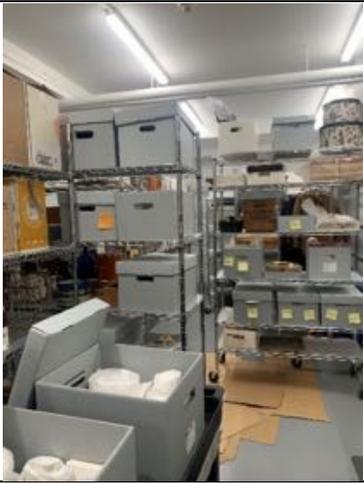
<p>Modular industrial rolling racks are used for boxed storage.</p>	<p>A floor plan detailing the placement of storage furnishings maximizes space and accessibility.</p>

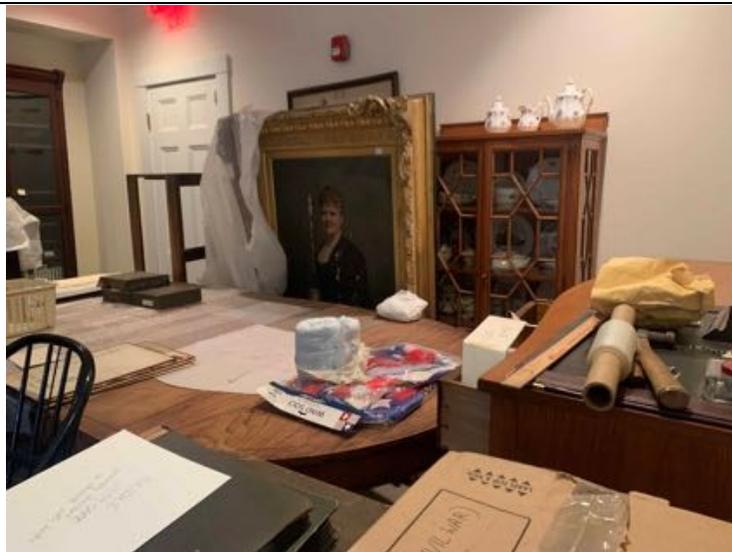
The Library houses reference books, an overflow of china and oversized paintings. An inventory is in process.

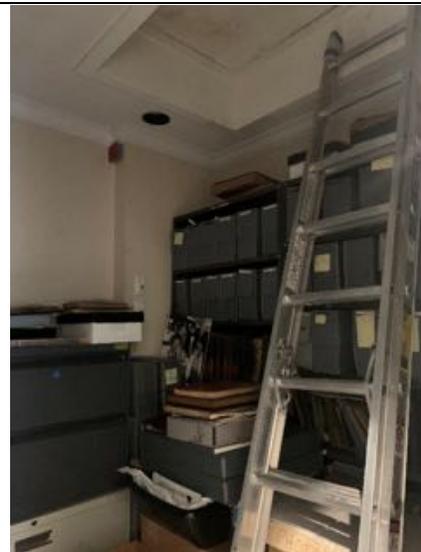
Archives are temporarily stored in a small room waiting inventory and finders aids processing.

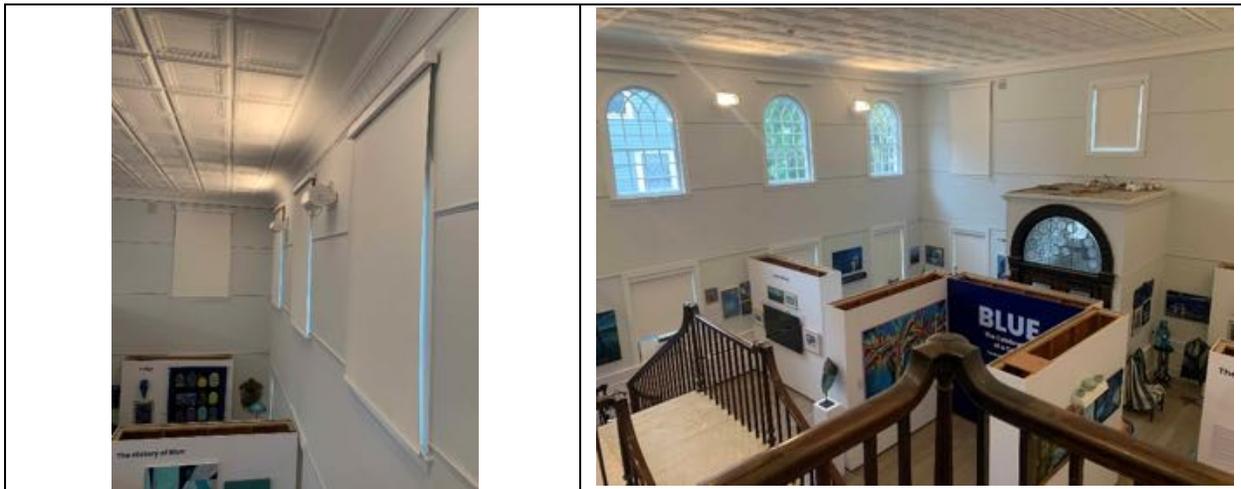
Ultra violet filtration is 100% on all storm windows in gallery rooms except for the windows in the small corner elevator addition gallery and stairwell spaces. These windows register transmission levels from 70 mW/m<sup>2</sup> to more that 200 mW/m<sup>2</sup> indicating that artworks displayed in these spaces are insufficiently protected.

Interior storms with 100% UV filtration combined with automated shades, and uplighting allow flexibility to maintain suitable light levels

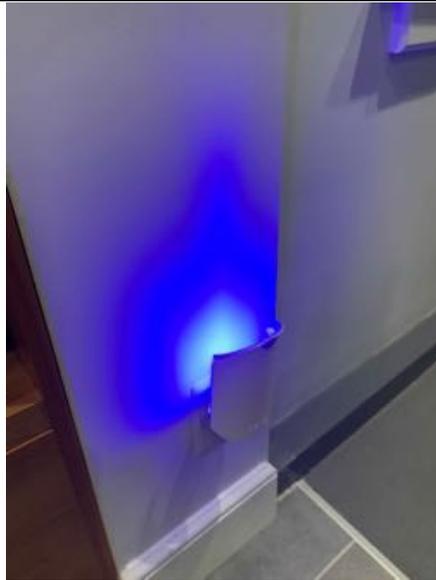
A low voltage blue pest light is a DIY monitoring device for moths, flies and gnats.

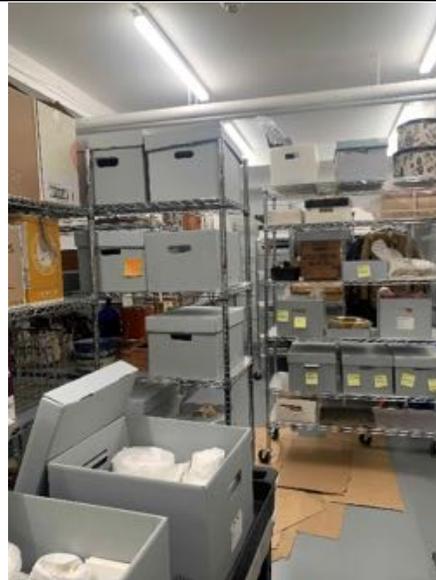
The inventory and rehousing project is organizing collections into boxes on rolling shelves raised 12” off the floor.

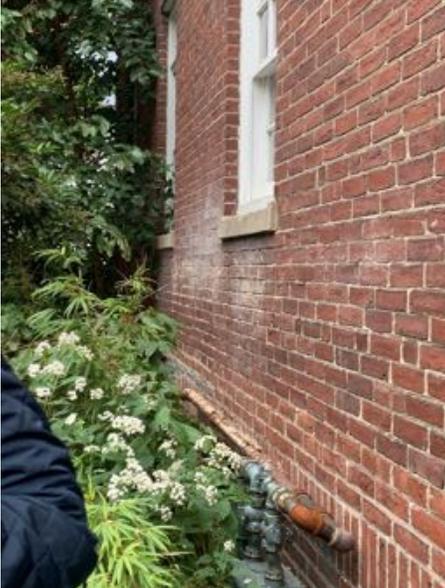
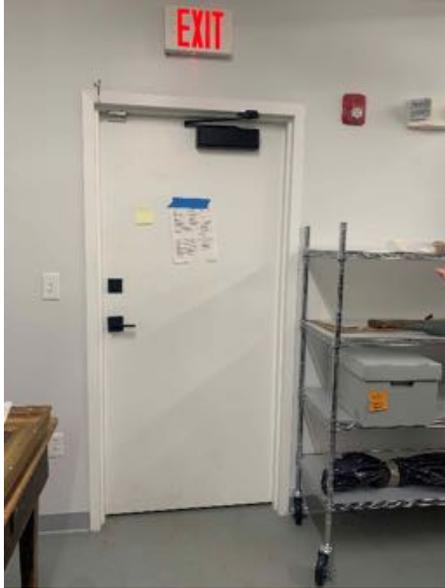
<p>Remove all plantings within 18-24" of the building, making a graveled space that deters pests from crossing over.</p>	<p>Install door sweeps and fill gaps in chases, windows, sills, outlets and light canisters to create pest barriers.</p>

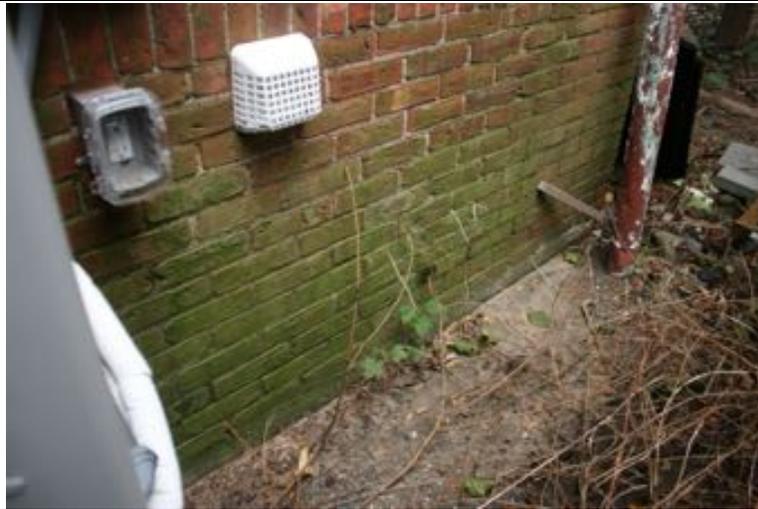
Drywells are reported to capture in-ground downspout runoff. Splashback of water at the base of the brick walls is prevalent, along with minor erosion of mortar and presence of biological growth on the north and south walls.

Base of north wall: algae on bricks and plant growth

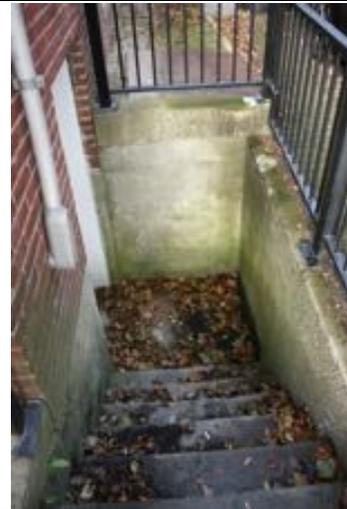
Areaway at northeast corner of building: Accumulation of debris on landing and algae on walls.

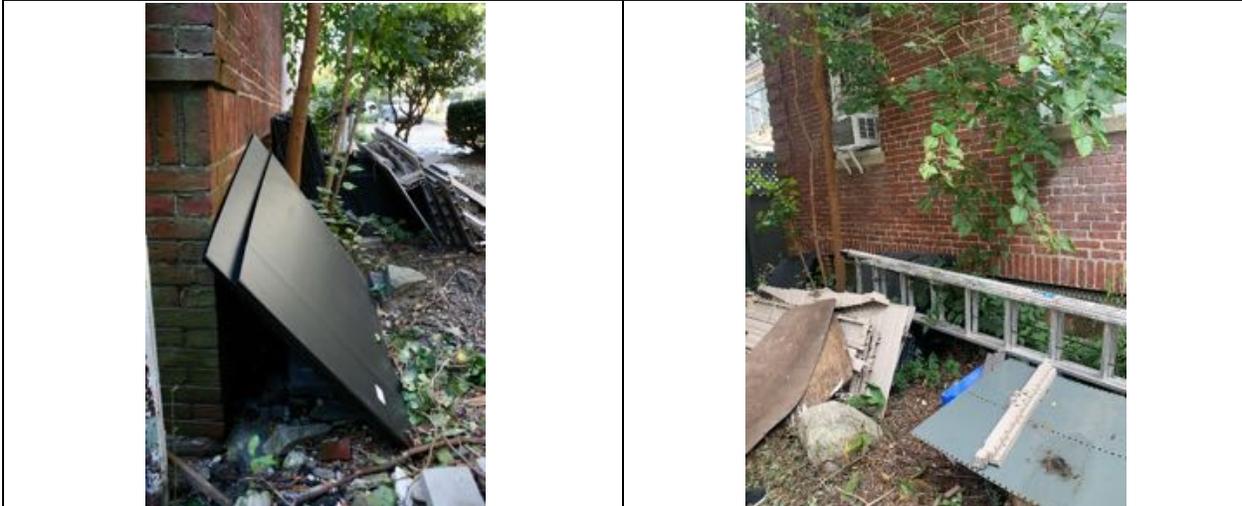
Miscellaneous building materials are stored against the west building wall, and trees and shrubs grow close to the façade (east), north, west, and south elevations, impeding air flow and obstructing sunlight that would help dry building elements after rain and snow falls.

West elevation: Construction materials, debris, and vegetation accumulated along the wall.

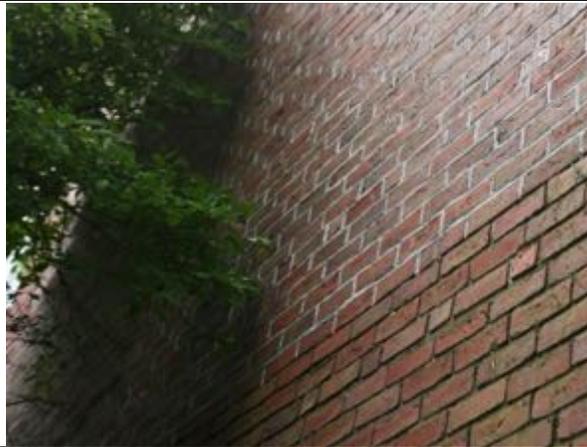
North elevation: Mortar erosion at bottom half of wall.

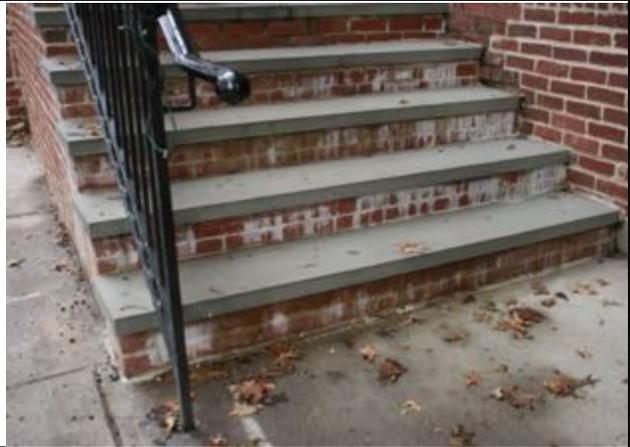
South elevation: Efflorescence on entry stairway.

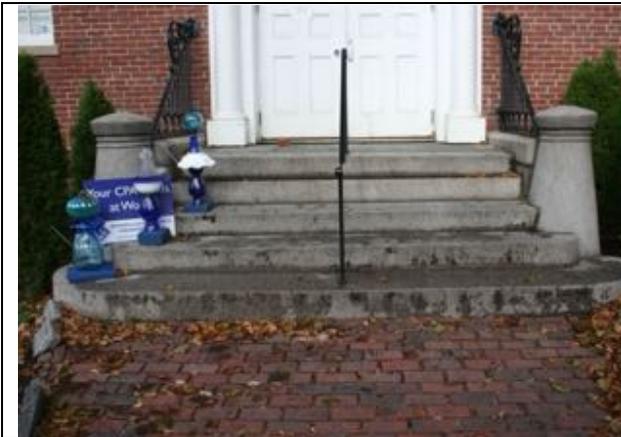
The main entrance on the Central Street façade consists of a paneled foyer with double-leaf doors surmounted by a wood fanlight on both the interior and exterior and framed by wood pilasters and pediment on the exterior. These elements were salvaged from the original Somerville Public Library building. The stone stairway has iron railings on each side, fastened to the brick wall with ornamental rosettes.

East (Central Street) entrance: Granite steps, metal railings, door handle and lockset.

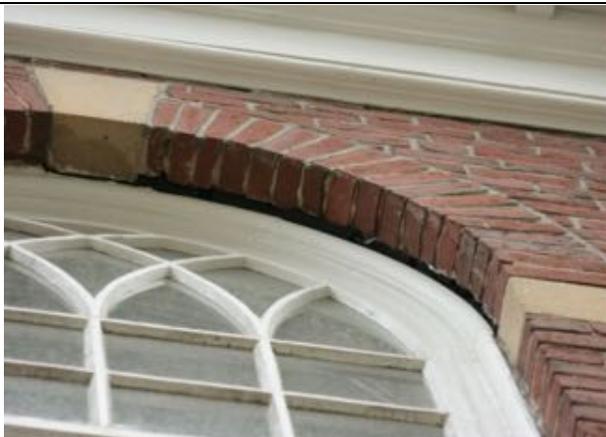
Gap between wood window frame and adjacent brickwork: Round-arched window on south elevation.

Wood windows are typically in good condition. Significant gaps around the window frames were observed at several of the round-arched windows at the upper level of the Main Gallery: two on the south (Westwood Road) elevation and three on the north elevation. On the first floor of the south elevation, the concrete lintel of the window in the third bay from the right (above the base of the stairs) exhibits diagonal cracking. On the second floor of the east (Central Street) façade, there appears to be a gap between the steel lintel and flared brick trim on the center window. Efflorescence is visible in the brick surrounding the oculus window in the Central Street pediment.

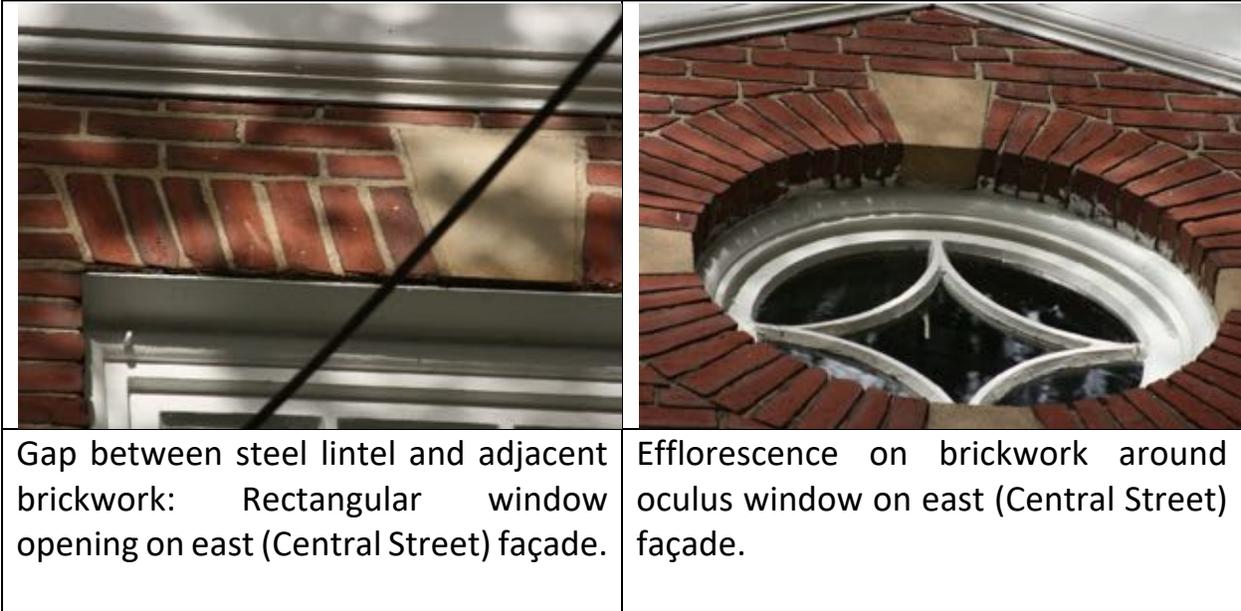
The basement entrance in the areaway at the northeast corner of the building has a steel lintel that has rusted and exhibits gaps between the lintel and the adjoining brick work. Similar gaps occur on the sides of this doorway. Holes and damaged brick suggest the location of previous areaway railing attachments to the wall.

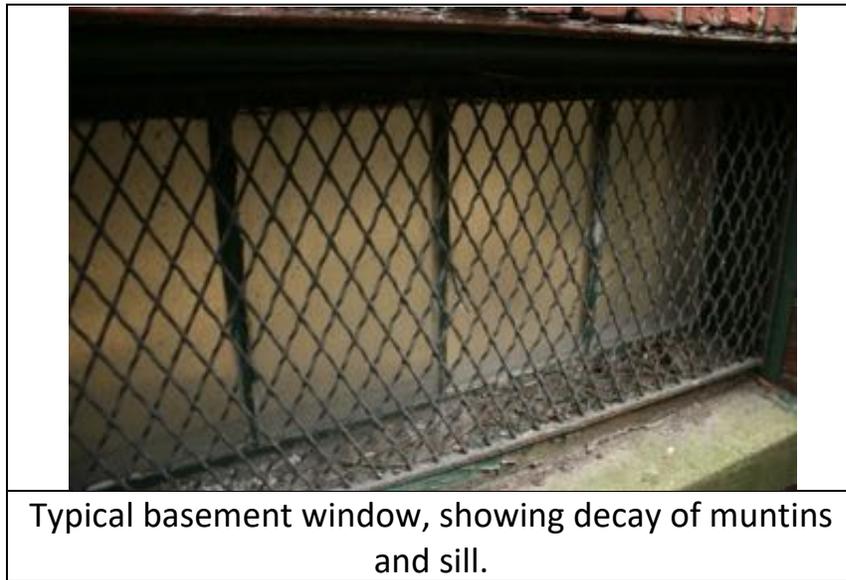
Basement windows historically consisted of 4-light wood sash with concrete sills and steel lintels supporting soldier brick trim. Finishes on the extant wood

basement windows are typically worn, with failing glazing putty. New single-light sash have been installed in the two northernmost windows on the west elevation. Algae is present on the concrete sill of the westernmost basement window on the north elevation.

In order to improve the watertightness of the new Collections Storage room, four basement windows were recently bricked-in and their steel lintels were removed: these include one opening at the north end of the Central Street façade and the three easternmost windows on the north elevation. Massachusetts Historical Commission, as the holder of a preservation easement on the building, has stated that brick infill at three of these window openings must be removed and replaced with faux window sash and that steel lintels be replaced to match the historic design.

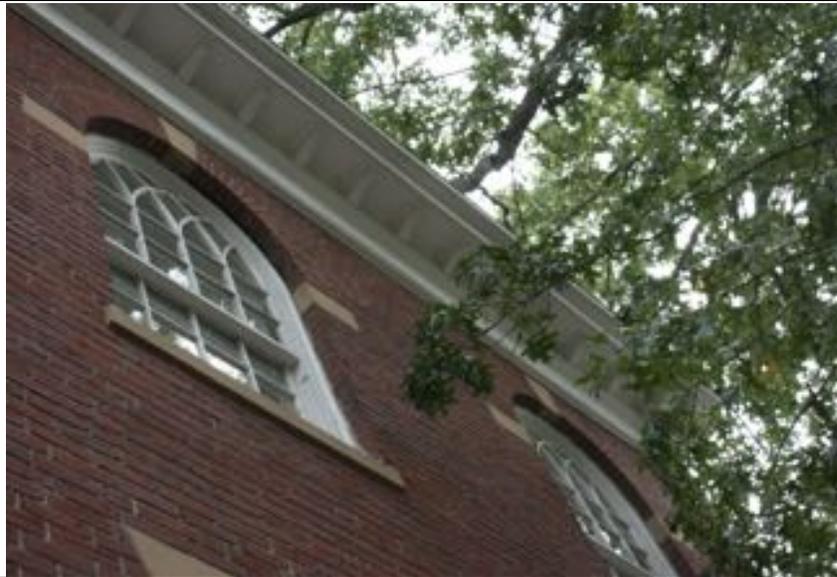
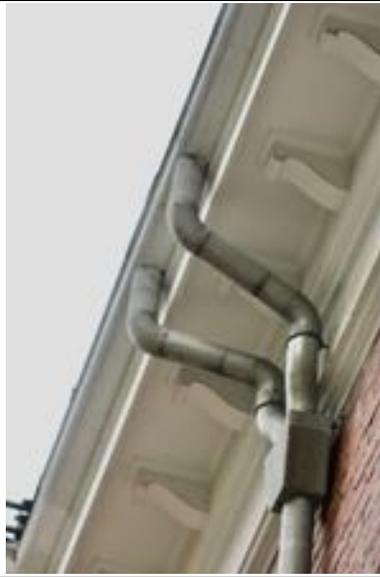
of harboring debris. Downspouts empty next to the building at the southwest corner, eroding the mortar of the adjacent brick wall, and into in-ground pipes at the remaining corners of the building. During a rainstorm occurring the week of the site inspection, the Y-shaped downspout configuration on the south wall was observed to be leaking. The downspout at the northeast corner of the building is rusting at the first floor/basement level.

<p>Overhanging tree at south (Westwood Road) elevation.</p>	<p>Y-shaped downspout on south (Westwood Road) elevation.</p>

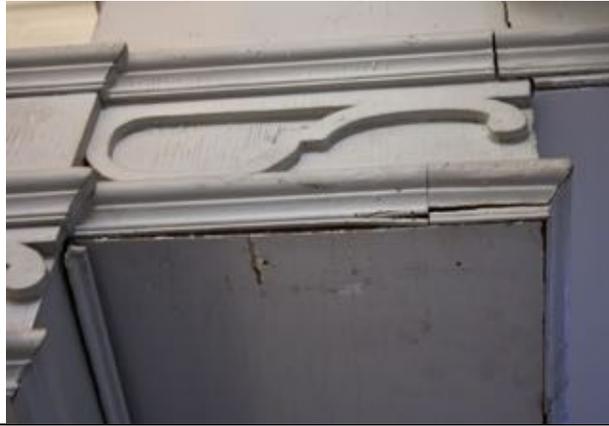
The wood floor of the mezzanine at the west end of the Main Gallery is worn and would benefit from refinishing. The Bulfinch Stairway in the Main Gallery—an icon of the Museum’s collection— also has worn finishes, minor separation at many of the joints between elements, and a loose railing at the north flight of stairs. It is assumed that these conditions will all be addressed in the repairs and refinishing of the staircase that is planned for 2024.

Typical condition of woodwork at Bulfinch Stairway.

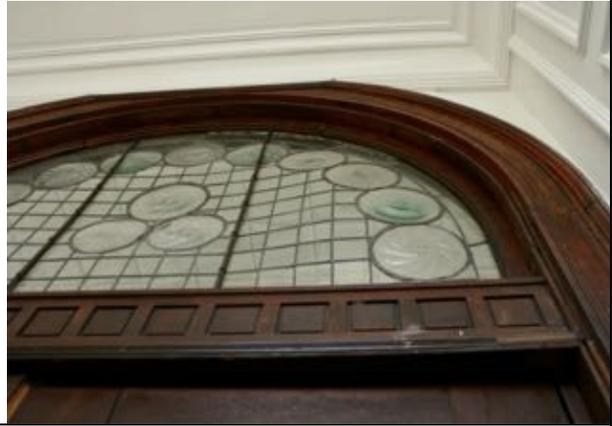
Leaded glass transom in entry foyer adjacent to Main Gallery: Buckled glass at north end.

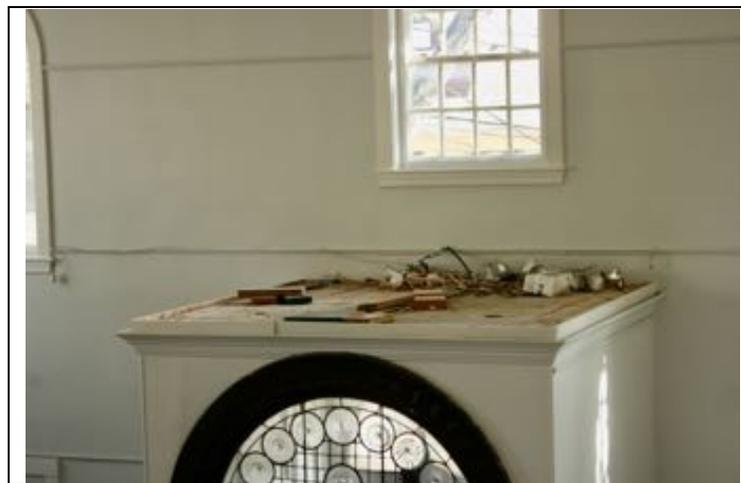
Debris on top of entry foyer in Main Gallery.
