**City of Somerville
Athletic Fields Assessment**

**FIELD EVALUATION
DATA SHEET**

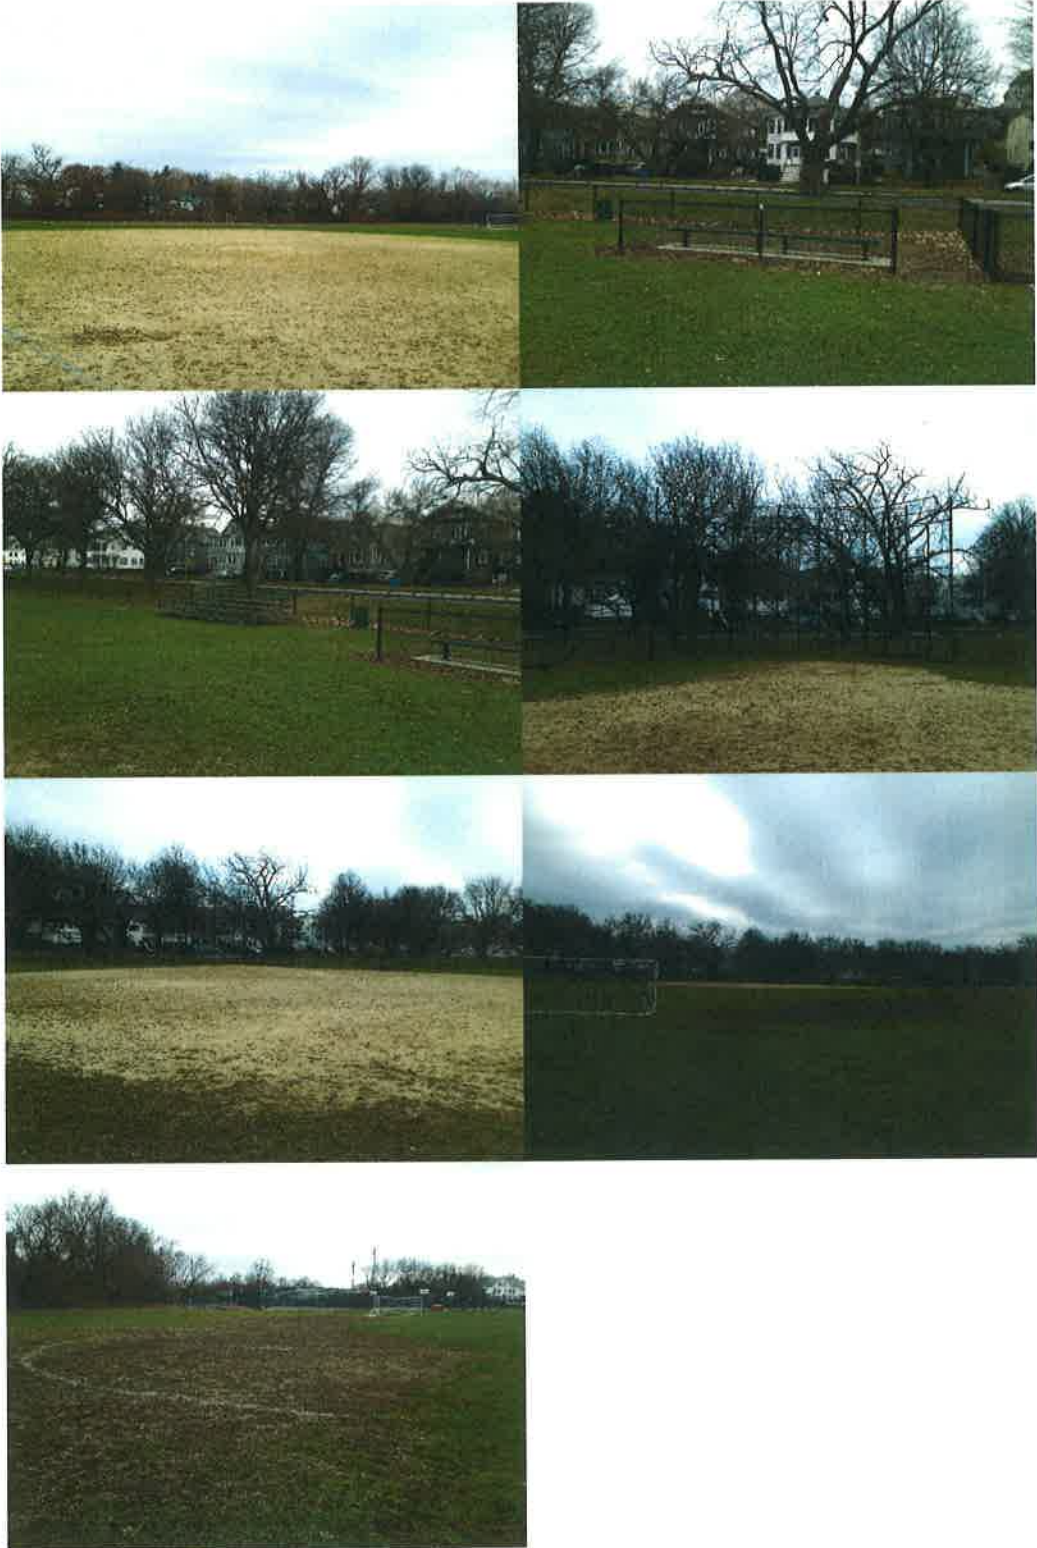
3. Photo

Irrigation:	Unknown ??
Drainage:	<ul style="list-style-type: none"> • Catch basins around field • No formal drainage
Lighting:	No
Fencing:	4' Perimeter fence down right field in fair condition No outfield fencing

Condition	Comments
Pitcher's Mound and Rubber	Good rubber Very poor around	Need to build up mound area
Bases and Home Plate	HP – good

No base present	
Scoreboards	NONE	
Backstop	Yes, fair condition (vinyl is coming off)	
Dugout(s)	Wooden benches on concrete pads behind 4' fence	
P.A. System	No	
Spectator Seating	Yes, wooden bleachers	
Flag Pole	No	
Player Benches	Wooden – fair	
Goals/Goal Posts	N/A	
Field Marking/Striping	N/A	
Parking Facilities	@Dilboy Stadium/Pool	
Site Accessibility	Not ADA	
Site Safety	Good	
Site Buildings	Dilboy pool complex/stadium

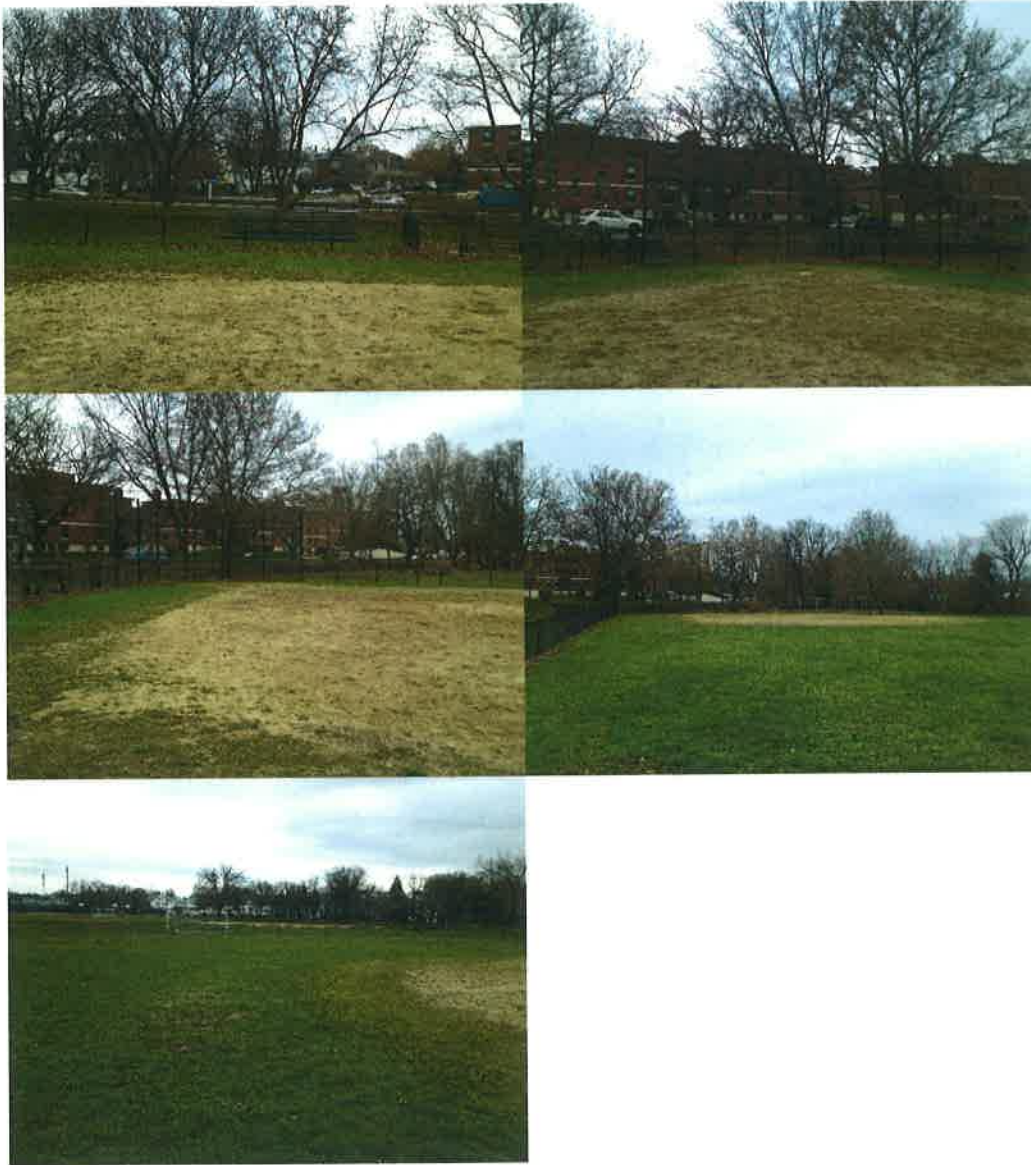
- Photo Documents

Irrigation:	Unknown
Drainage:	<ul style="list-style-type: none"> • Catch basin around field • No formal field drainage
Lighting:	No athletic lighting
Fencing:	4' outfield/sideline fencing fair condition 15+/- black vinyl/CLF backstop fair condition Black vinyl starting to peel off

Condition	Comments
Pitcher's Mound and Rubber	Good rubber	Set to high
Bases and Home Plate	HP – fair condition	Bases not present
Scoreboards	No	
Backstop	Fair	Black vinyl peeling off
Dugout(s)	No	
P.A. System	No	
Spectator Seating	Wooden bleaches not ADA	
Flag Pole	No

8. General Turf Condition: 3
 (Good condition, needed re-seeding an annual maintenance)

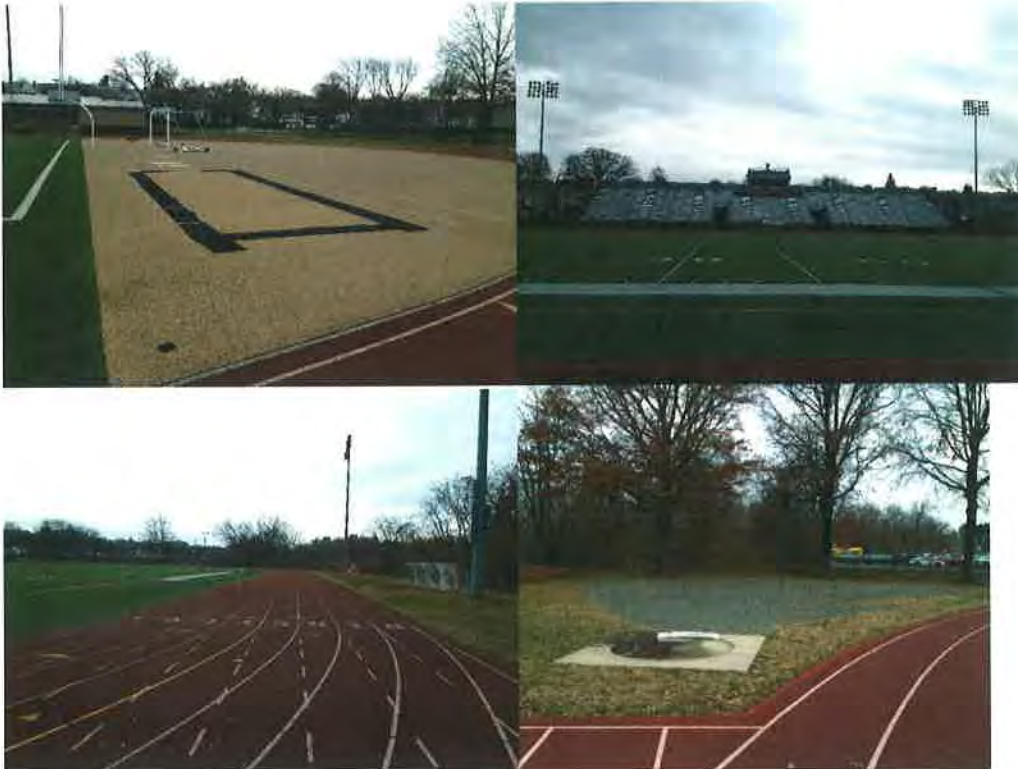
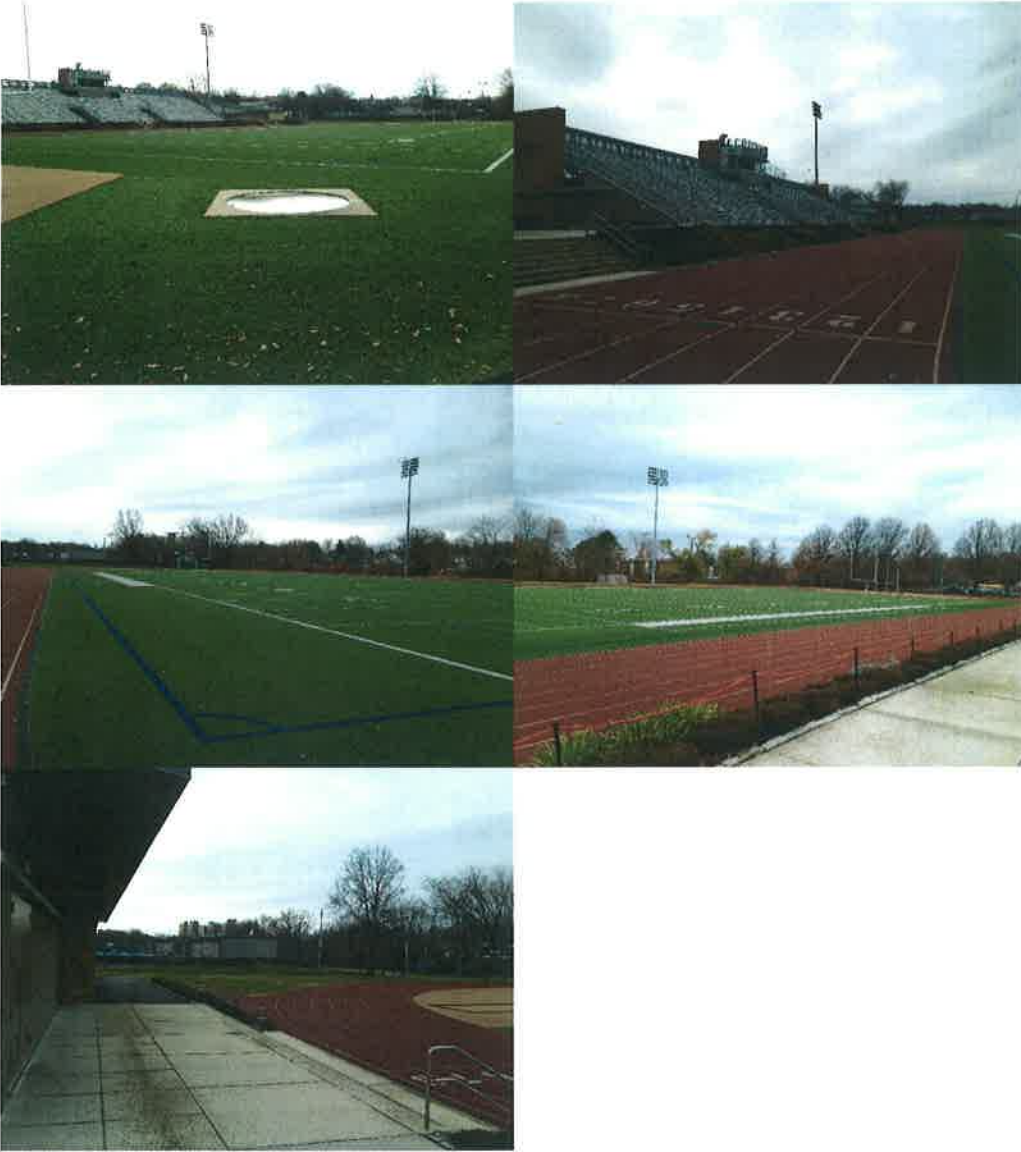
3. Photo

Irrigation:	N/A Synthetic Turf
Drainage:	Assumed synthetic turf underdrain system <ul style="list-style-type: none"> • Stove base – flat panel – collector pipes • Drains well Trench Drain – inside edge of sack - slot drain in D - Areas
Lighting:	Yes 4-pole USL Athletic – System 30 lamps per pole
Fencing:	Yes 6' perimeter fencing Black vinyl in good condition

Condition	Comments
Pitcher's Mound and Rubber	N/A	
Bases and Home Plate	N/A	
Scoreboards	Yes	Good condition
Backstop	N/A	
Dugout(s)	N/A	
P.A. System	Press box	
Spectator Seating	200 grandstand	Good
Flag Pole	Yes (3)	North end

Track – Good Condition
Synthetic Turf – Good Condition

- 2,000 person grandstand good condition
- South end zone run-out short
- Track needs to be re-surfaced/striped
- Track events good condition

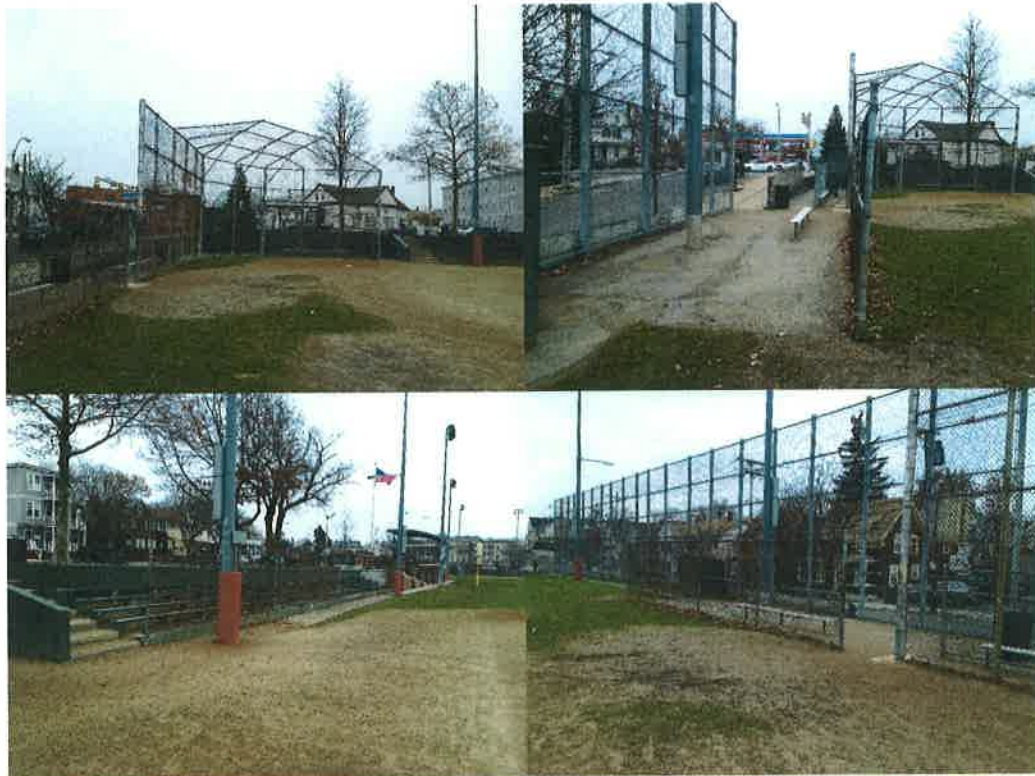
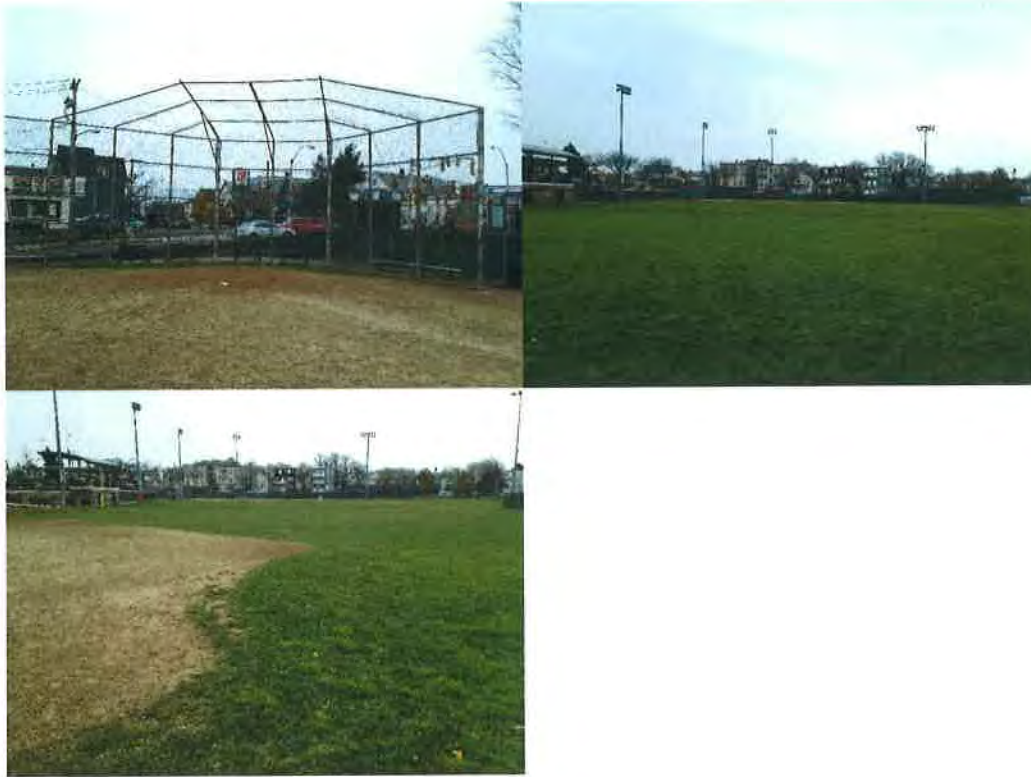
3. Photo Documents:

Lighting:	Yes MUSCO lighting system in good condition
Fencing:	<ul style="list-style-type: none"> • Backstop needs to be replaced • Perimeter fencing is in fair condition • No out field fencing

Condition	Comments
Pitcher's Mound and Rubber	Fair	
Bases and Home Plate	Fair	
Scoreboards	None	
Backstop	Poor condition	
Dugout(s)	Benches behind CLF, conflict with spectator area	
P.A. System	None	
Spectator Seating	Outdated not ADA compliant	
Flag Pole	At entrance	
Player Benches	Aluminum benches good condition	
Goals/Goal Posts	Foul poles in good condition	
Field Marking/Striping	N/A	
Parking Facilities	On street

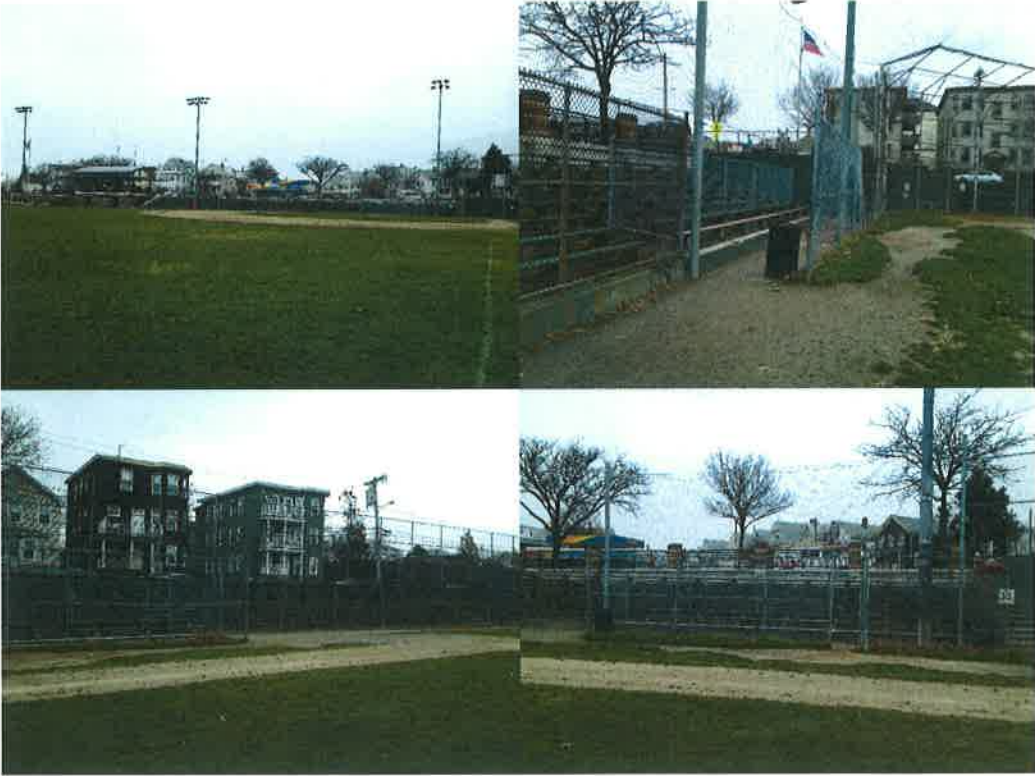
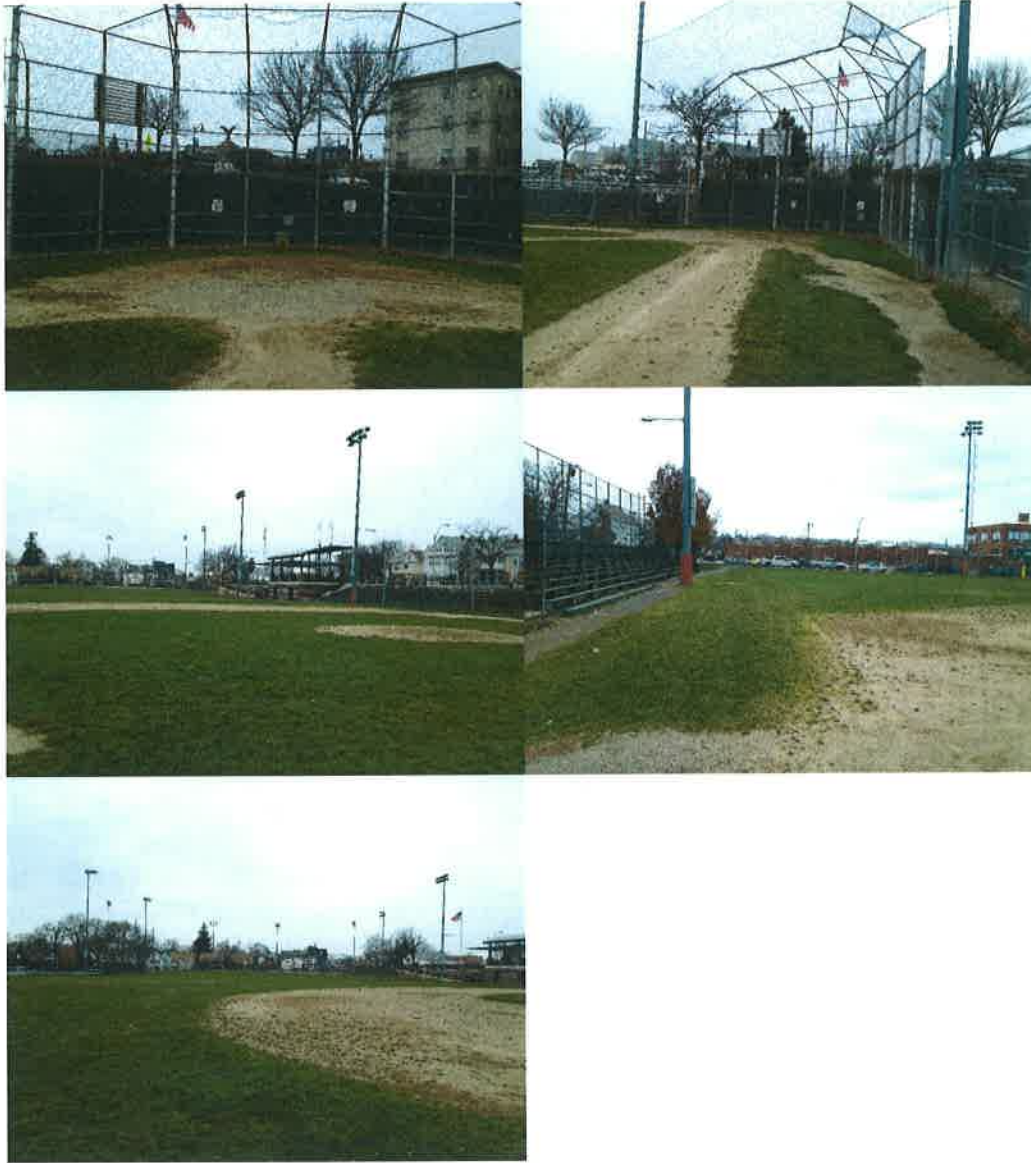
3. Photo Documents:

Irrigation:	Yes, irrigation boxes present
Drainage:	<ul style="list-style-type: none"> • No formal drainage • Catch basing throughout area • No tunnel grading- hips-dips
Lighting:	Yes, MUSCO lighting system 13 total poles b/w baseball/softball
Fencing:	15' CLF – left field fair condition 15'-20' – Out field None – Right field in fair condition CIF – galvanized Backstop needs to be replaced poor condition

Condition	Comments
Pitcher's Mound and Rubber	Mound/rubber need to be reconstructed/upgraded	
Bases and Home Plate	Not present	
Scoreboards	Outfield – poor/outdated

Backstop	Poor condition needs to be replaced	
Dugout(s)	Benches behind CLF conflict with spectator area	
P.A. System	None	
Spectator Seating	Wooden benches built into slope right/left sidelines Not ADA very poor	
Flag Pole	At entrance	
Player Benches	First row of bleacher poor condition	
Goals/Goal Posts	N/A	
Field Marking/Striping	N/A	
Parking Facilities	On street/DPW spaces	
Site Accessibility	Bleachers field not ADA	
Site Safety	Good	
Site Buildings	B/W softball/baseball building

- Infields need seasonal maintenance
- Spectator seating needs to be replaced

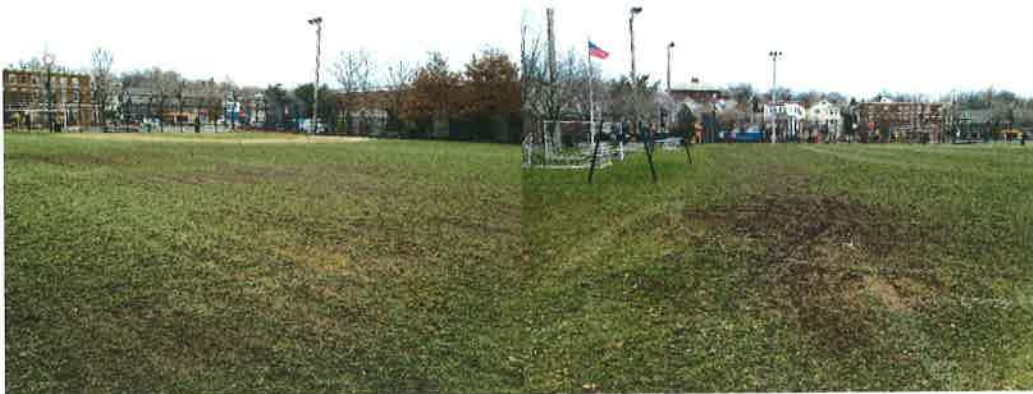
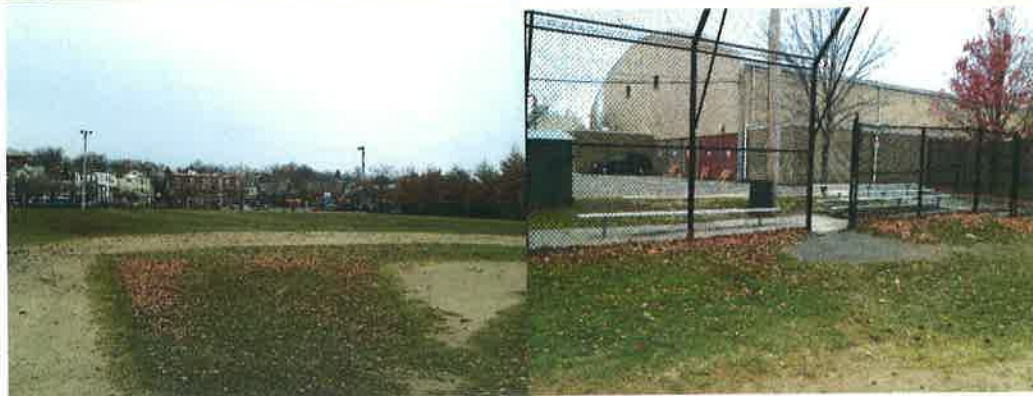
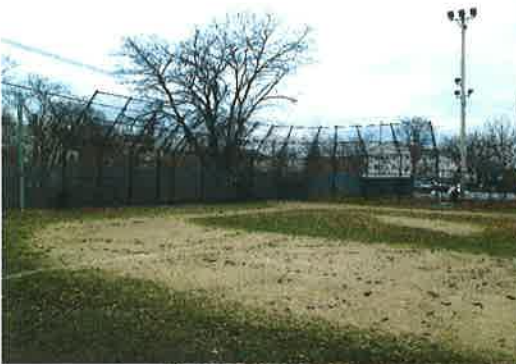
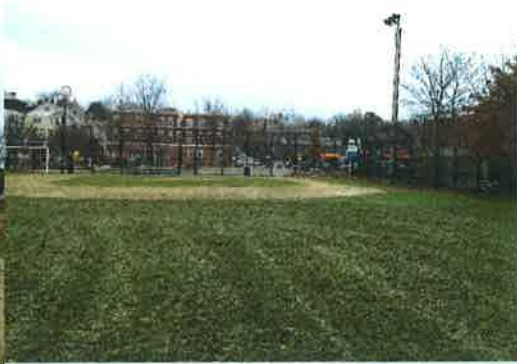
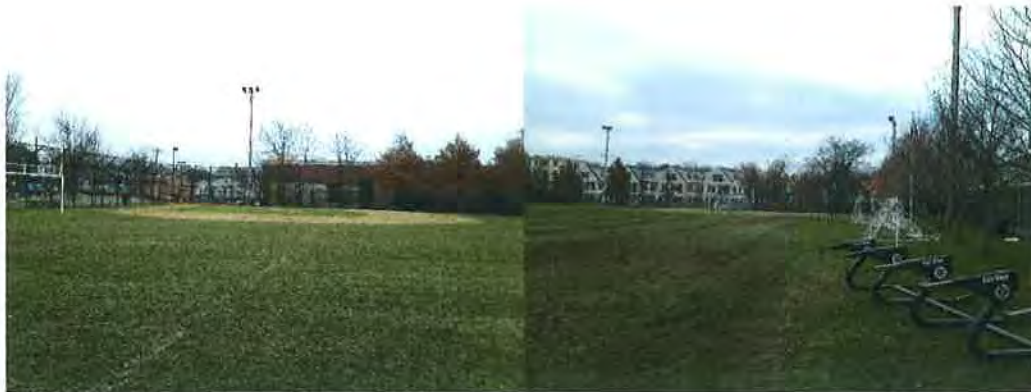
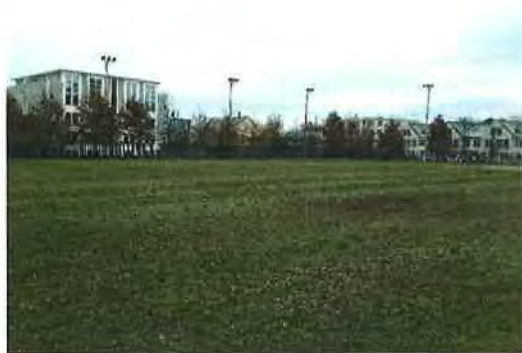
3. Photo Documents:

Lighting:	Light fixtures on telephone poles outdated.
Fencing:	Black vinyl perimeter fencing in good condition. Backstops in good condition.

Condition	Comments
Pitcher's Mound and Rubber	Good condition	
Bases and Home Plate	Bases not present	
Scoreboards	Good condition	
Backstop	Good condition	
Dugout(s)	Benches behind CLF	
P.A. System	None	
Spectator Seating	Aluminum 3-tow bleachers good condition	
Flag Pole	Yes, good condition	
Player Benches	Good condition	
Goals/Goal Posts	No poles	
Field Marking/Striping	N/A	
Parking Facilities	Limited on street parking

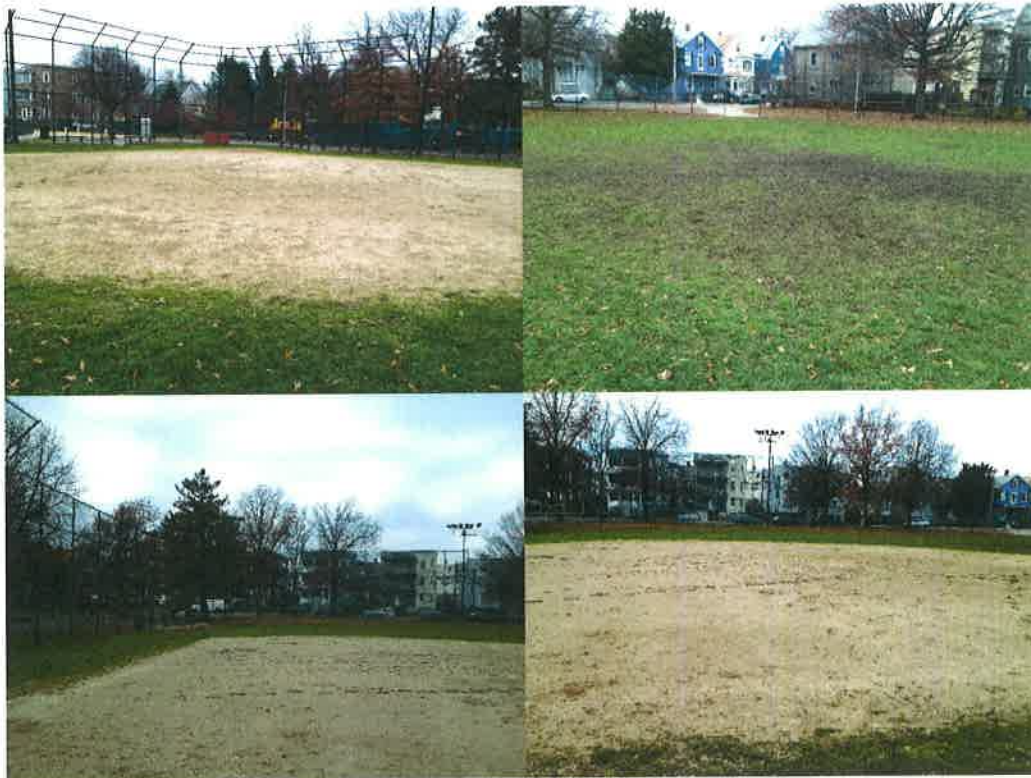
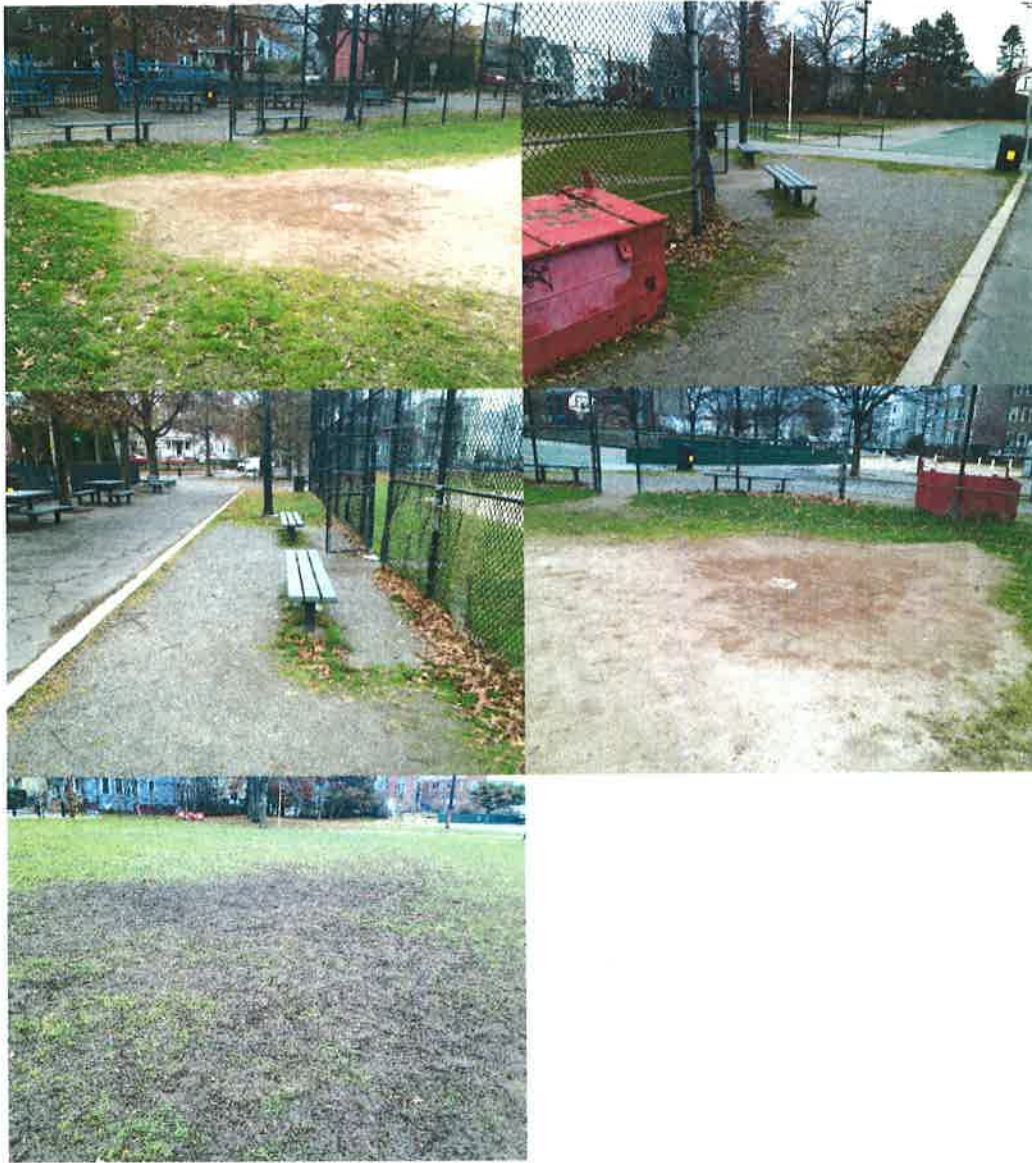
3. Photo Documents:

Irrigation:	Yes
Drainage:	No formal drainage Various CB at field limits
Lighting:	Yes, outdated upgrade will help with glare and spill
Fencing:	No formal outfield fencing Backstop in fair condition Perimeter fencing in poor condition

Condition	Comments
Pitcher's Mound and Rubber	Fair condition	
Bases and Home Plate	Bases not present HP fair condition	
Scoreboards	None	
Backstop	Far condition	
Dugout(s)	None

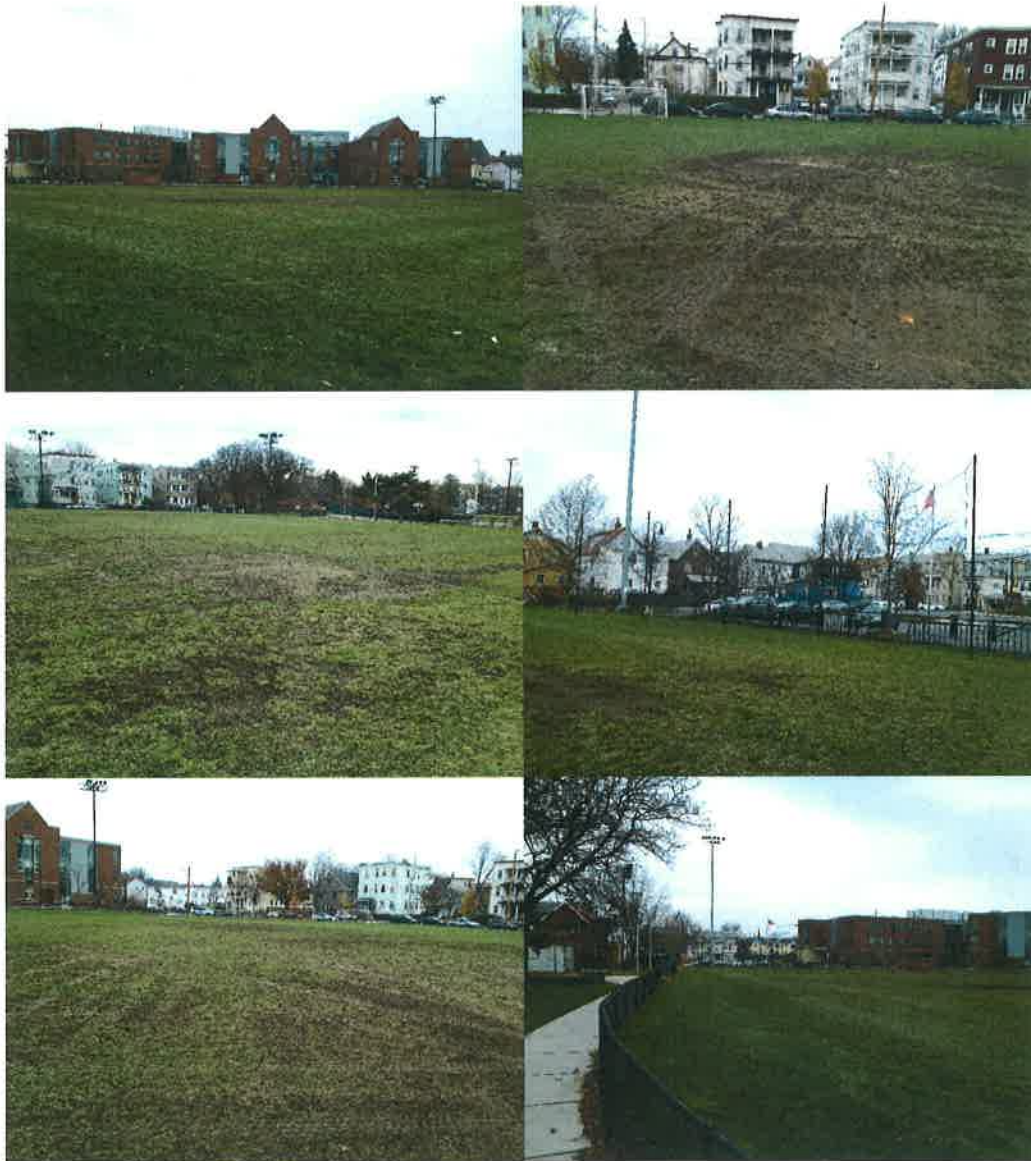
3. Photo Documents:

Drainage:	Various CB throughout field area
Lighting:	Yes, outdated Upgrade will improve spill and glare
Fencing:	4' Black vinyl CLF in fair condition

Condition	Comments
Pitcher's Mound and Rubber	N/A	
Bases and Home Plate	N/A	
Scoreboards	None	
Backstop	N/A	
Dugout(s)	N/A	
P.A. System	None	
Spectator Seating	None	
Flag Pole	@School	
Player Benches	None	
Goals/Goal Posts	Soccer goals In fair condition	
Field Marking/Striping	Not currently Striped	
Parking Facilities	@ school/street Limited	
Site Accessibility	Site is ADA Accessible

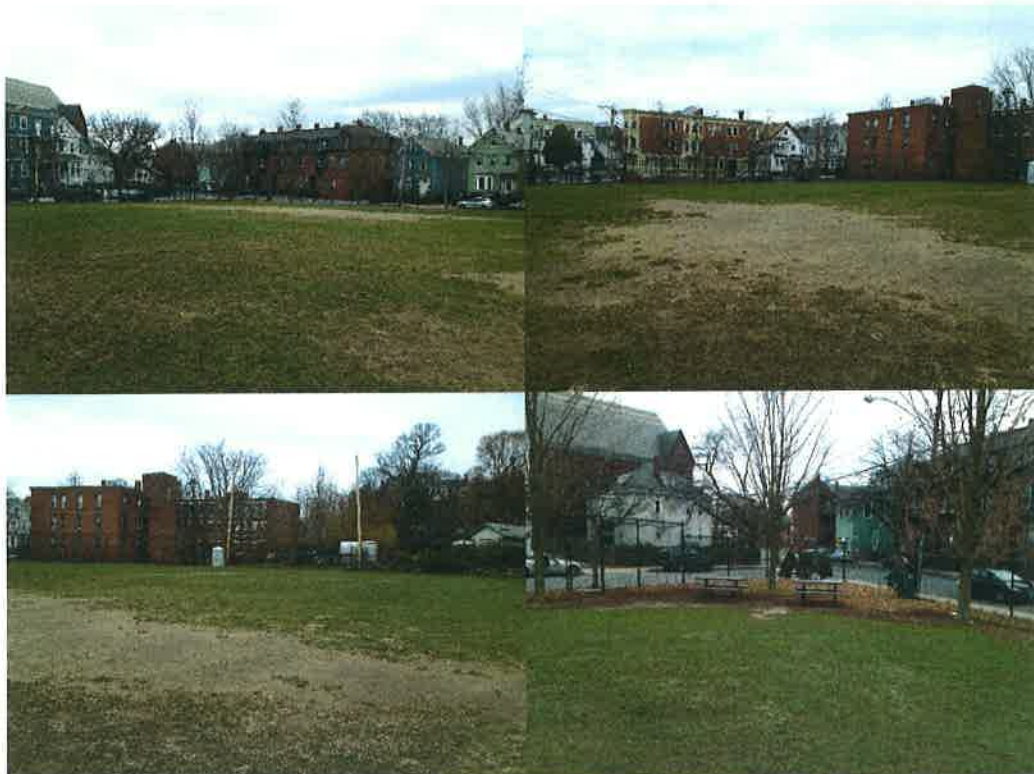
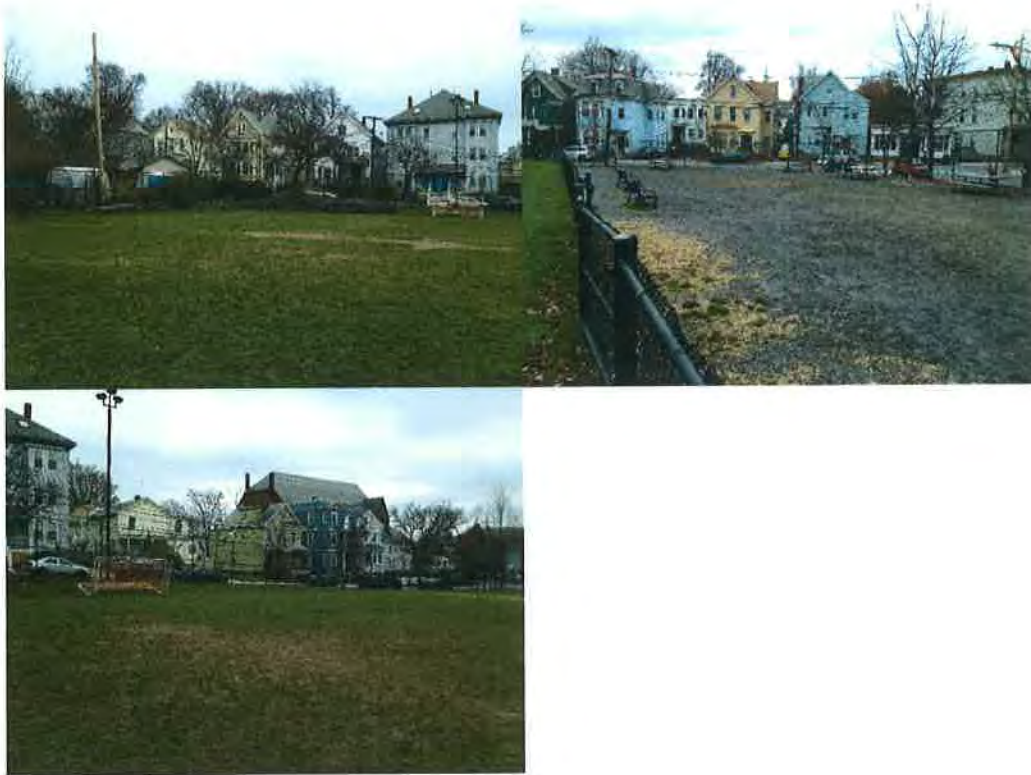
3. Photo Documents:

Condition	Comments
Pitcher's Mound and Rubber	N/A	
Bases and Home Plate	N/A	
Scoreboards	None	
Backstop	N/A	
Dugout(s)	N/A	
P.A. System	None	
Spectator Seating	Picnic tables	
Flag Pole	None	
Player Benches	None	
Goals/Goal Posts	Soccer goals in fair condition	
Field Marking/Striping	Currently not striped	
Parking Facilities	@ Street	
Site Accessibility	Limited access	
Site Safety	Good	
Site Buildings	None

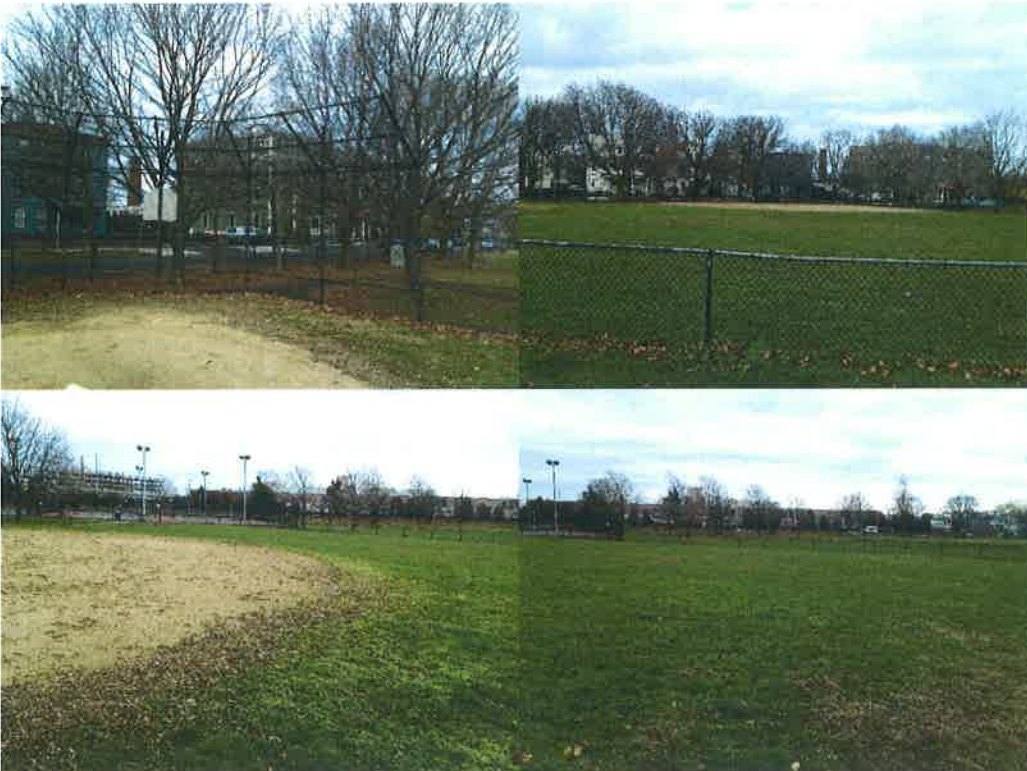
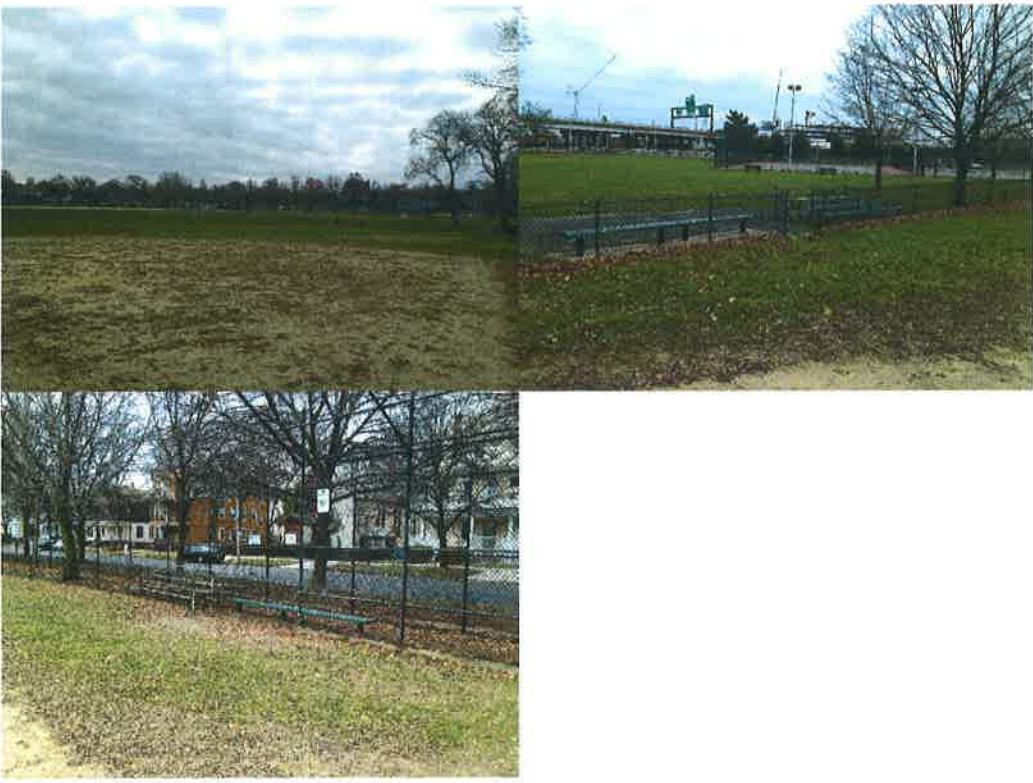
3. Photo Documents:

Condition	Comments
Pitcher's Mound and Rubber	Fair condition	
Bases and Home Plate	Bases no present	
Scoreboards	None	
Backstop	Fair conditions Black vinyl starting to peel	
Dugout(s)	None	
P.A. System	None	
Spectator Seating	@Baselines -- not code compliant	
Flag Pole	None	
Player Benches	Wooden benches on concrete pad -- fair condition	
Goals/Goal Posts	N/A	
Field Marking/Striping	N/A	
Parking Facilities	@Street	
Site Accessibility	Site is ADA accessible	
Site Safety	Good	
Site Buildings	None

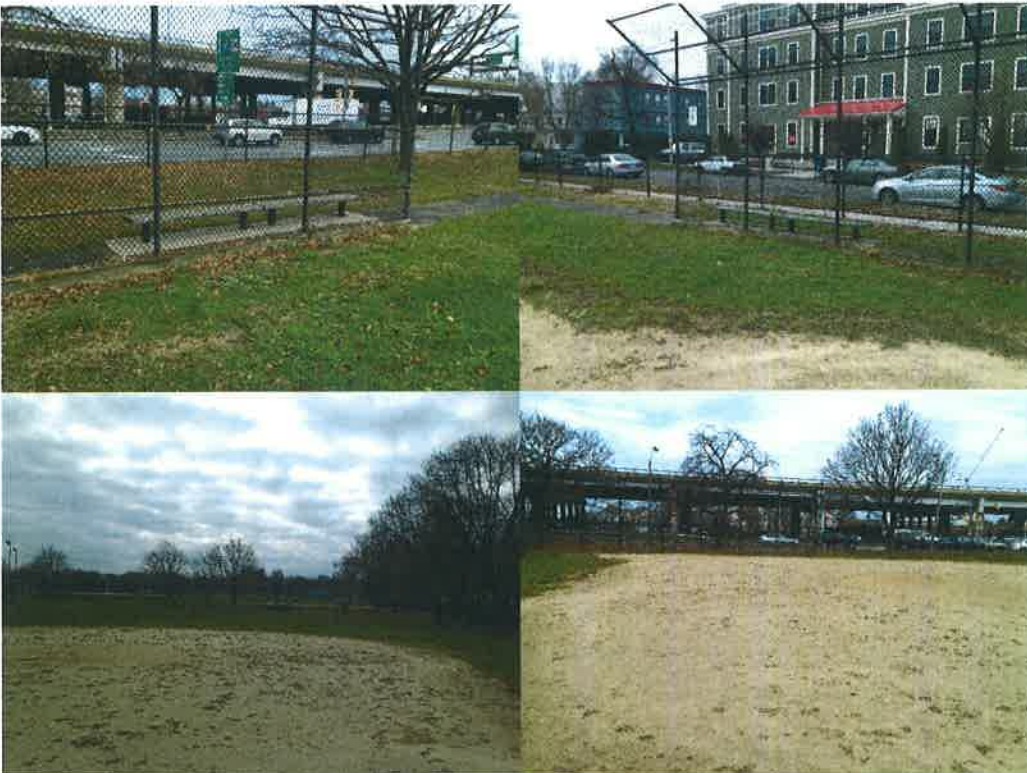
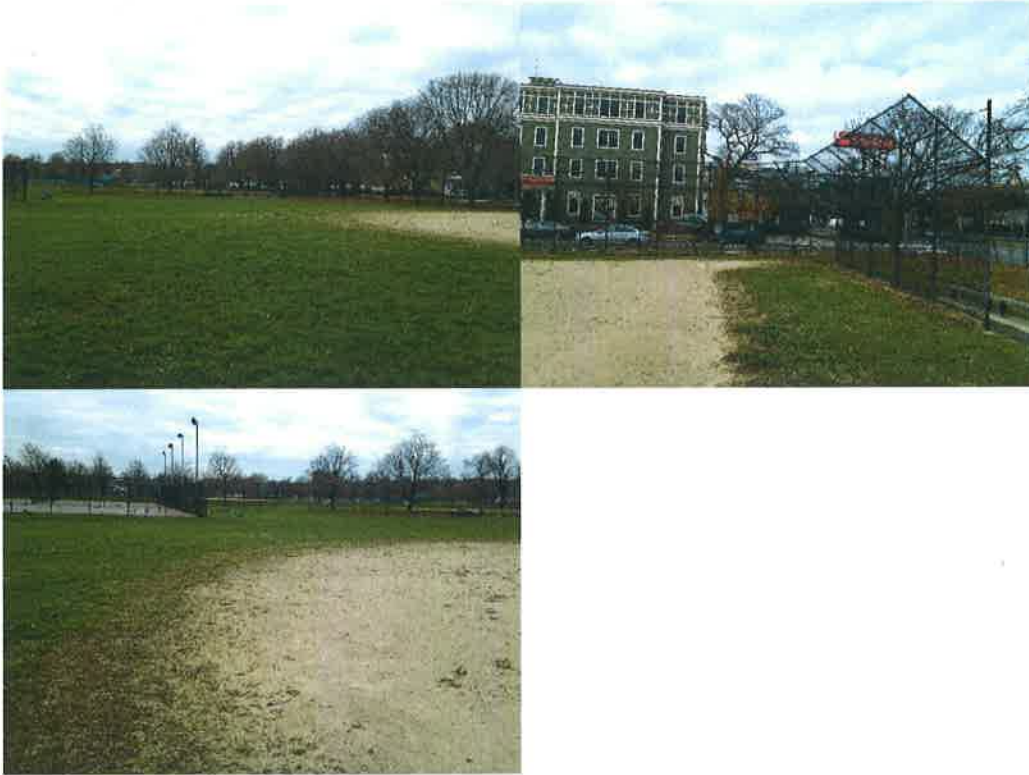
3. Photo Documents:

Condition	Comments
Pitcher's Mound and Rubber	Fair condition	
Bases and Home Plate	Bases not present	
Scoreboards	None	
Backstop	Four black vinyl railings	
Dugout(s)	None	
P.A. System	None	
Spectator Seating	None	
Flag Pole	None	
Player Benches	Wooden benches on concrete pad fair condition	
Goals/Goal Posts	N/A	
Field Marking/Striping	N/A	
Parking Facilities	@street	
Site Accessibility	Site is ADA accessible	
Site Safety	Good	
Site Buildings	None

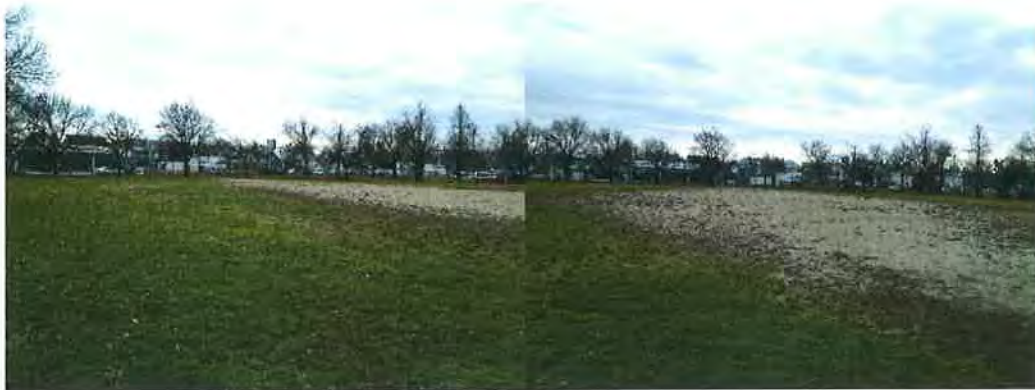
3. Photo Documents:

Condition	Comments
Pitcher's Mound and Rubber	N/A	
Bases and Home Plate	N/A	
Scoreboards	None	
Backstop	N/A	
Dugout(s)	N/A	
P.A. System	None	
Spectator Seating	None	
Flag Pole	None	
Player Benches	None	
Goals/Goal Posts	None	
Field Marking/Striping	None	
Parking Facilities	@Street	
Site Accessibility	Site is ADA accessible	
Site Safety	Good	
Site Buildings	None

8. General Turf Condition: 1

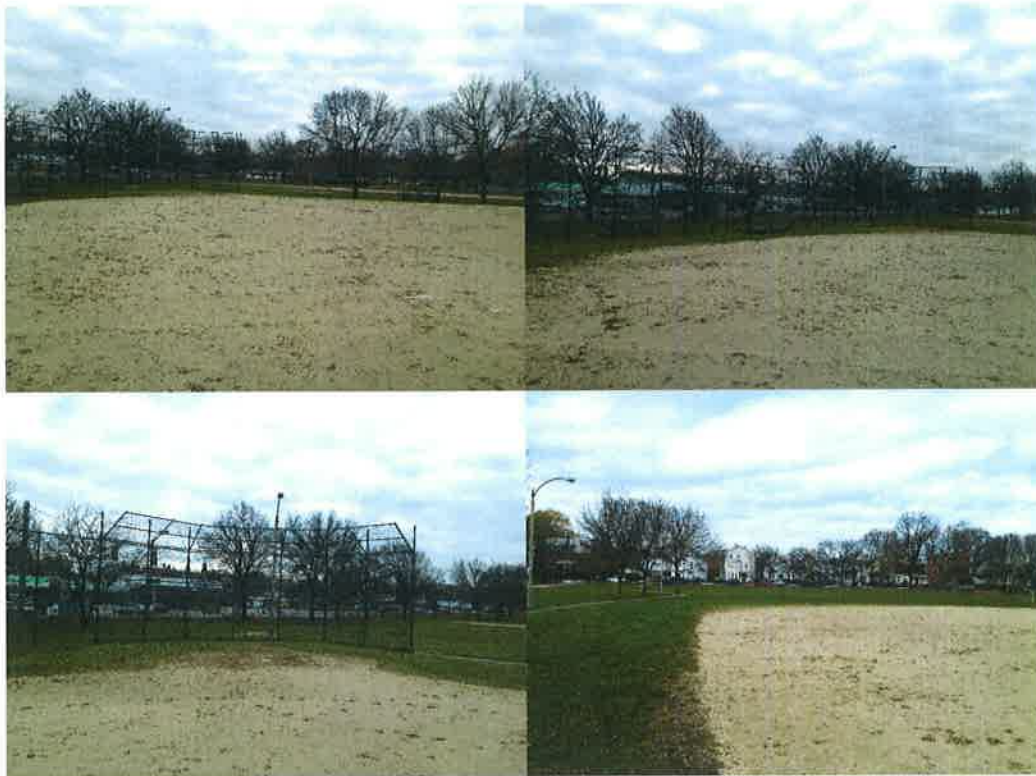
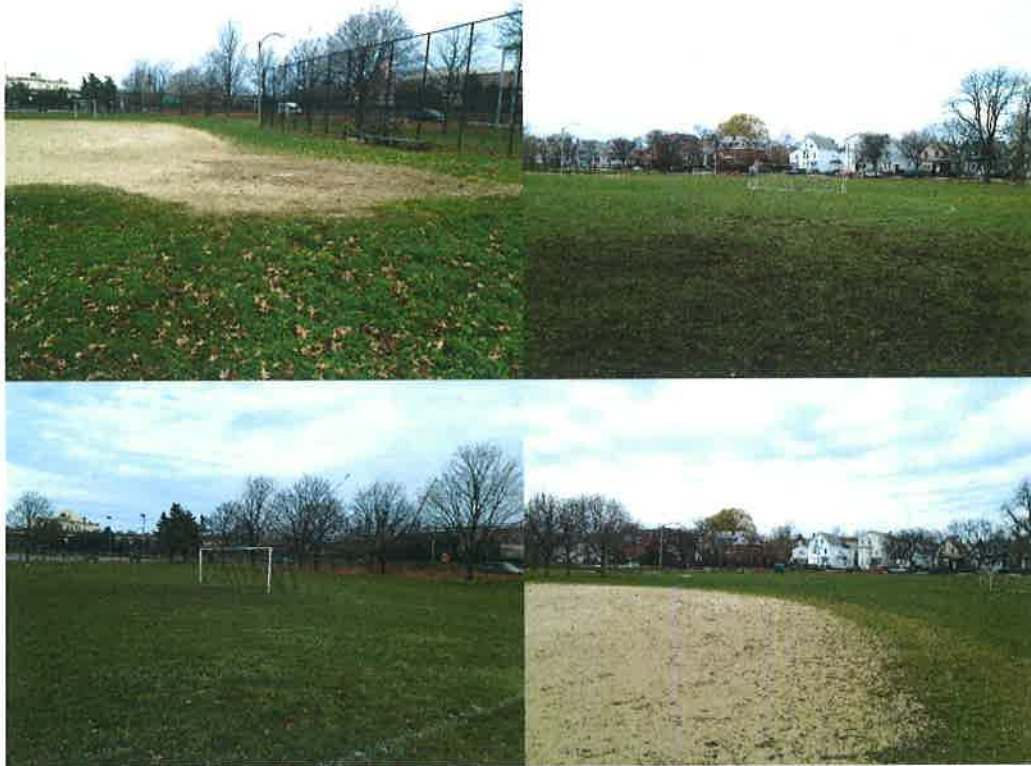
3. Photo Documents:

Lighting:	No athletic lighting Site lighting
Fencing:	Backstop fair condition No outfield fencing
