**City of Somerville
Athletic Fields Assessment**

**FIELD EVALUATION
DATA SHEET**

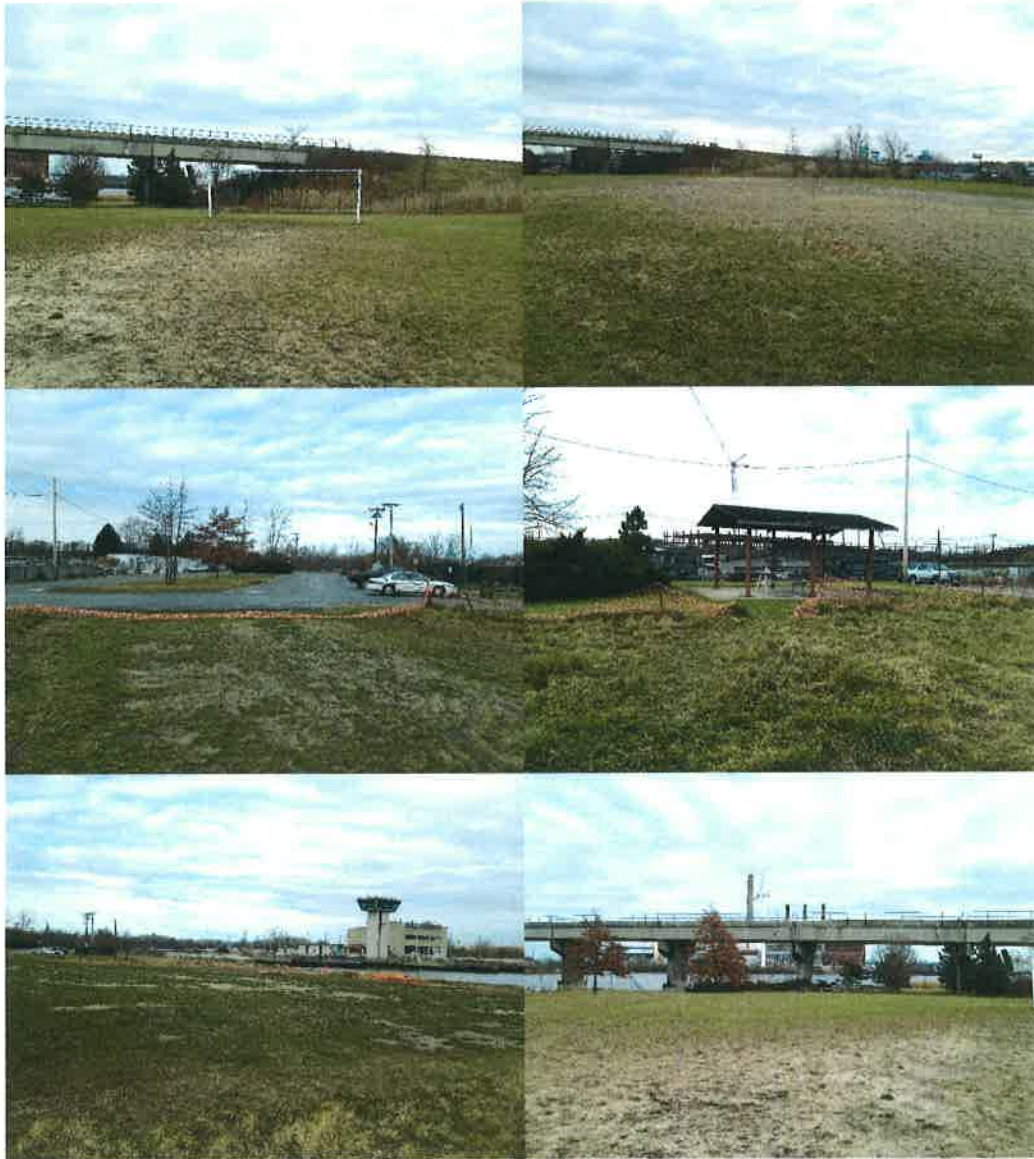
3. Photo Documents:

Large open area with large areas void of turf
