FY20 FUNDING CYCLE APPLICATION COVER PAGE

THE PROPE	TION COTES	T HGB
1. PROJECT INF	ORMATION				
PROJECT NAME:	Addressa	ble Fire Alarm :	System		
PROJECT LOCATIO	ON: <u>277 Br</u>	oadway Some	rville, MA 021	145	
LEGAL PROPERTY	OWNER OF	RECORD: The E	lizabeth Peat	oody House As	ssociation
R					
ONE SENTENCE D			e Elizabeth Pe	eabody House	is seeking funds to install an addressable fire alarn
Please indicate (to this project	(minimum of c	one) in the chart.
	Open Space	Recreational Land	Historic Resources	Community Housing (blended projects only)	ESTIMATED START DATE: April 2020
Acquisition				projects only)	
Creation					ESTIMATED COMPLETION DATE: June 2020
Preservation			X		
Support					CPA FUNDING REQUEST: \$38,000
Rehabilitation/ Restoration			X		Total Budget for Project: \$38,000

Elizabeth Peabody House Building Conditions Assessment

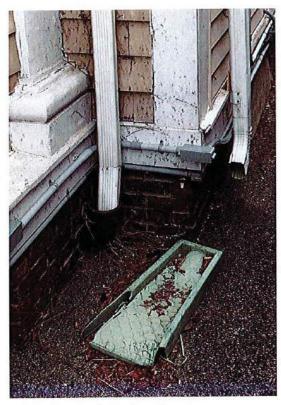
Some rain leaders do not reach grade. Of those that do, some downspouts are directed into storm drainage piping, and some are directed onto splash blocks pitching onto grade. Roof water run-off control should be improved to protect the walls and foundations, and also to eliminate ice build-up on the winter.

2 Downspouts at the southwest corner

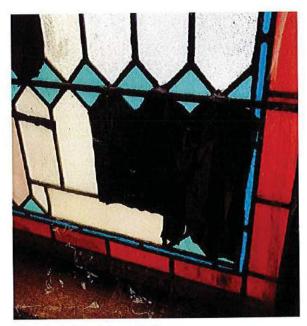
The stained glass windows are an important "character defining" historic element of the building. Unfortunately, stained glass windows are delicate and subject to stress from excessive heat or cold as well as age. Although much of the stained glass windows are intact, deterioration is occurring quickly. Most of the windows have an exterior panel which is failing. Consequently, many have lost lights and leading. A temporary remediation with building sealant tape has been done on many of the windows. It is effective but ugly and cannot be a long-term solution.

4 Patched stained-glass detail

Included in this report is a proposal to restore the stained glass windows and provide exterior Lexan. The total estimated cost \$61,608. That does not include related carpentry work (TBD) or soft costs.

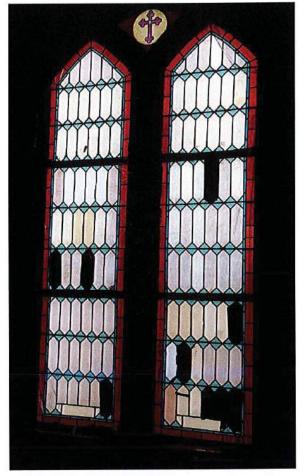
5 Patched stained-glass window

- Scrape, paint and replace as required the:
 - First floor window trim
 - Wooden spandrels between the first floor and upper level windows.
- Survey all other windows for thermal failure and create a schedule for restoration or replacement on a case-by-case basis.
- Repair the basement windows and screens.
- Create a capital reserve to restore and protect the stained-glass windows. Alternate proposals and prices should be solicited. Alternatively, this and other exterior restoration may qualify for CPA funding

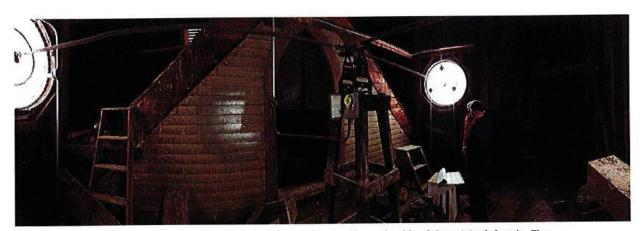
7 Panorama view of the interior of the clock tower showing the end gable of the original church. The geared mechanism to run the clocks is to the right of the ogee window. Note also the crossed-braced framing in the exterior walls.

- Periodically monitor the tower to make sure that the hatch is closed and no birds get in.
- Dispose of the roofing waste stored in the tower.
- See also the structural report.
