CPA Full Grant Application FY26

Project Name: VIDA REAL BROADWAY ROOF PRESERVATION

Project Location: 404 BROADWAY SOMERVILLE

PART II: CONDITIONS ASSESSMENT & TREATMENT RECOMMENDATIONS

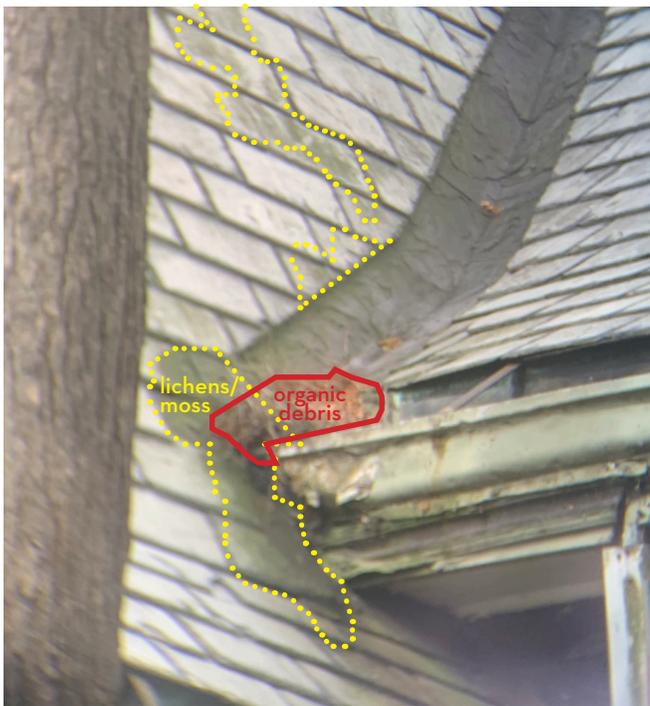
Roofs are complex assemblies of various parts, including sheathing, underlayments, sheet metal flashings, surfacing, gutters, and downspouts. There are many opportunities for deficiencies to develop, and a problem with one facet of the assembly could easily – and often does – cause problems with the others. This is especially true of historic roofs, which often have materials with very different lifespans. For the purposes of this report (and as mentioned in the previous section), ‘roof’ refers to all portions of the building exterior surfaced with slate. Given the almost identical construction of the building’s sloped ‘true’ roofs and slate-surfaced walls, similar deficiencies have developed at both. As such, similar treatments are required for proper remediation.

Fortunately, roof construction remains strikingly consistent throughout the historic (1890s) portion of the church. The slates here employed are identical in color, cut, and composition. This of course comes with the exception of small areas where slates were cut differently for ornament and where small repairs have been executed.

The slate roofs and walls are almost certainly original to the 1893 construction. At 130 years old, the roofs are aged, but not to the point of requiring extensive replacement. A well constructed roof utilizing a durable species of slate can last upwards of 200 years with only minor repairs, and these roofs are no exception.

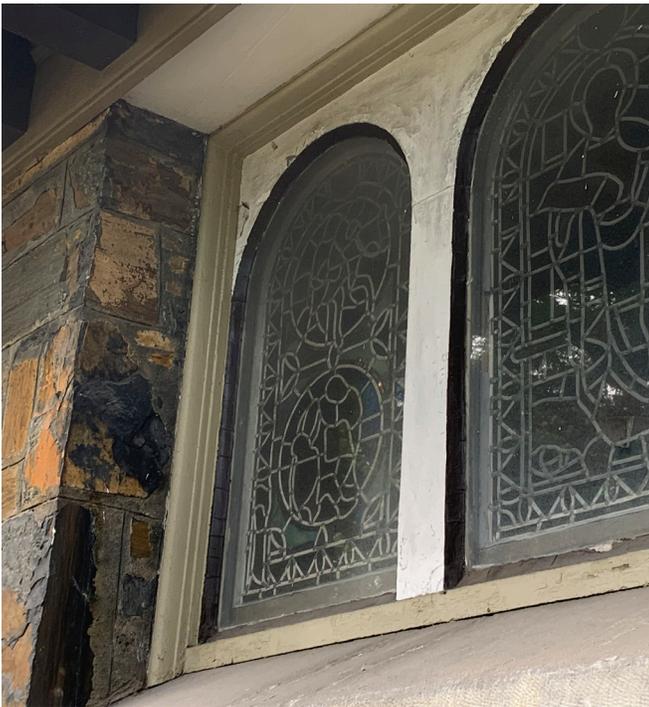
Windows and doors vary throughout the church vary widely in condition. Like in previous subsections of this narrative, the scope of assessment is limited to openings only within the historic portion of the building, including, of particular note, stained- and otherwise leaded-glass windows. As in the 'Character Defining Features' narrative on pp. 11-17, the windows are here assessed by type and, within each type, notes as to the condition(s) of specific, that is, individual, windows are provided.

The majority of the leaded-glass windows at the historic portion of the church have buckled significantly. This condition results from the material properties of lead. Of course, it is the material of choice for glassmaking, as it is very pliable when heated; this, however, comes with two major drawbacks: firstly, continual exposure to sunlight softens the lead comes, thereby allowing the window to settle (downward, under the force of gravity). This is what causes 'buckling,' or the frequently-observed phenomenon where the glass assembly within the sash develops waves, particularly near the bottom. Secondly, lead expels gas ('offgases') when exposed to heat. While the fumes are of minimal concern to humans, they make installation of storm windows difficult; the gas gets trapped between the two layers of glass and a 'greenhouse effect' ensues, thereby accelerating the rate at which the lead warms, softens, and settles. This is generally addressed through installation of one-way gaskets in the storm panels, which allow the gas to escape. *Such is the recommended approach for all storm panels to be installed at Vida Real.*

Unless recommended otherwise, proposed stained- and leaded-glass window restoration is to involve the following steps: (1) removal of sash from frames; (2) removal of leaded glass assembly from each sash; (3) replacement of existing lead comes (making sure to carefully document the panes'

arrangement); (4) scraping of existing topcoat on wood stiles, rails, and (in situ) frames; (5) epoxy consolidation of rotted/spongy wood as required; (6) re-application of finish on wood components; (7) re-setting of glass assembly in restored wood sash with new caulk or glazing compound; (8) replacement – or, in the absence of existing, installation – of weatherstripping; (9) cleaning and polishing of existing window hardware and replacement of irreparable hardware (sash locks, pulleys, cranks, weights, etc.) with hardware to match existing; (10) reinstallation of sash within restored frames, with new stops as required; and (11) installation of low-profile, exterior storm panels from Allied or an equivalent manufacturer, gasketed (as mentioned above) to allow for off-gassing of leaded glass.

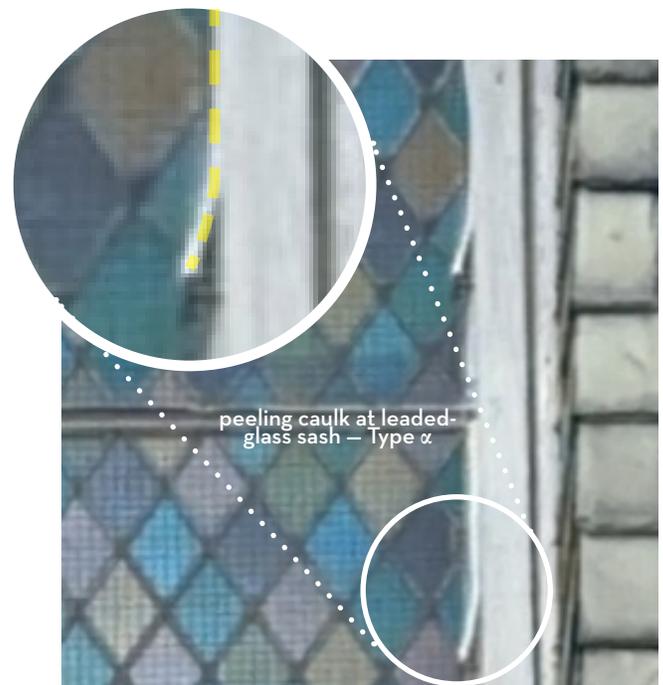
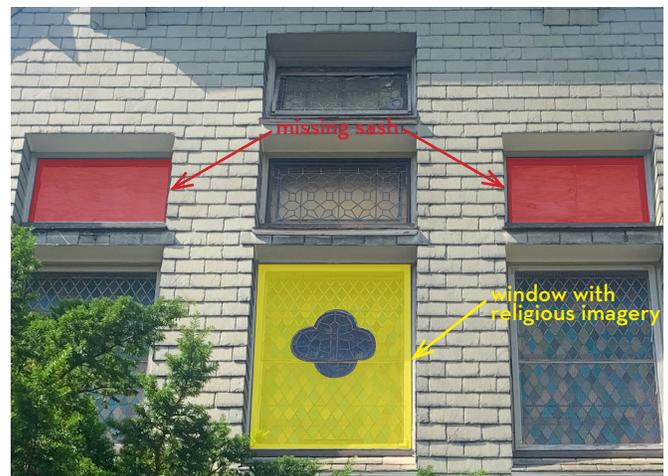
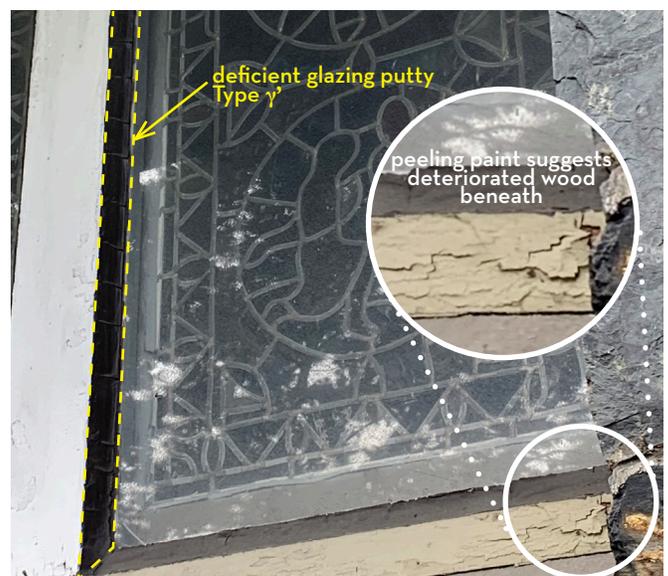
deteriorated sills from absorption of standing water – Type δ

deteriorated wood stop

δ – For one reason or another, turret windows are in significantly worse condition than many of the building's other leaded-glass windows. This could be due to difficulties with access, more complicated installation detailing, or some combination thereof. *That said, these windows are in need of comprehensive restoration, according to the recommendations provided earlier.*

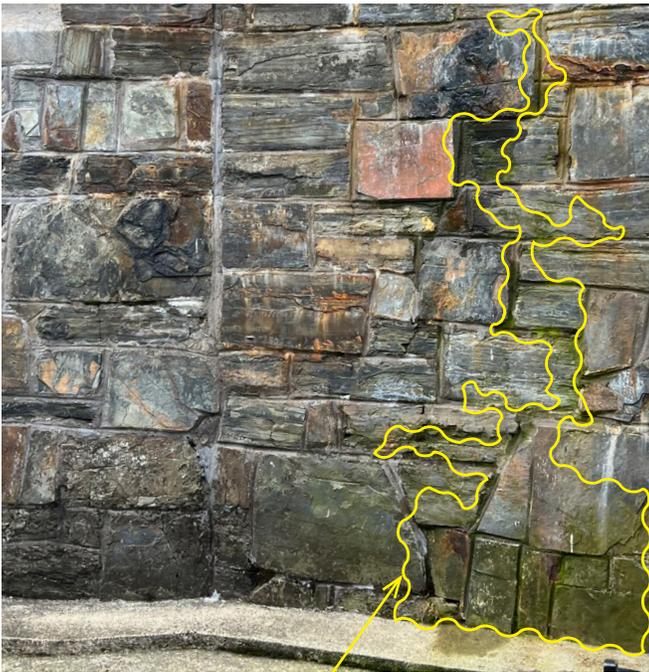
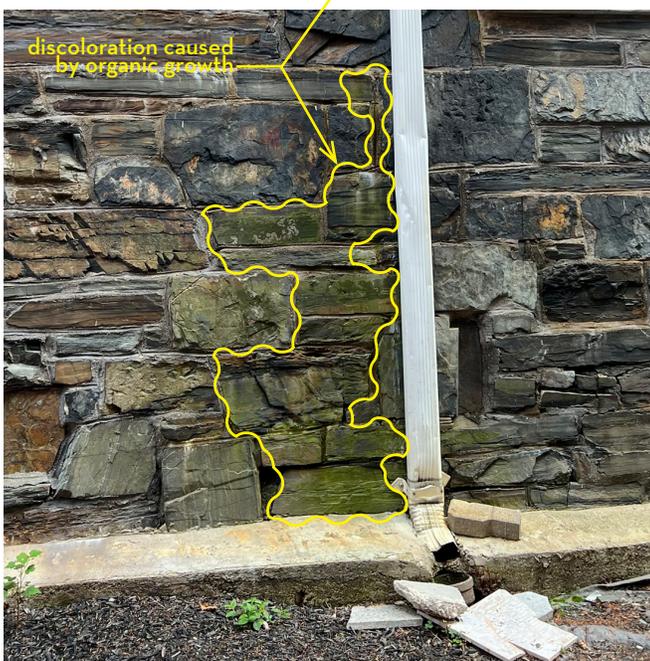
In general, masonry at Vida Real is in far better condition than any other parts of the building envelope. This, of course, is due in part to the recent repointing campaign at the bell tower; other areas have not, as would be expected, suffered from much mortar loss. This condition is typically among the earliest symptoms of moisture penetration in masonry, so the fact that it is not observable is a good sign. Such is usually followed by leaks at the interior, deterioration of adjacent wood members, and lastly, spalling and/or efflorescence at the stone faces.

It is worth noting that the only conditions observable at the church are items lower on this list, meaning they are of little to no concern. Things like organic growth and staining pose a negligible threat to the masonry and can be left unchecked for decades.

We typically recommend against cleaning masonry, as it can often do more harm than good in terms of the onset of moisture and absorption of harsh chemicals. If the discoloration of masonry is bothersome, a gentle cleaning with soap and water could mitigate it; by no means, however, should the masonry be pressure washed, as this can lead to loss of masonry particulates and/or mortar.
