# 2013 Pedestrian Accessibility Study

Somerville, Massachusetts

**May, 2013**

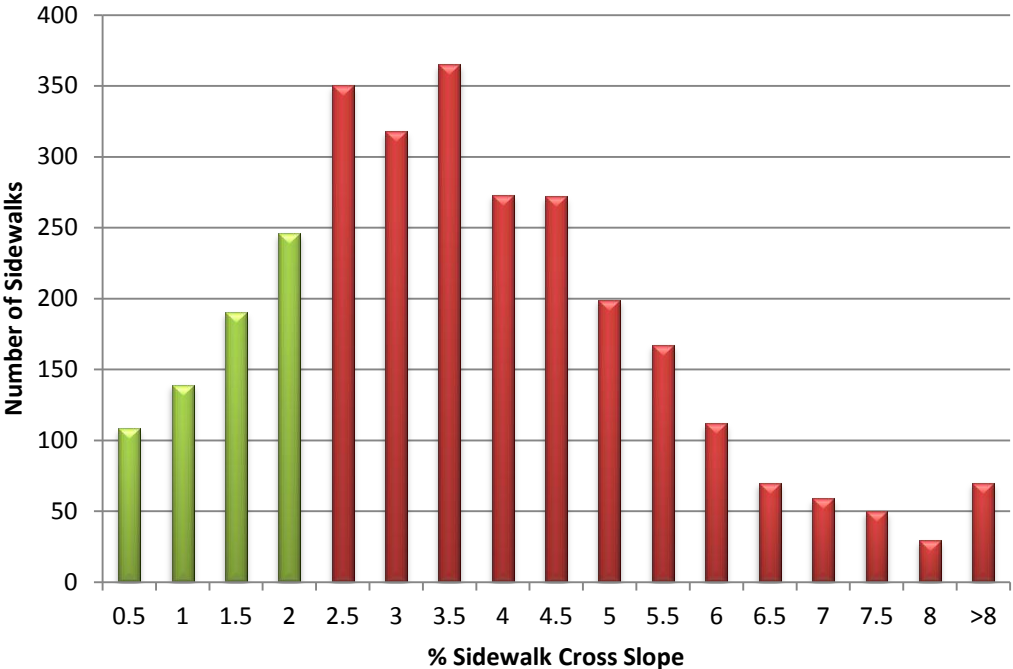
**Figure 2**  
**Distribution of Sidewalk Cross-Slope**

This investigation has revealed approximately 77% of Somerville sidewalks do not comply with MAAB requirements.

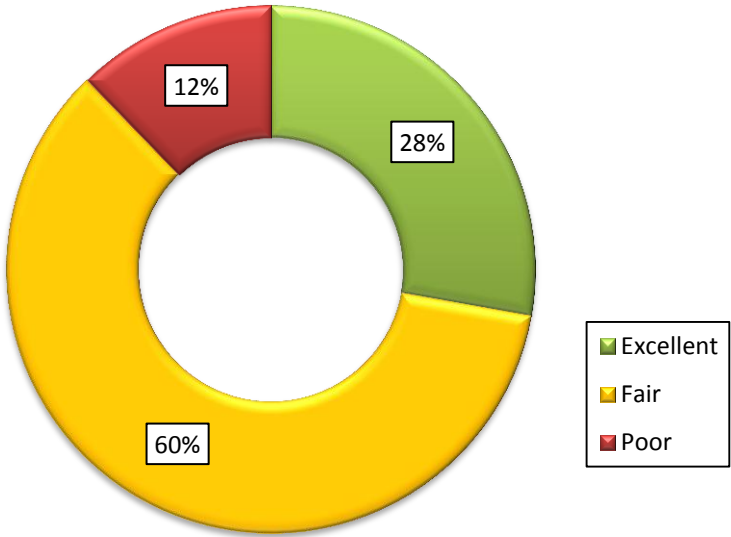
**Figure 5**  
**Surface Material Conditions**

Surface material conditions revealed that the majority of pedestrian ramps in Somerville are in Fair condition, with more in Excellent condition than Poor condition. Figure 5 shows the split between these three categories.

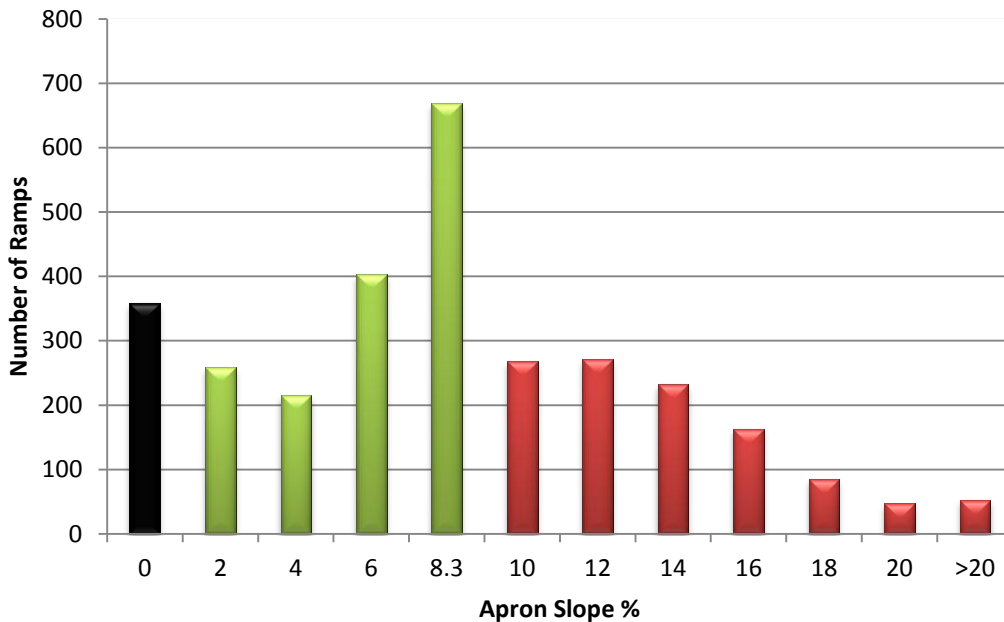
**Figure 6**  
**Distribution of Ramp Slope Percentage**

To get a more in depth analysis of MAAB compliance beyond visual inspection, pedestrian ramp and landing slopes were integrated. MAAB maximum slope for ramps and landings is 8.3% and 2.0% respectively. Figures 6 and 7 show distributions of both attributes with green bars showing compliant standards and red showing non-compliant standards and a black bar representing ramps which are missing and have 0 values.

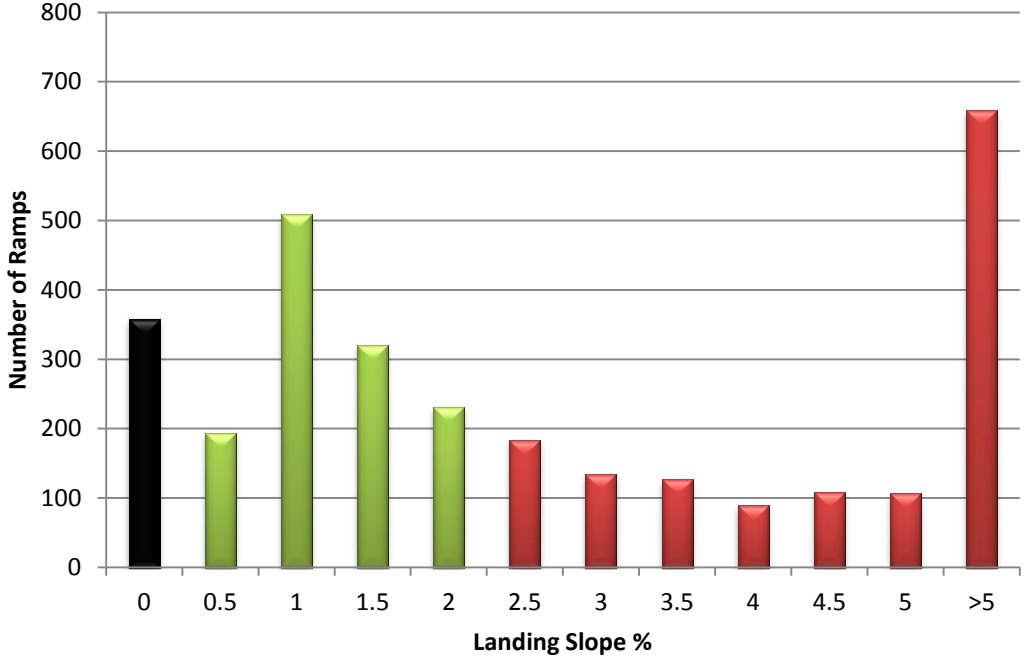
**Figure 7**  
**Distribution of Landing Slope Percentage**

In determining likelihood of MAAB compliance, five primary attributes were used: visual inspection, ramp slope, landing slope, crosswalk deficiencies, and presence of a lip. In using these, it was determined that 2,428, or 80% of the total ramps in Somerville are likely not compliant with MAAB standards.

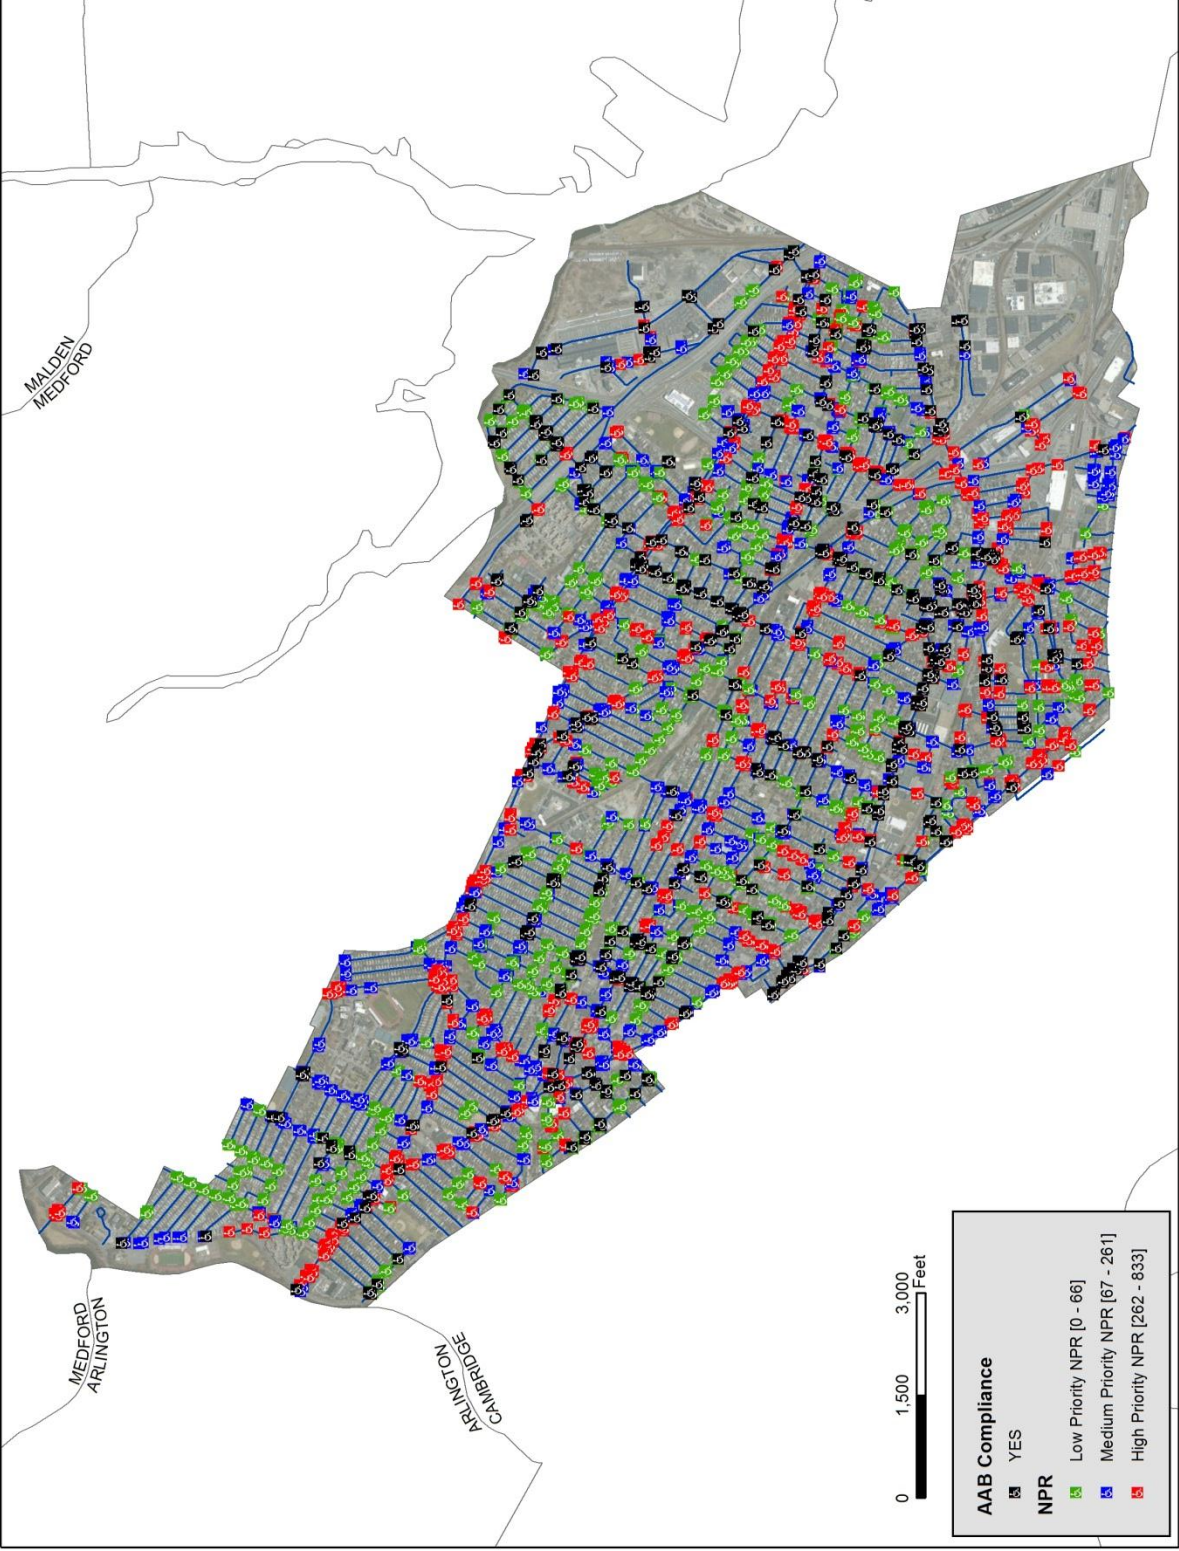
**Figure 9**  
**Network Ramp NPR**

Once the final NPR values were summed for ramps, they were distributed into three categories based on a geometric split. Figure 11 shows the priority levels for all likely non-compliant ramps, as well as locations of compliant ramps throughout the network.

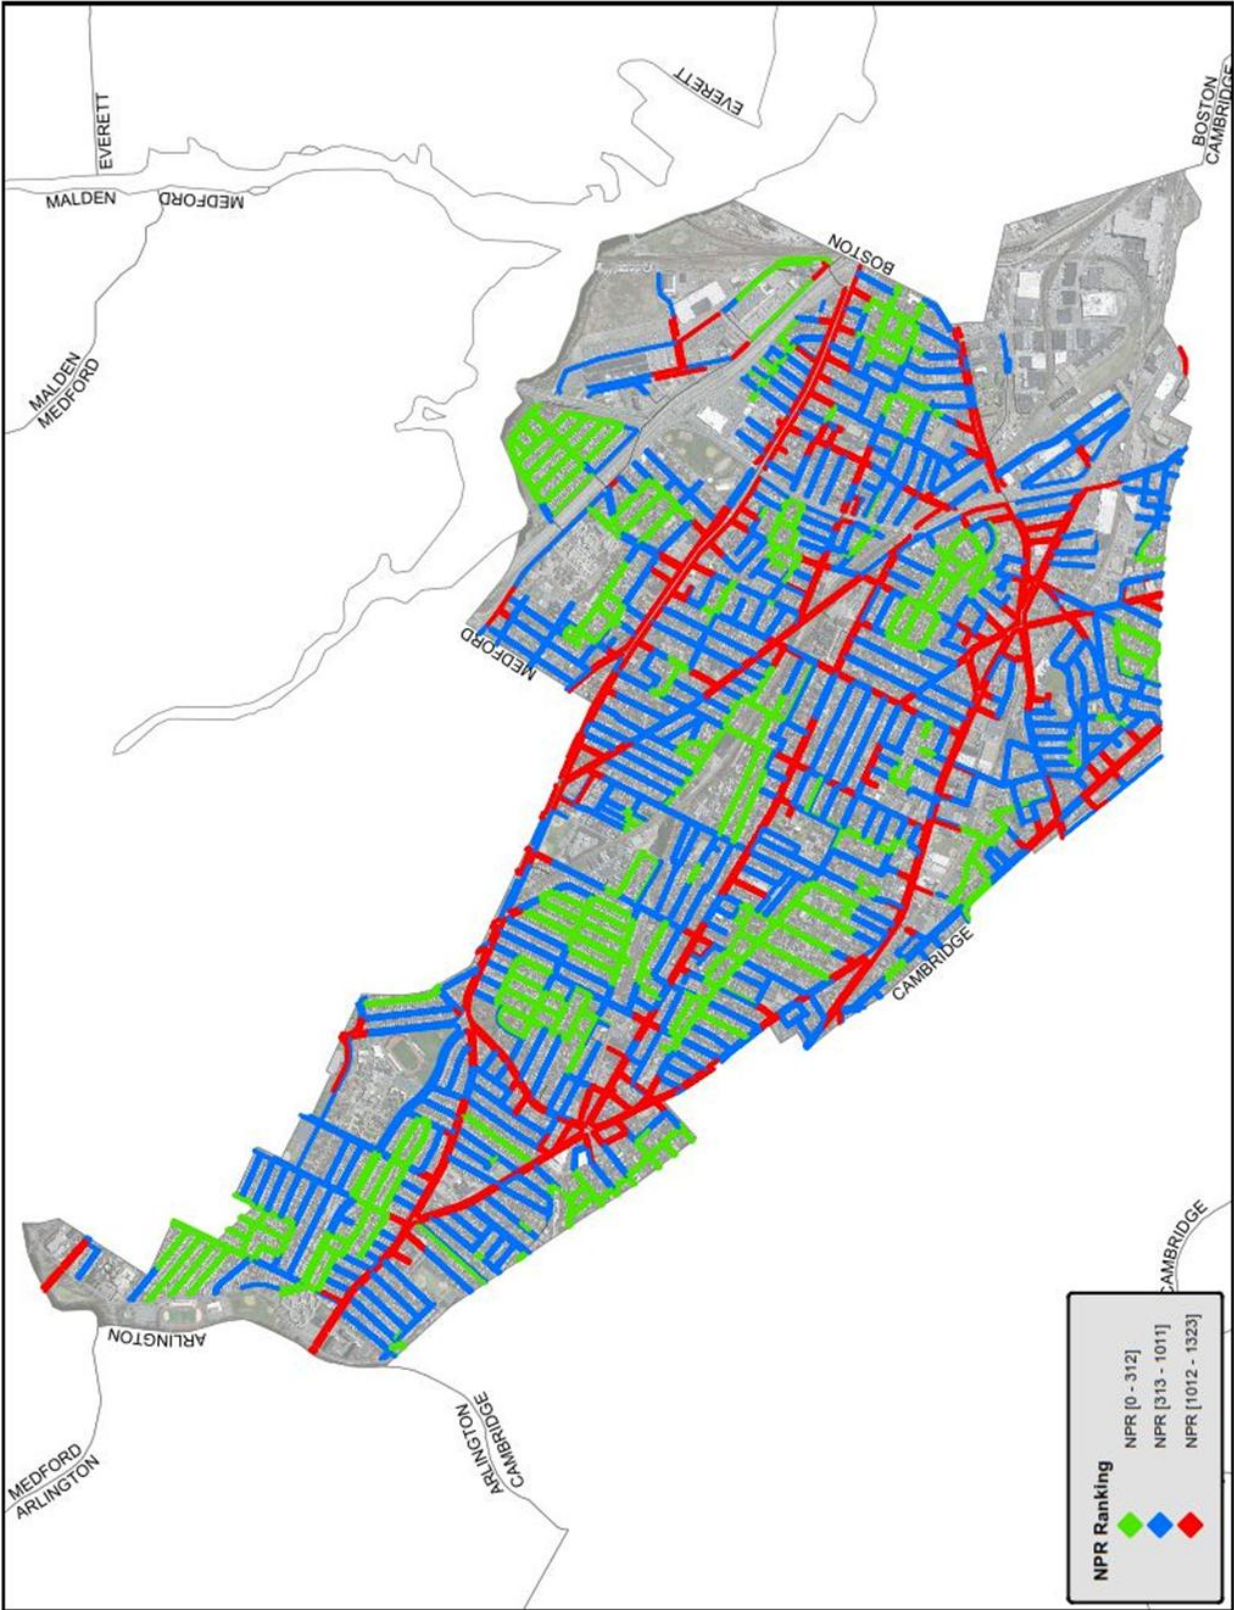
**Figure 11**  
**Network Sidewalk NPR**

Once the final NPR values were summed for sidewalks, they were distributed into three categories based on geometric split. Figure 12 shows the NPR values for sidewalks throughout the City.
