SD|LYONS

VEHICLE ANALYSIS – SDL# 10744.1

INSURED Somerville DPW
VEHICLE 2017 Ford F550 Super-Duty
VIN 1FDUF5HY1HED35804
ODOMETER Unknown
DATE OF LOSS April 13, 2018

Inspect the 2017 Ford F550 Super-Duty aerial bucket truck. Determine the origin and cause of the fire.

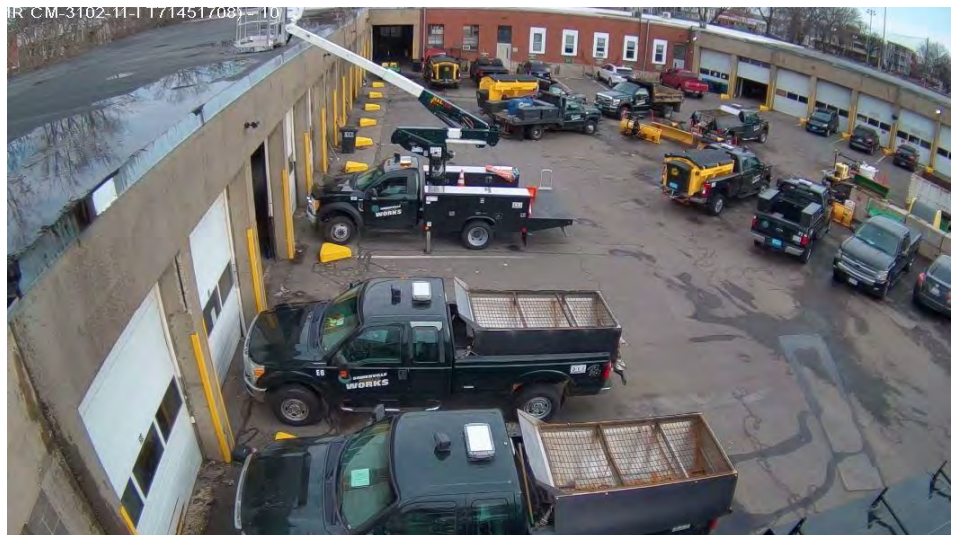
1 Surveillance Video

View of a surveillance camera mounted on a utility pole at the Somerville DPW. It shows the 2017 Ford F550 truck equipped with a Stamm/Versalift in operation. At this point in time the truck engine is idling and the aerial bucket is resting just above the roof of the DPW building. There is no smoke visible under the truck. The workers are not visible at this time and they were in the process of cleaning gutters for approximately 25-45 minutes.

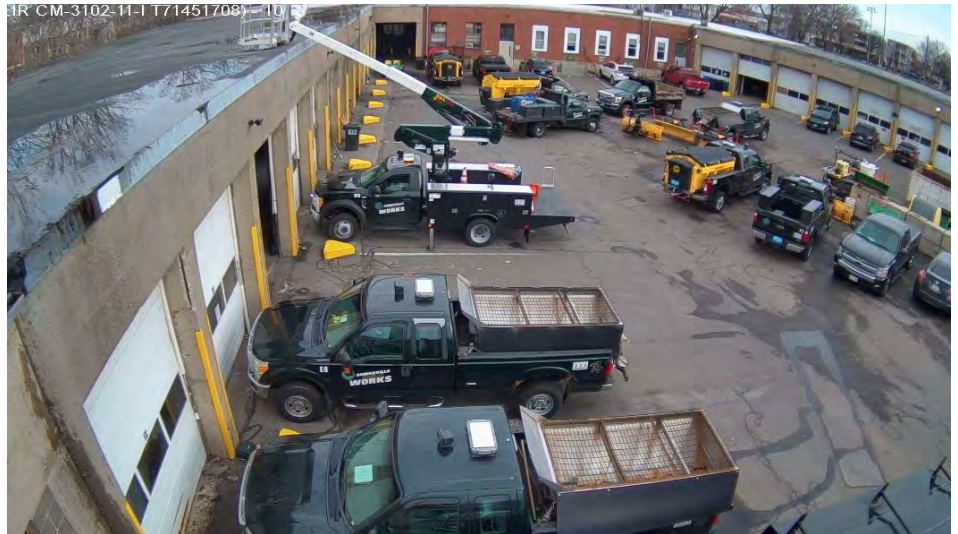
2

Another view of the Ford truck 4 seconds after the previous image. Slight smoke can be seen coming out from under the driver's side of the cab.

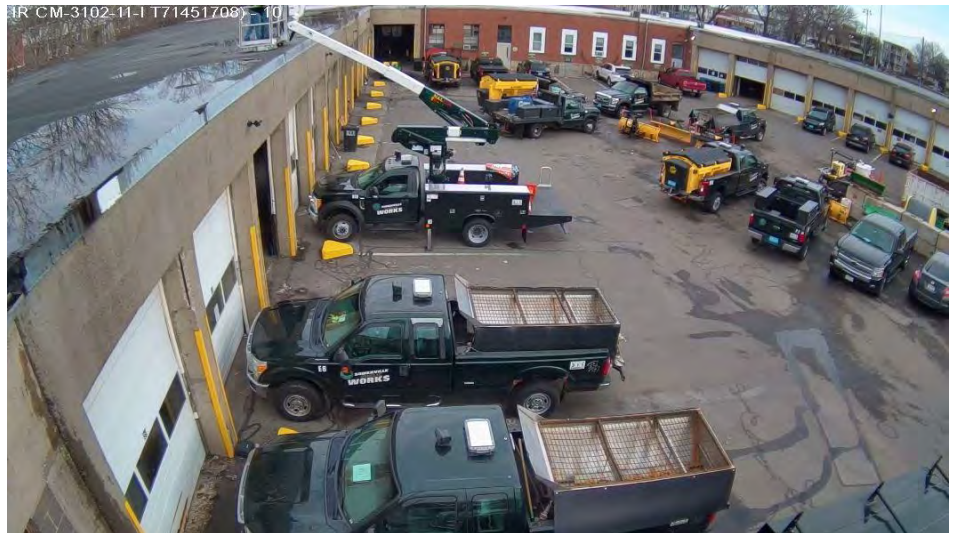
3

The video shows the workers walking back to the Versalift and getting into the bucket. While walking back, slight smoke was detected. They close the door and one of the workers activates the PTO. The video shows the aerial boom lifted several inches and the front of the Ford truck pitched down at the same time due to the weight suspended above and forward of the truck. Simultaneously, when the aerial boom moved, a larger puff of smoke can be seen underneath the truck in this image captured from the video.

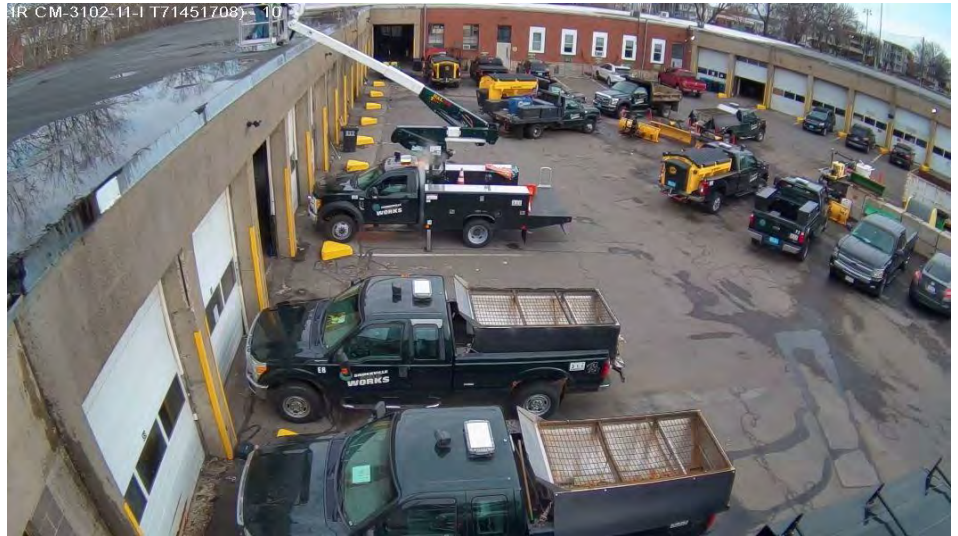
4

A second later after activation of the PTO, more smoke and a glow can be seen underneath the truck and fire coming up the back of the cab. The workers are still in the bucket.

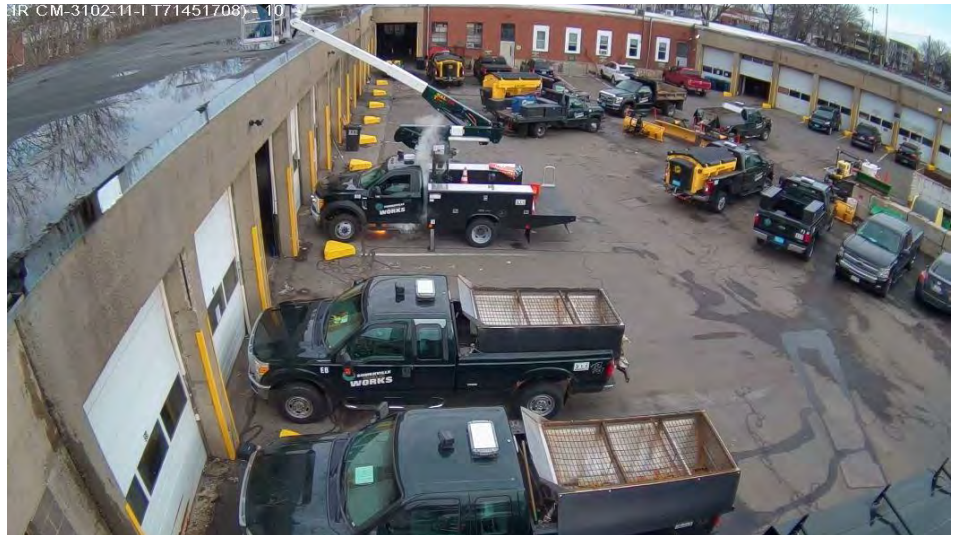
5

1.5 seconds later fire can be seen on the ground and smoke coming up from behind the cab. The fire on the ground is located just below the left side of the bellhousing on the transmission.

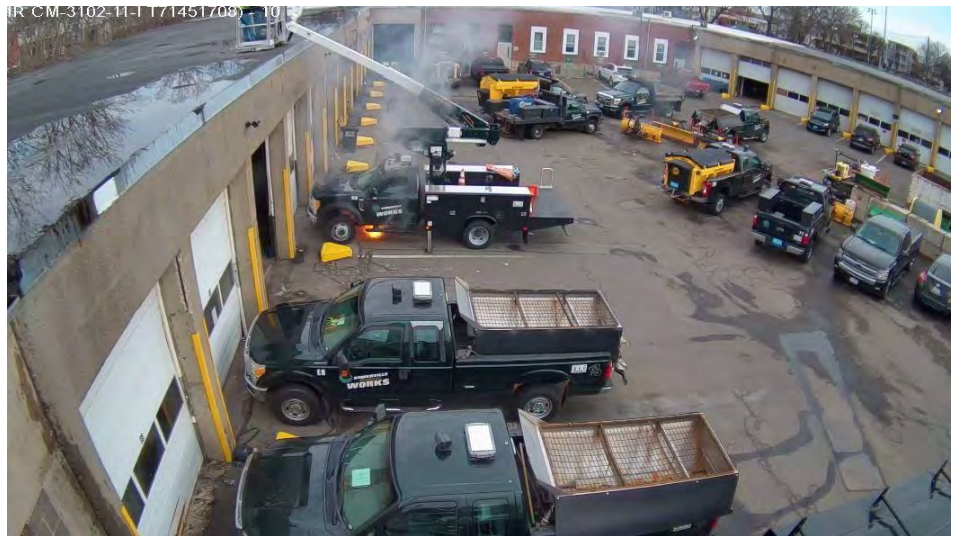
6

More fire can be seen on the ground below the left side of the transmission, and the workers are still in the bucket.

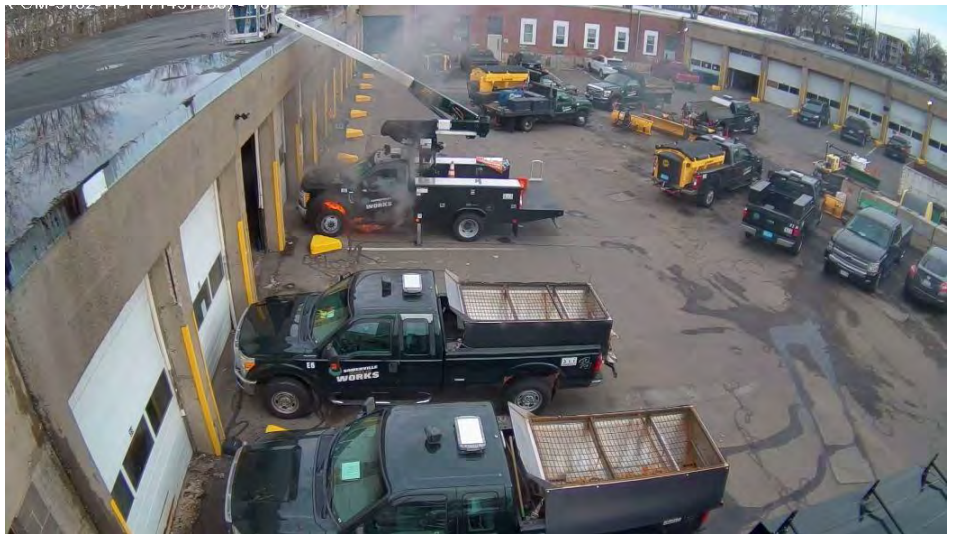
8

A pool of fluid can be seen burning on the ground below the cab and there is fire extension in the left front wheelhouse. The workers are still in the bucket.

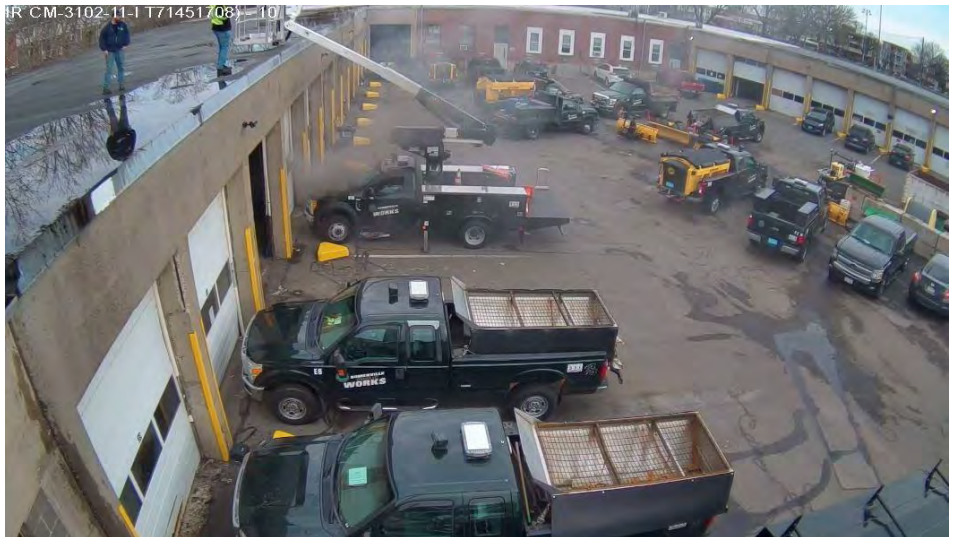
9

The workers are out of the bucket. A pool of fluid can be seen under the left front of the transmission, under the cab.

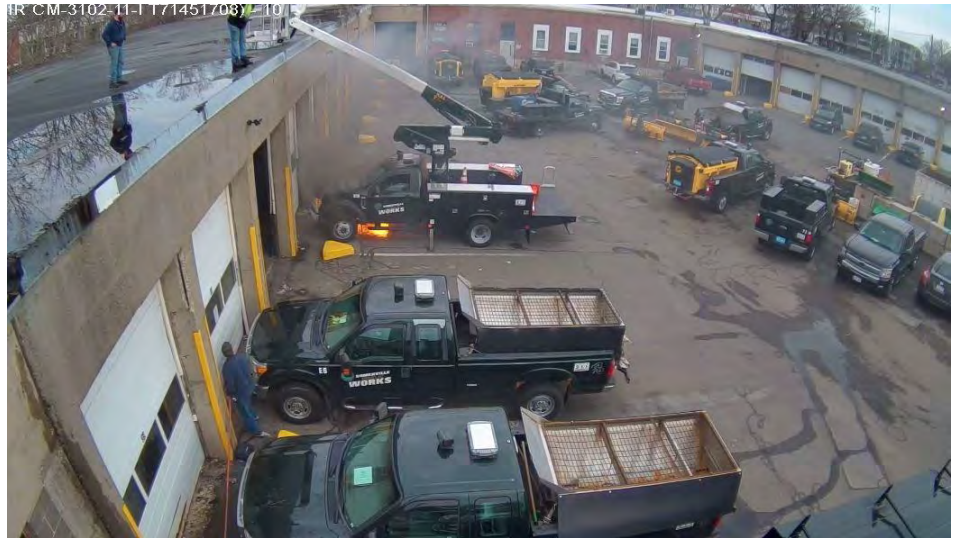
10

Seconds later the fluid is burning again and the puddle is larger. The mechanic can be seen in front of one of the garage doors, dragging a hose.

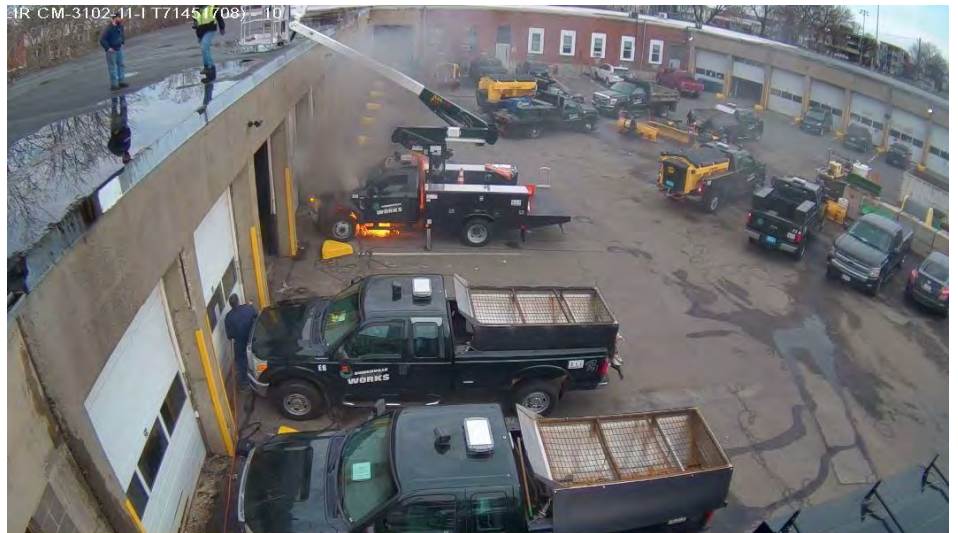
11

View of the fire spread underneath the cab of the truck and up the back of the cab. The mechanic is standing in front of a pickup truck with the hose.

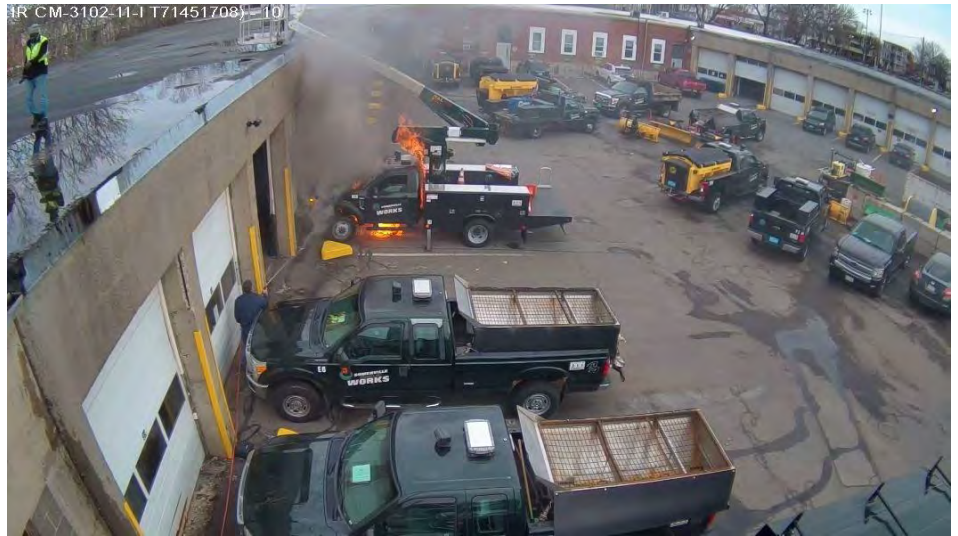
12

View of intense fire underneath the left side of the transmission and fire up the back of the cab. Fire can be seen at the back of the engine compartment. The mechanic was spraying water on the fire but it would not suppress it.

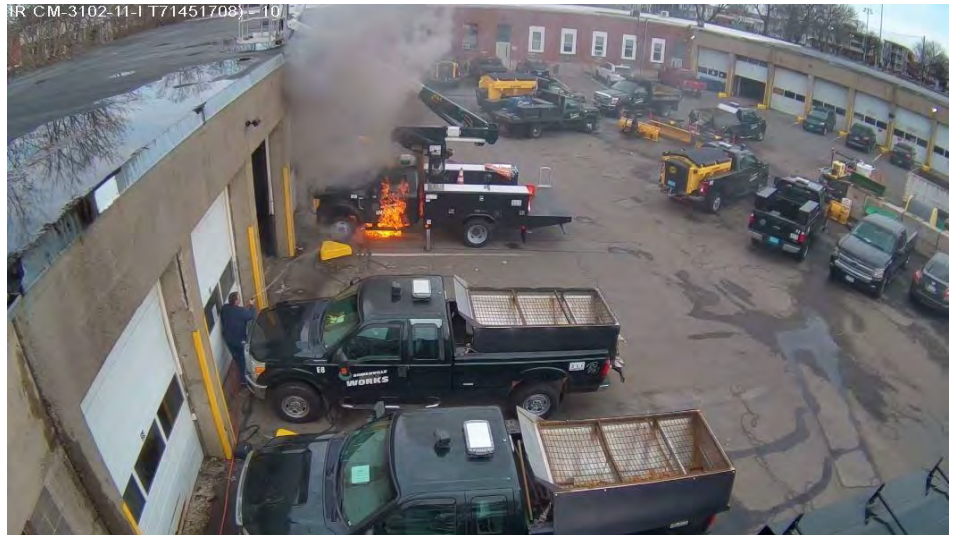
13

The fire then spreads on the ground underneath the cab and begins to extend up the rocker panel and up the side of the driver's door. There is a large pool of fire burning on the surface of the parking lot.

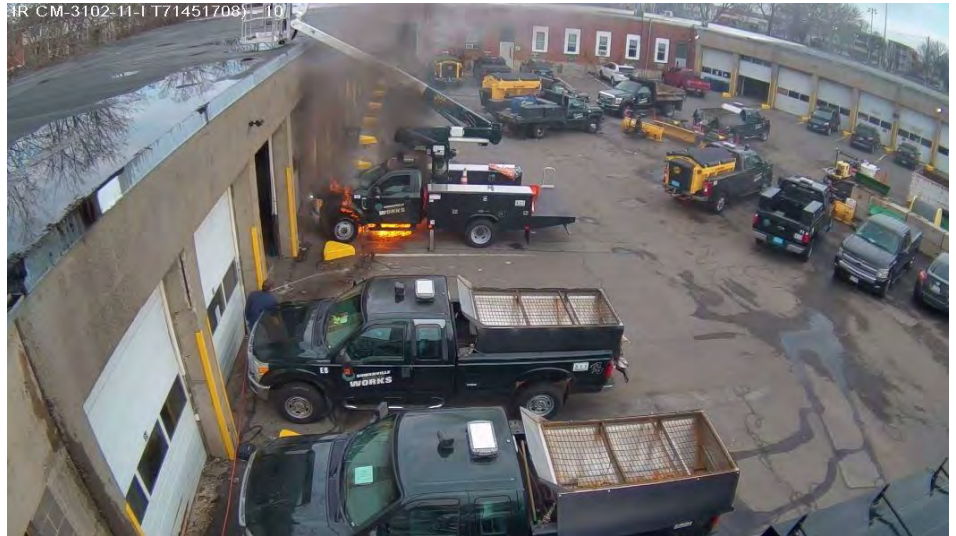
14

The pool of fire on the ground under the cab is larger and the fire is spreading into the engine compartment. Eventually the fire spreads up through the hole in the floor for the 4 WD shifter and the fire extends into the cab.

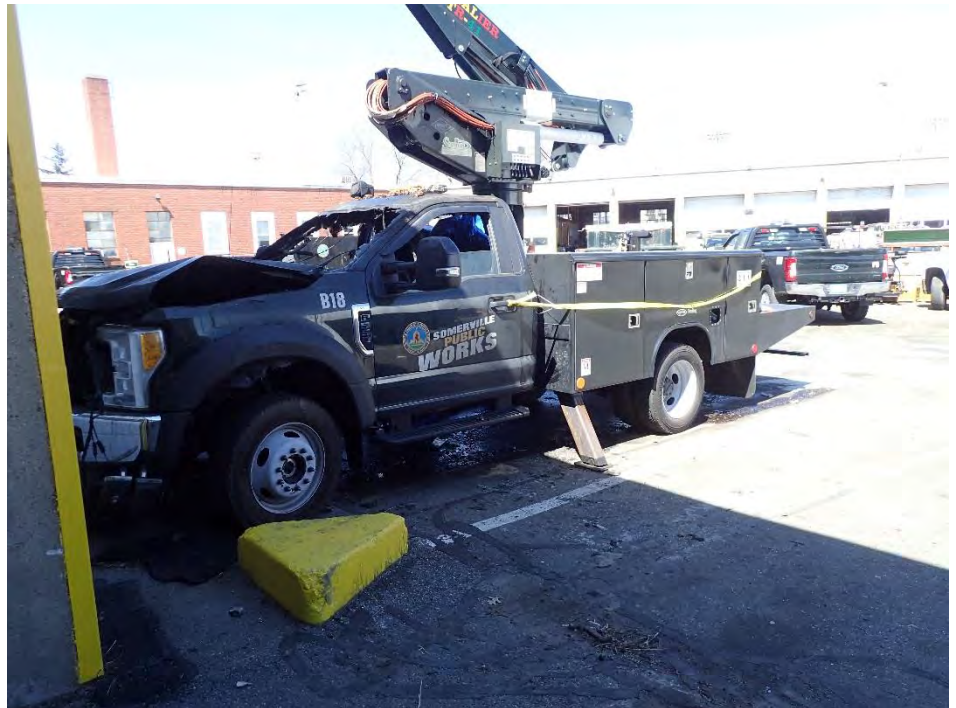
15 Inspection April 23, 2018

View of the 2017 Ford F550 aerial lift truck when it was first examined on April 23, 2018.

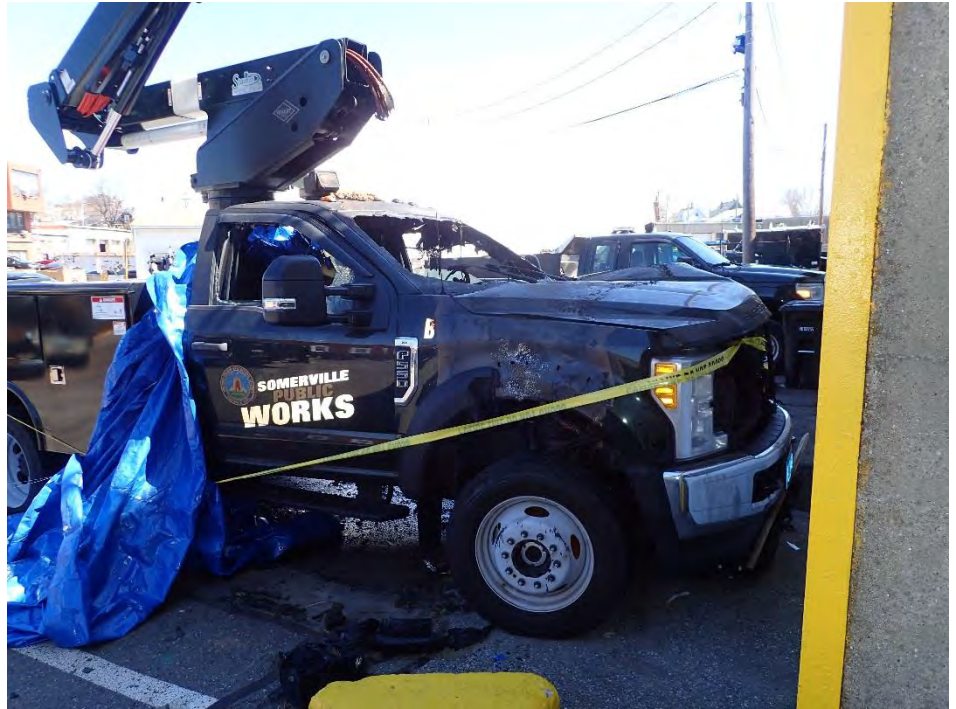
16

Right front view of the Ford truck. The truck had not been moved. There was a large puddle of fluid under the cab.

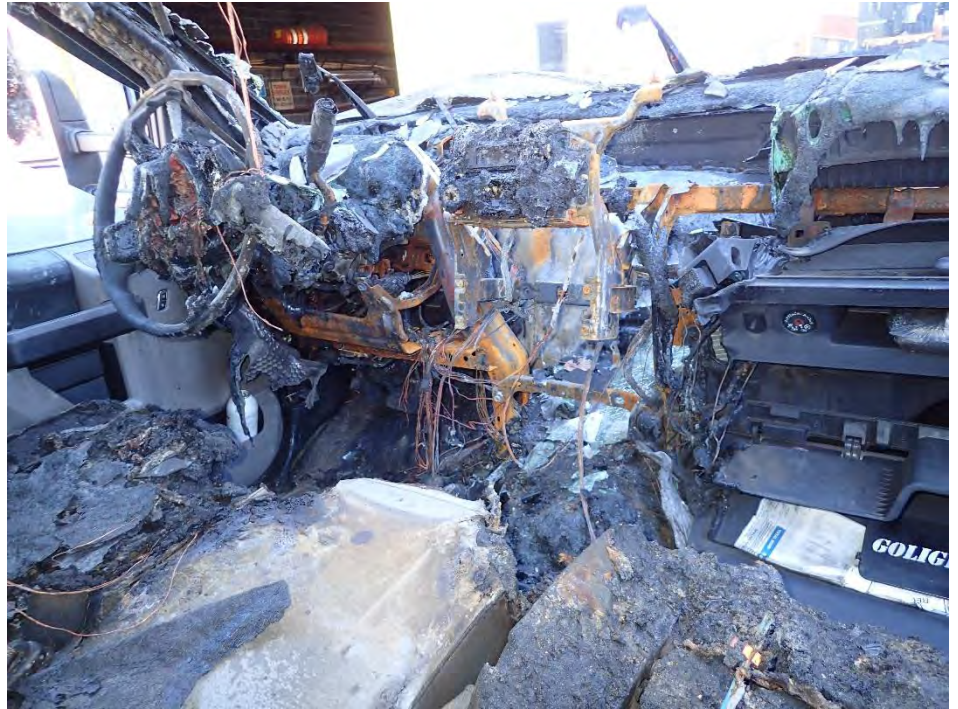
18

View of the passenger compartment. The fire extended up through a hole in the floor where the 4-wheel drive gearshift selector had been located. The shifter opening in the floor allowed the fire to vent up into the cabin then spread through the dash assembly and out through the windshield.

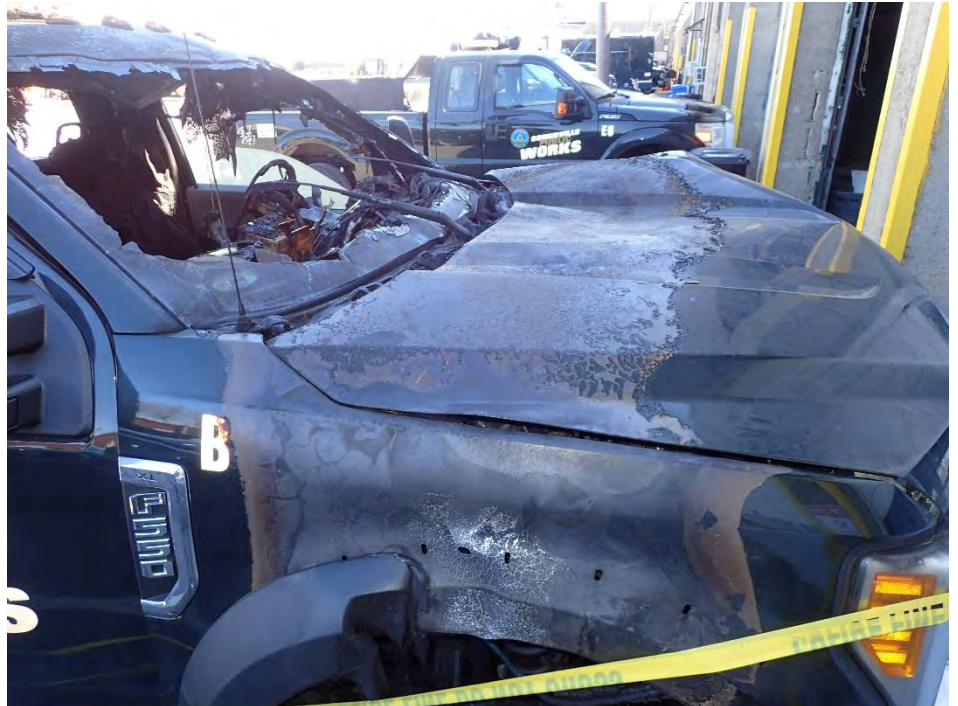
19

View of fire patterns on the hood and fender.

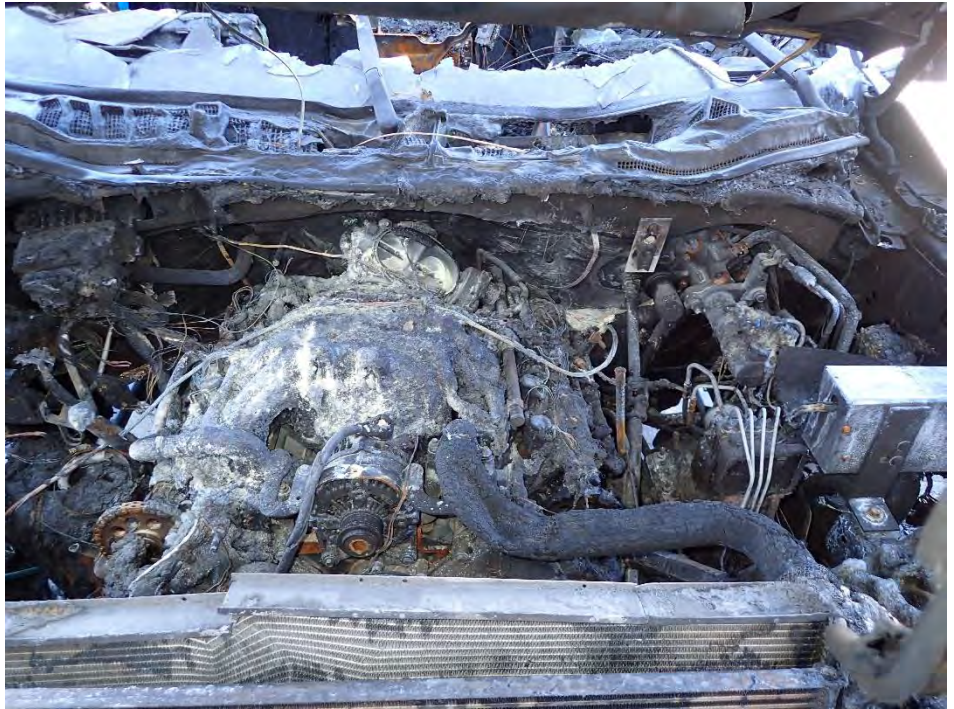
20

The fire spread throughout the engine compartment. The fire did not originate in the engine compartment.

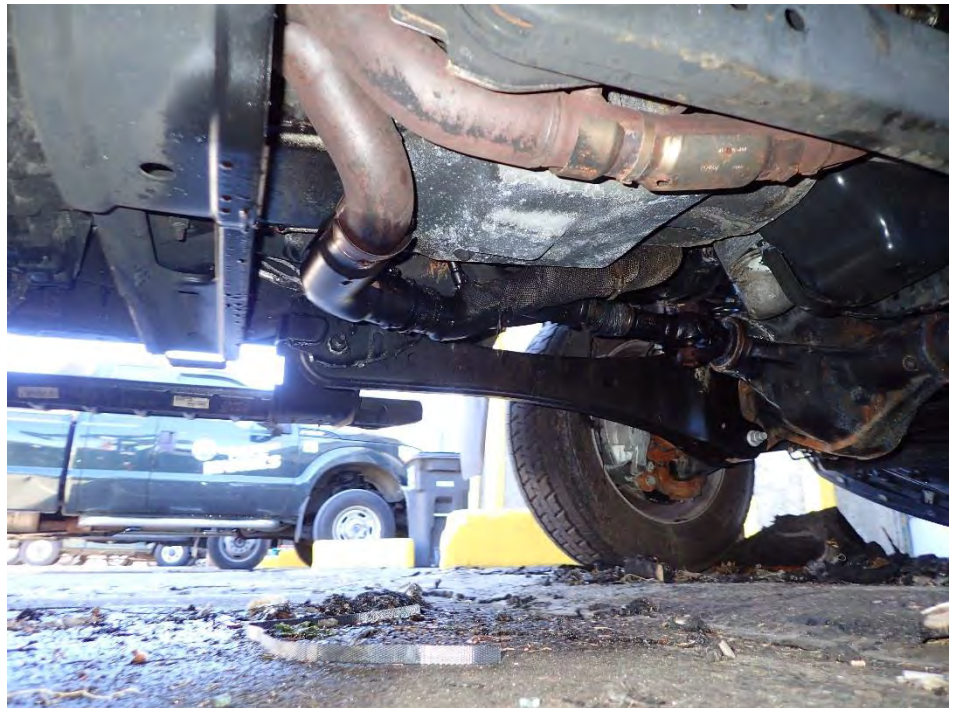
23

View of the underside of the transmission as seen from the right side (passenger side). Transmission fluid can be seen dripping off the exhaust pipes and transmission crossmember, and a puddle of it is on the ground below.

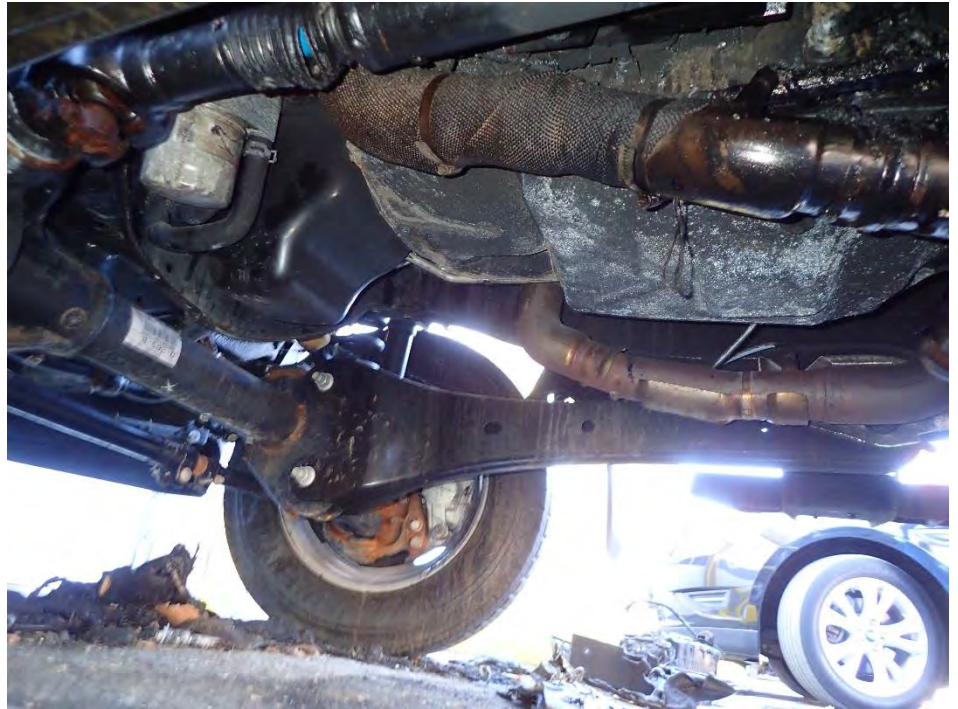
24

View of the underside of the transmission from the left side. The exhaust pipe heat wrapping was saturated with transmission fluid.

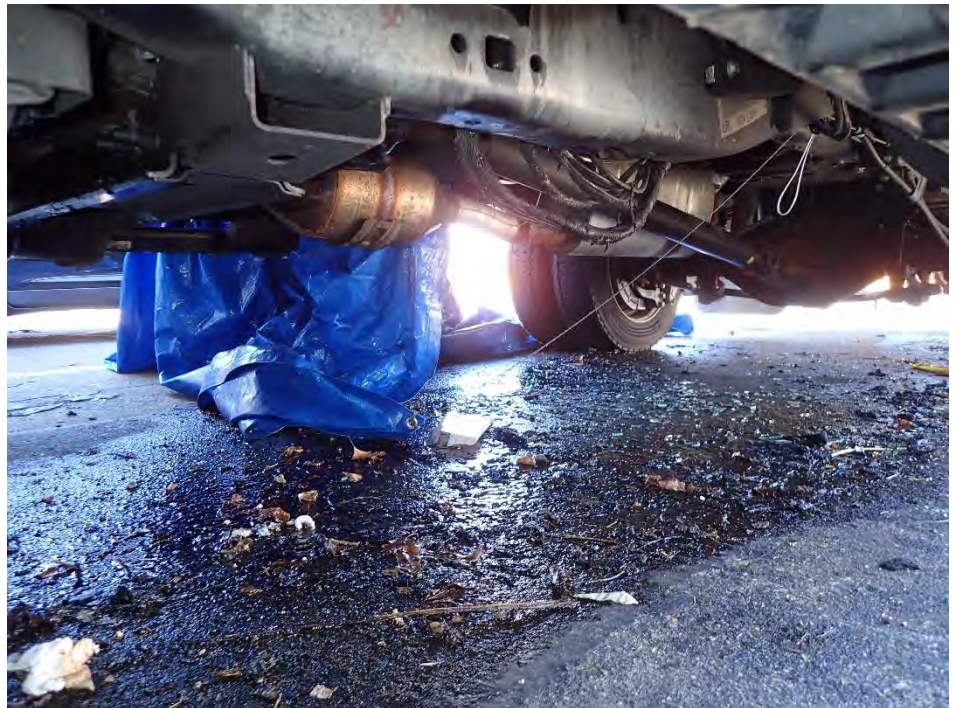
27

View of a puddle of transmission fluid underneath the truck.

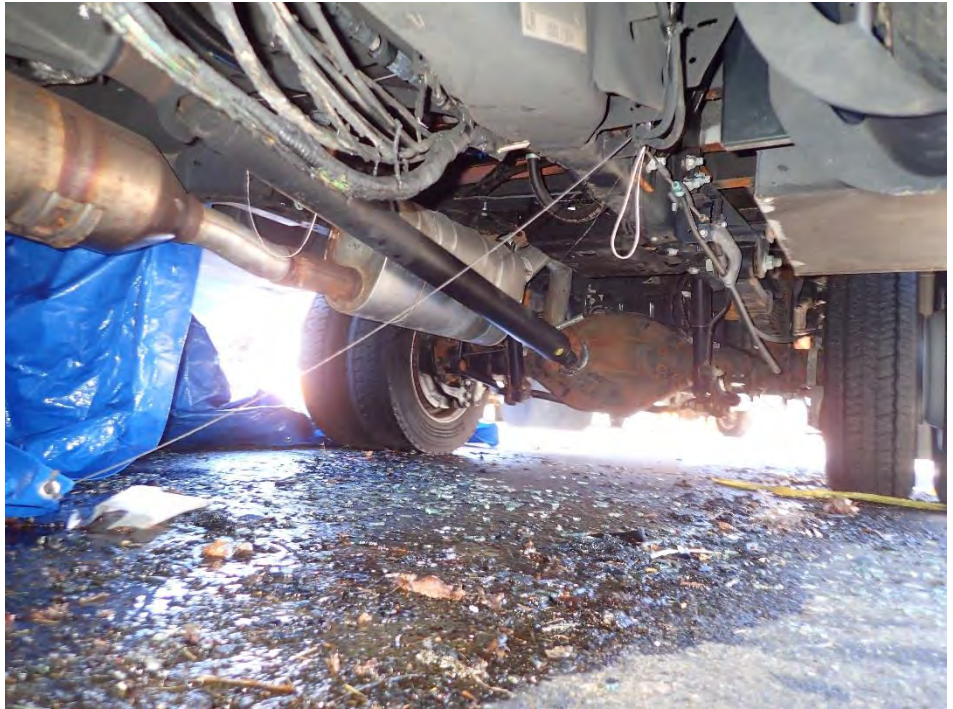
28

View looking toward the rear of the truck. There was no fluid extending beyond the transmission. Fluid had dripped to the ground during the fire.

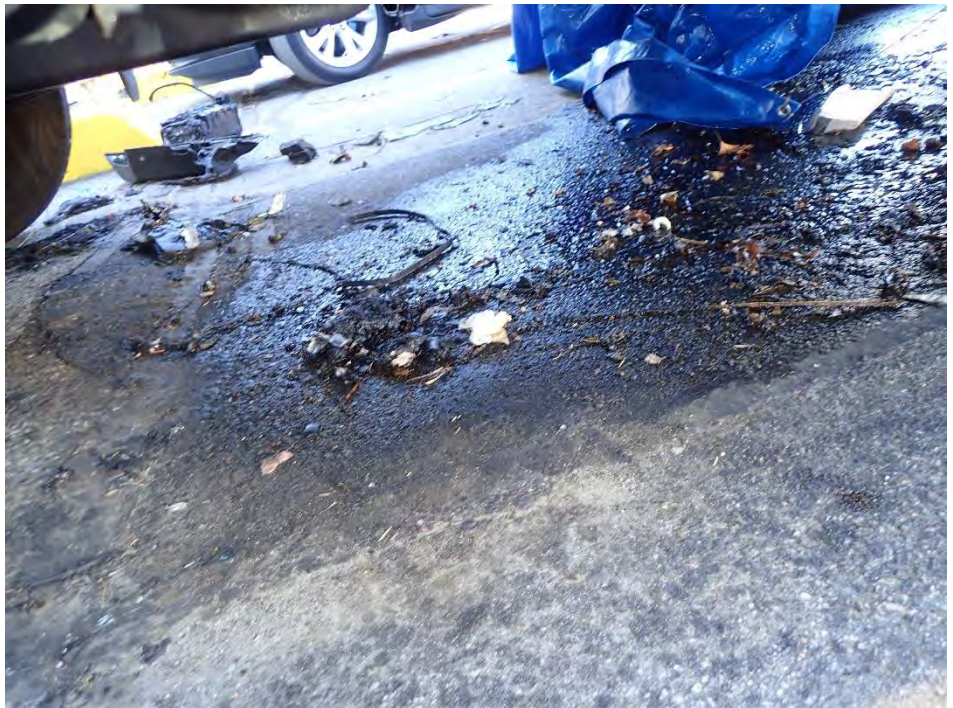
29

Another view of the puddle of fluid underneath the truck.

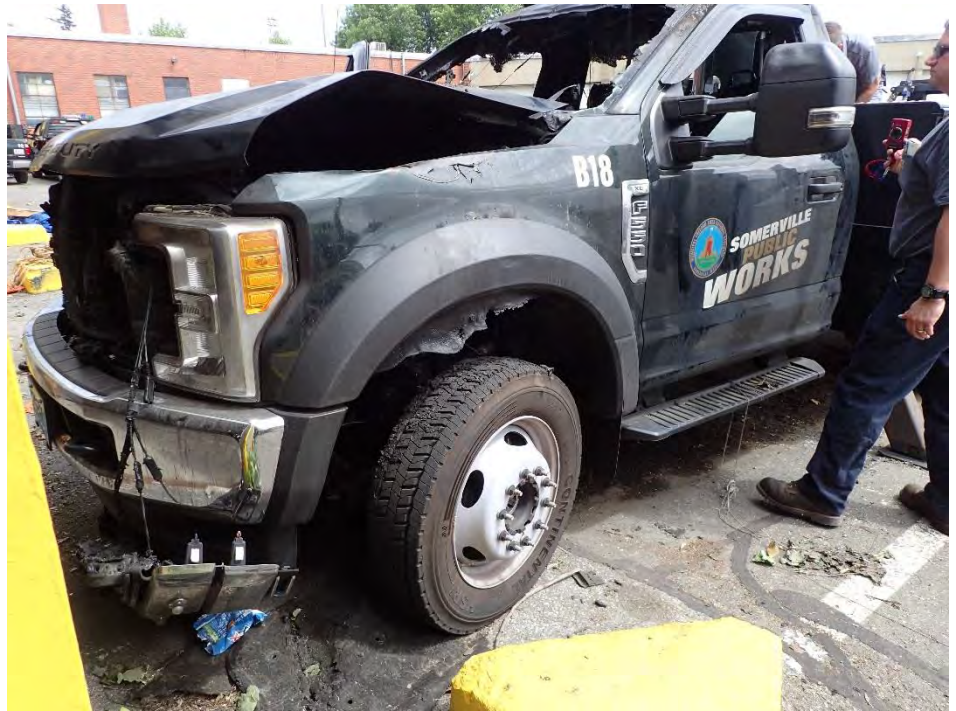
35

View of fire patterns at the left front. The fire extended into the left front wheelhouse area and the grille area at a later stage of development.

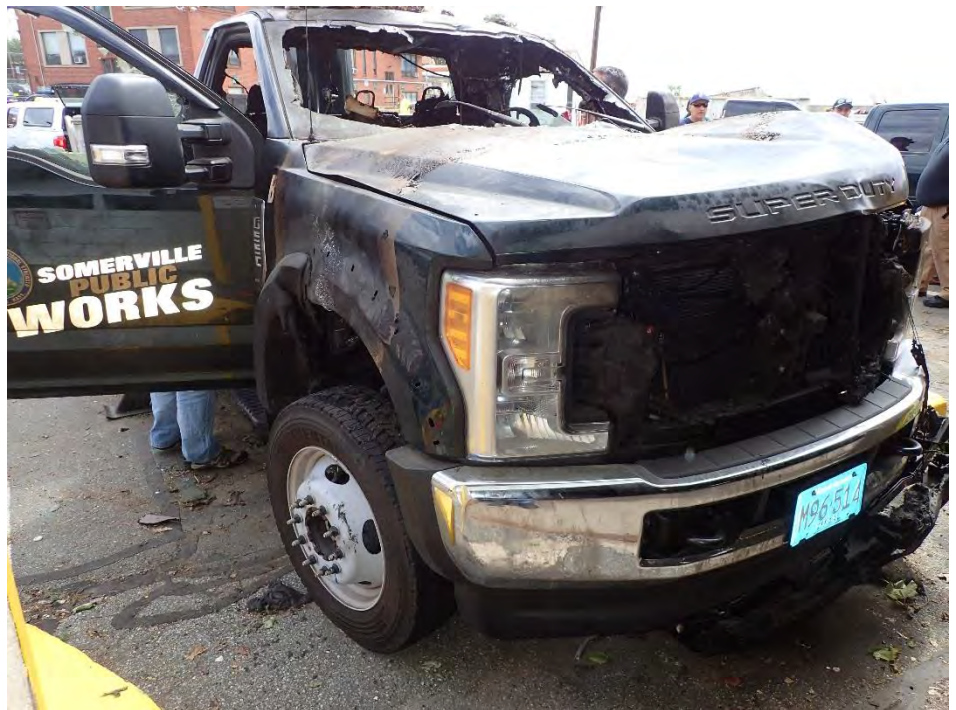
36

View of fire patterns at the right front. The fire also vented out the right side wheelhouse and scorched only the rear of the hood.

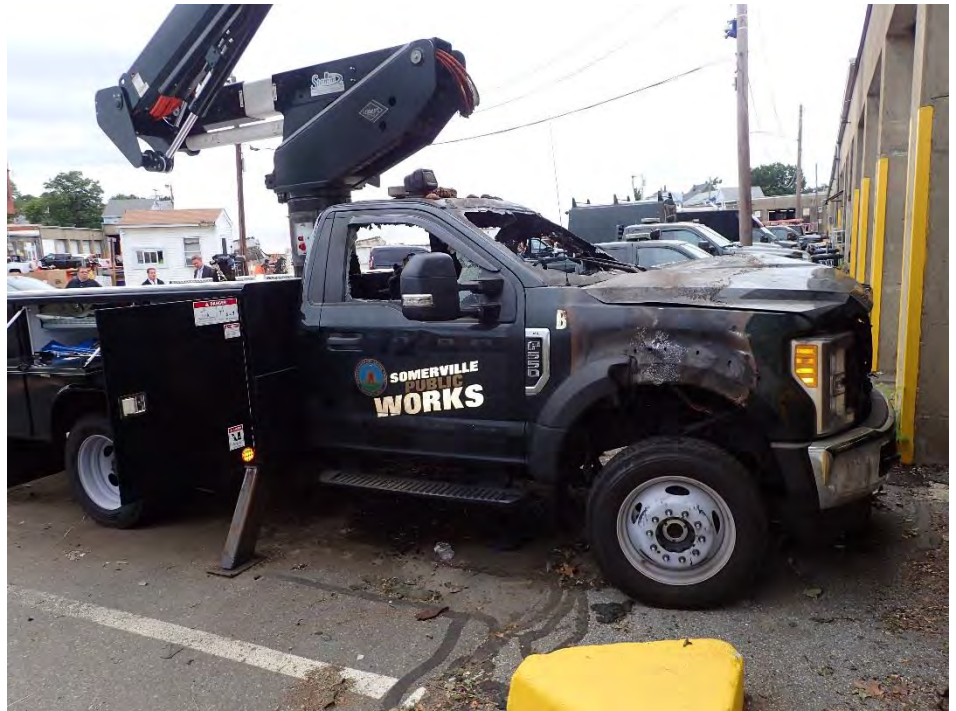
37

Overview of fire patterns on the right side. There was no scorching to the running board or passenger door.

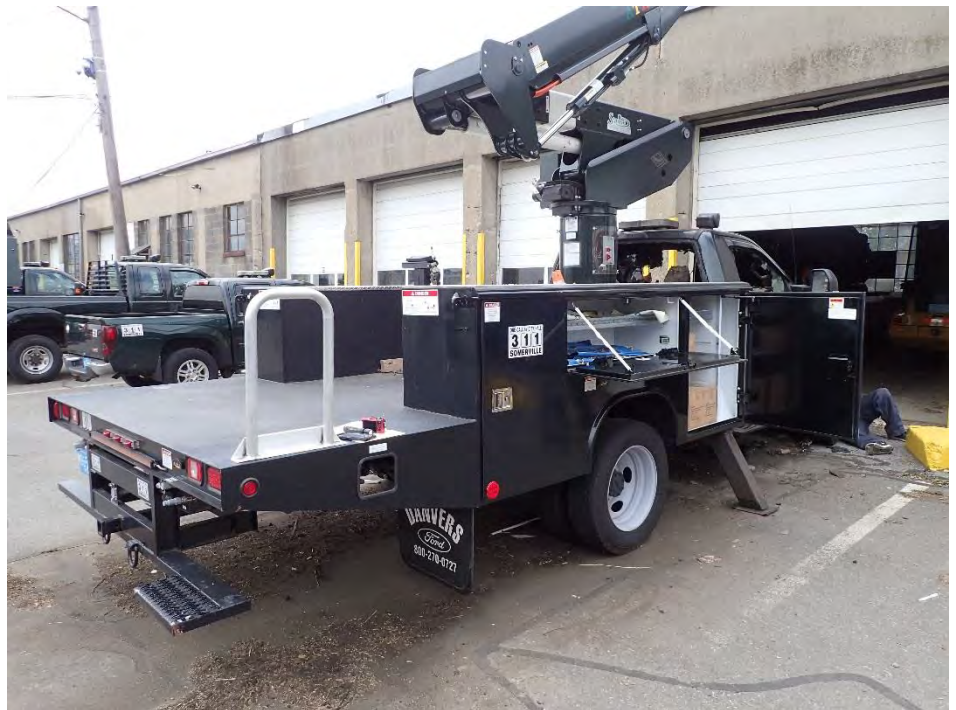
38

Fire did not extend to the aerial lift device.

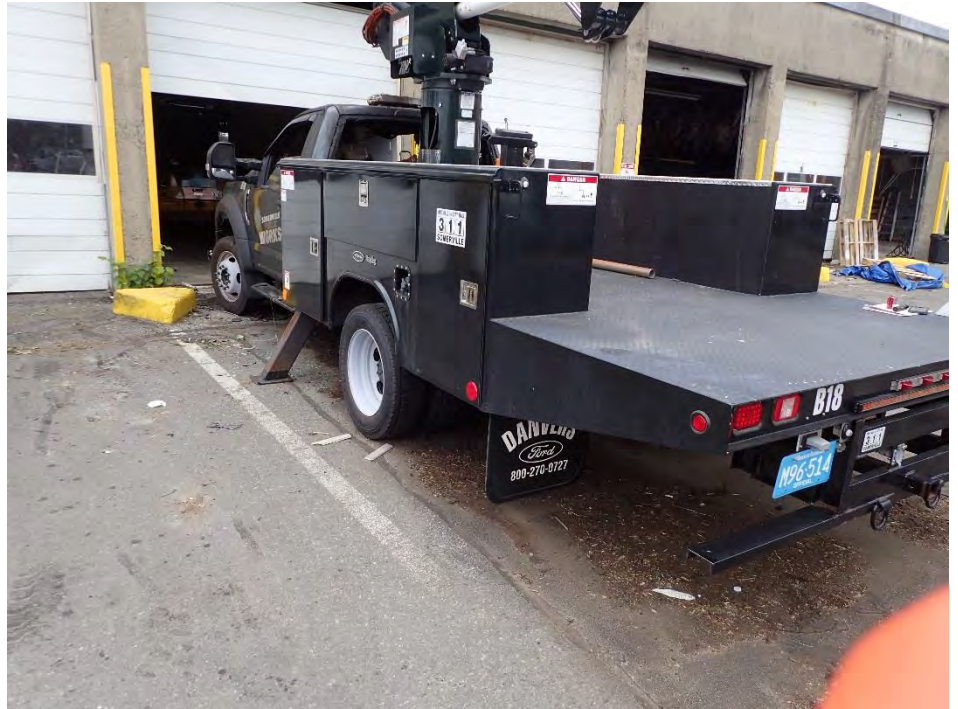
39

Left rear view. The platform was not burned.

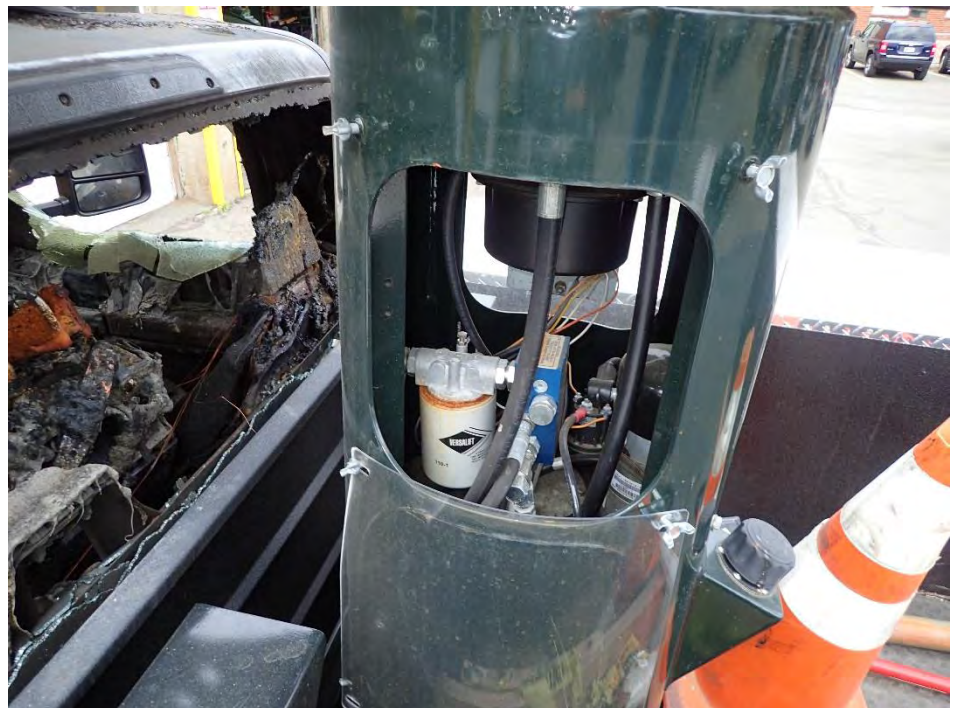
42

View of the reservoir and hydraulic filter. Nothing was burned in the turret.

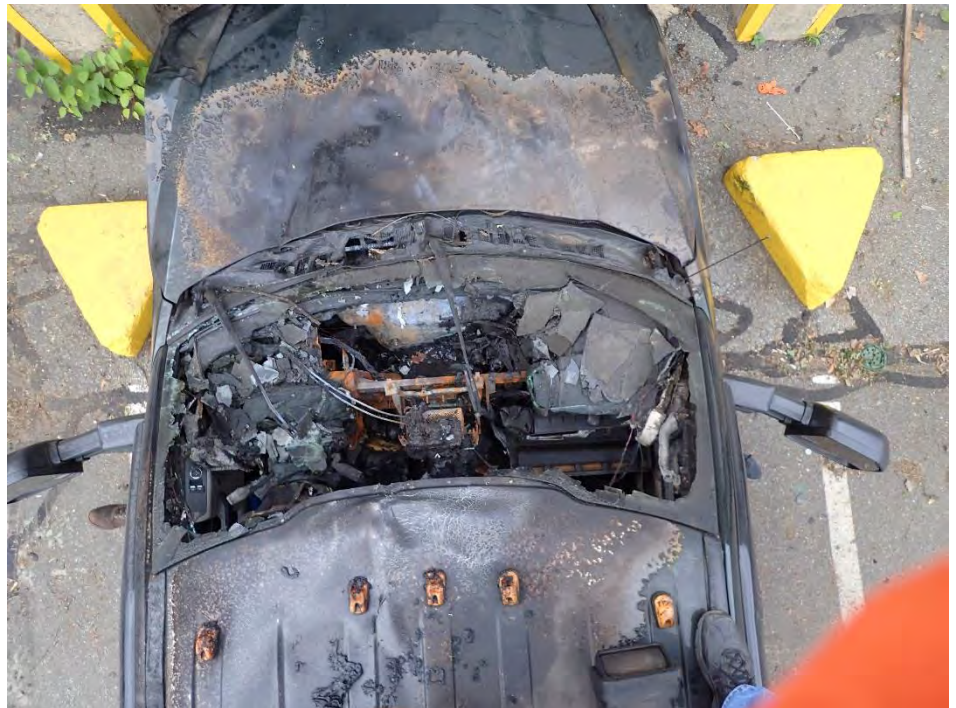
44

Overview of fire patterns on the cab and hood. The fire did not originate in the dash assembly or the cab. Fire patterns on the hood show the fire extended from underneath the left side of the cab and into the rear of the engine compartment.

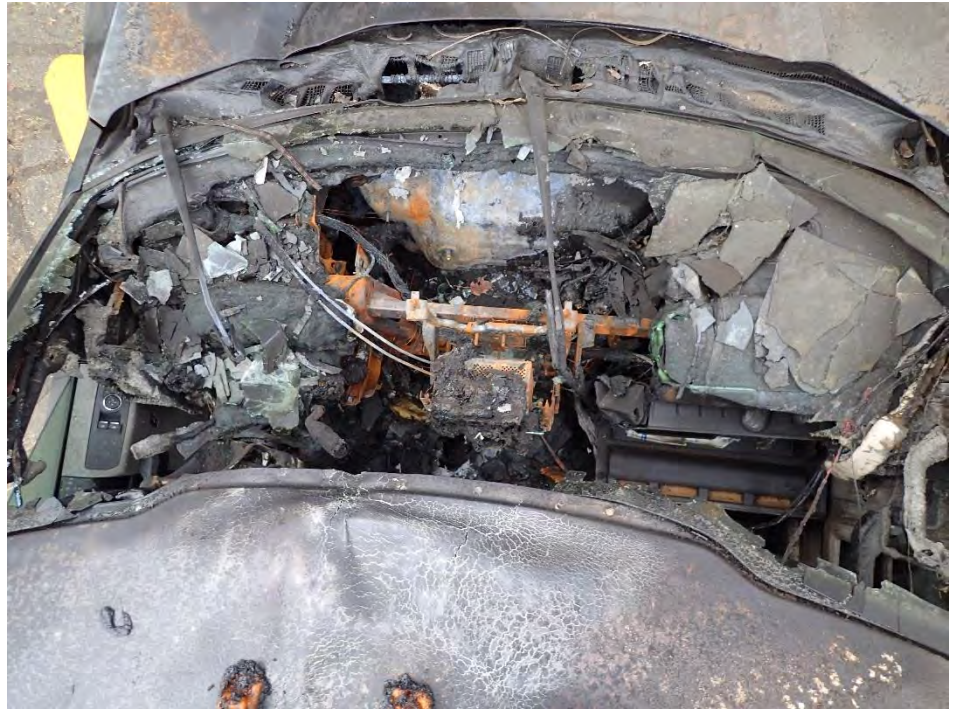
45

View of the loss of mass at the center of the dash. This occurred from when the fire progressed from underneath the truck up through the opening in the floor for the 4-wheel drive shifter and then into the dash assembly.

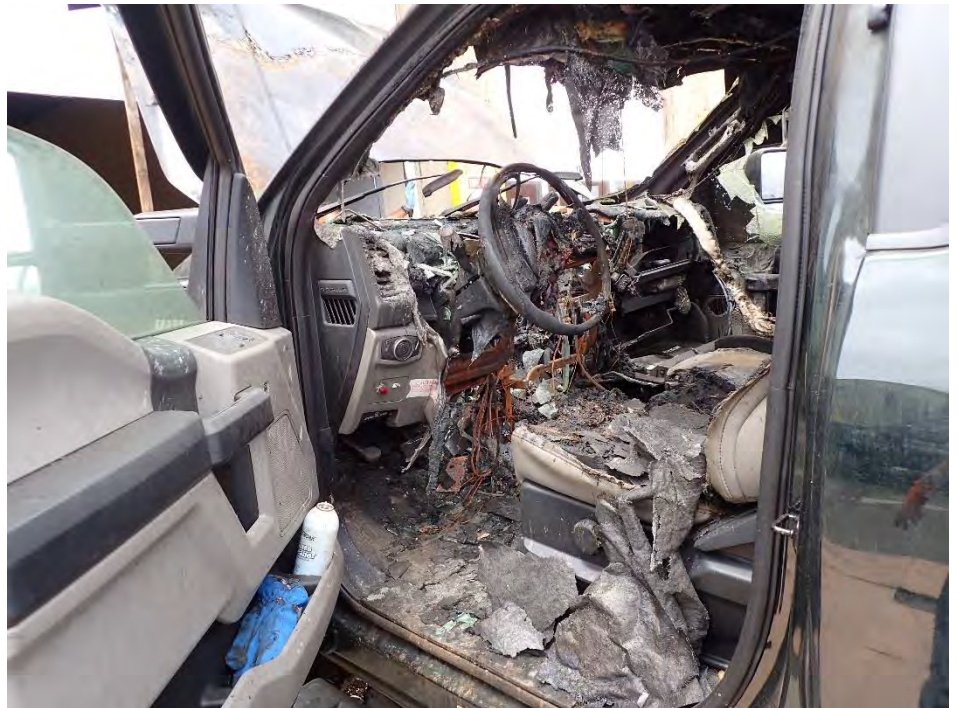
46

View of the left side of the cab. Much of the upholstery still remained intact. The fire spread to the passenger compartment at a later stage.

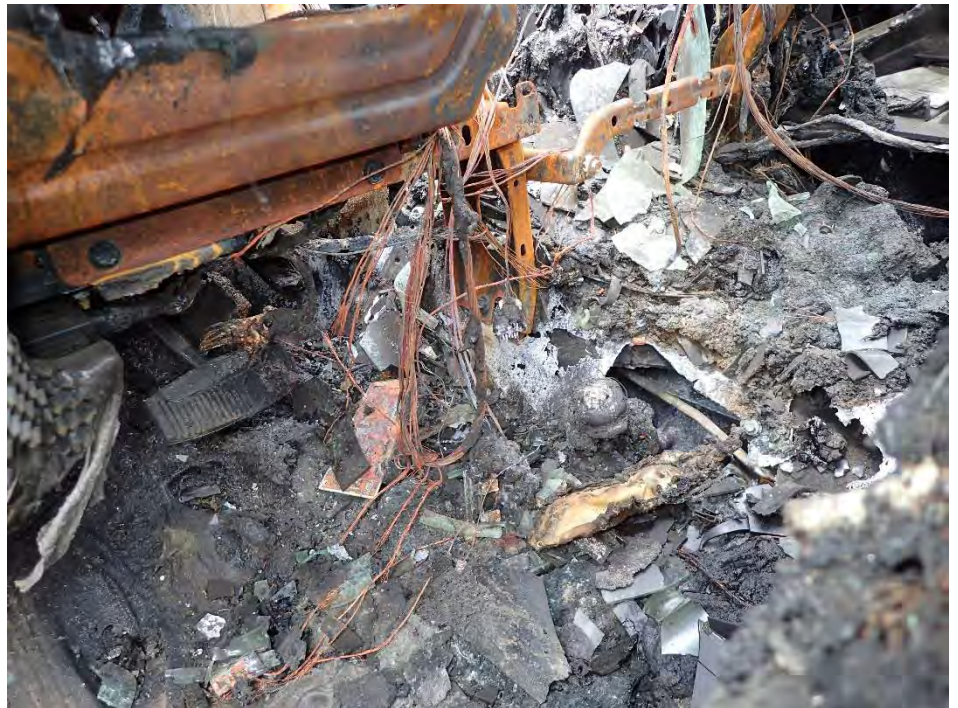
48

View of the opening in the left side of the transmission tunnel. The fire spread up through the opening and into the passenger compartment.

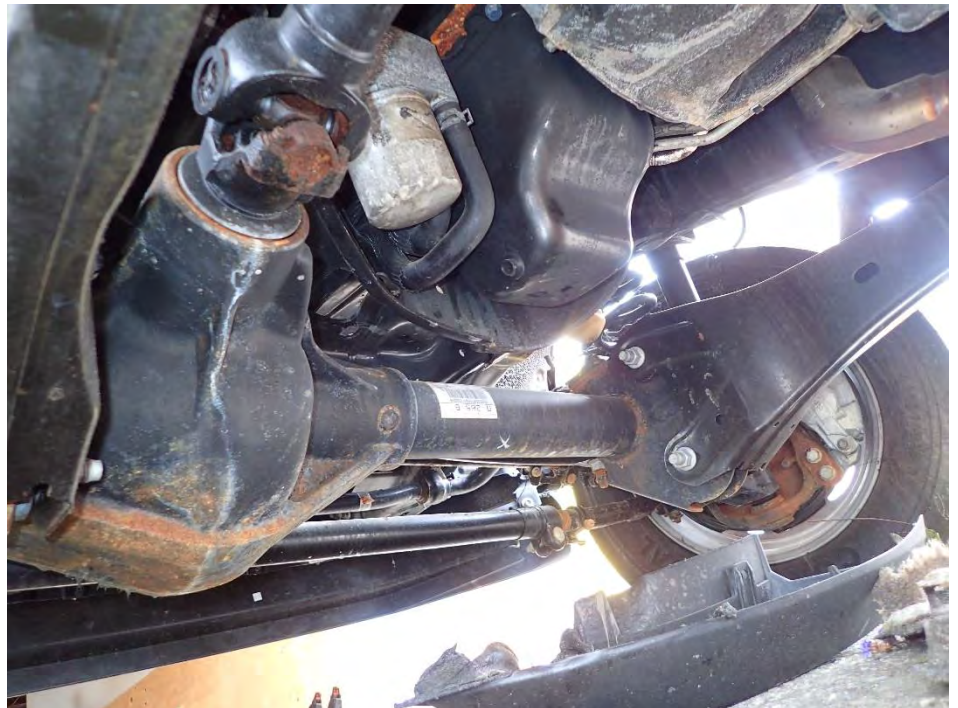
50

View of the underside of the engine and the front axle. The engine and the front axle were not burned. The paper label still remained on the axle tube.

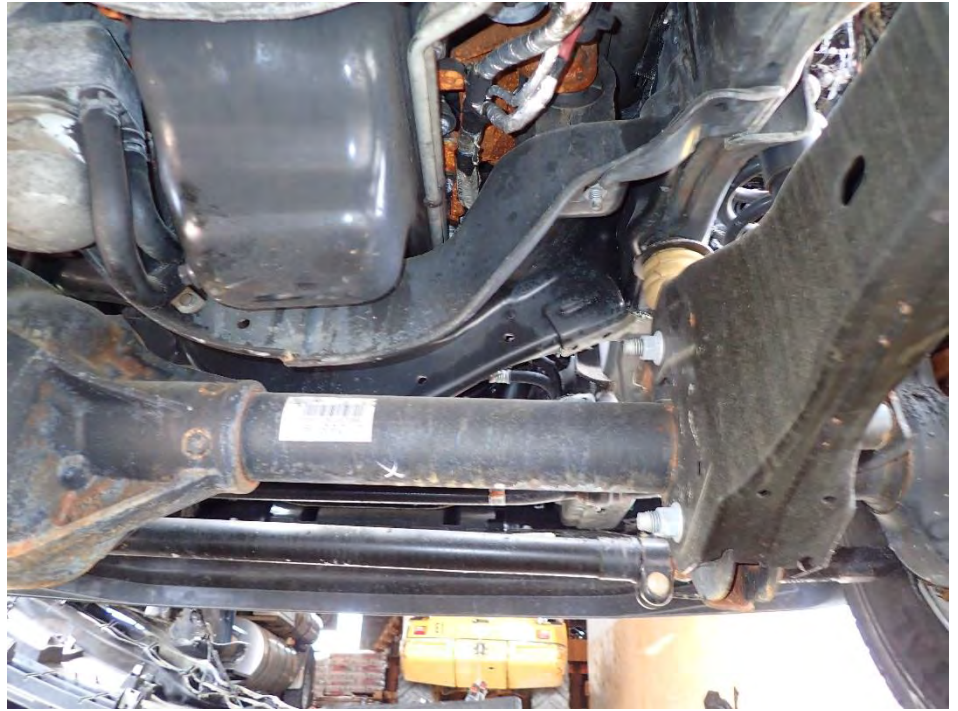
51

Another view showing the underside of the V10 engine and the front axle assembly. Nothing under the engine, including the hoses had been burned. The axle assembly was not damaged by heat.
