SD|LYONS

VEHICLE ANALYSIS – SDL# 10744.1

INSURED Somerville DPW
VEHICLE 2017 Ford F550 Super-Duty
VIN 1FDUF5HY1HED35804
ODOMETER Unknown
DATE OF LOSS April 13, 2018

Inspect the 2017 Ford F550 Super-Duty aerial bucket truck. Determine the origin and cause of the fire.

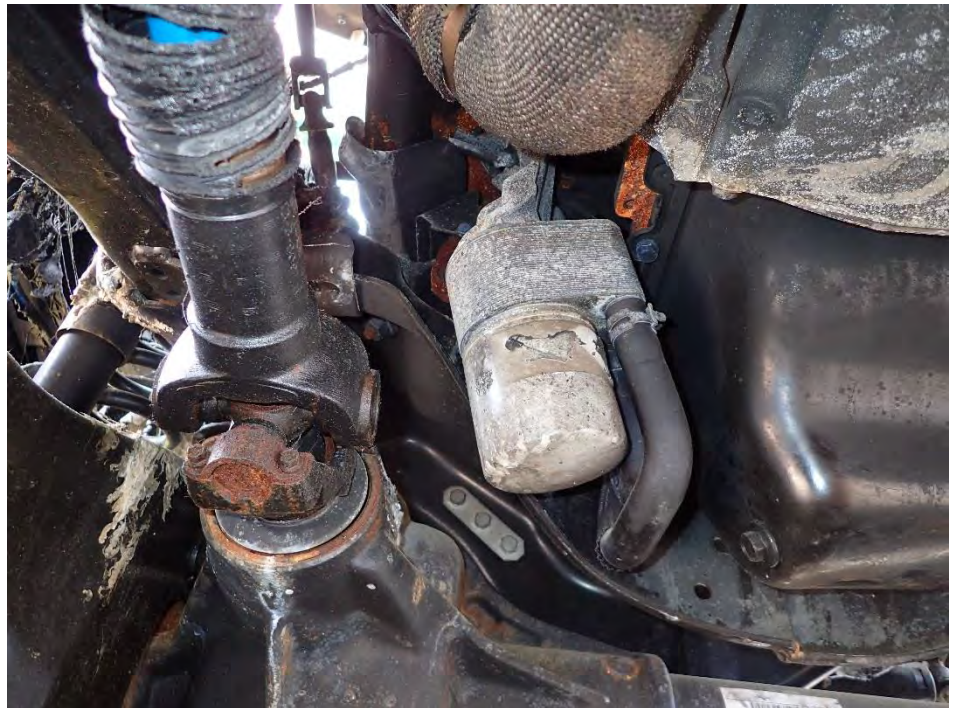
52

View of the left rear of the V10 gasoline engine. The oil pan was not burned and the oil filter and cooler lines remained intact. The fire did not spread underneath the engine.

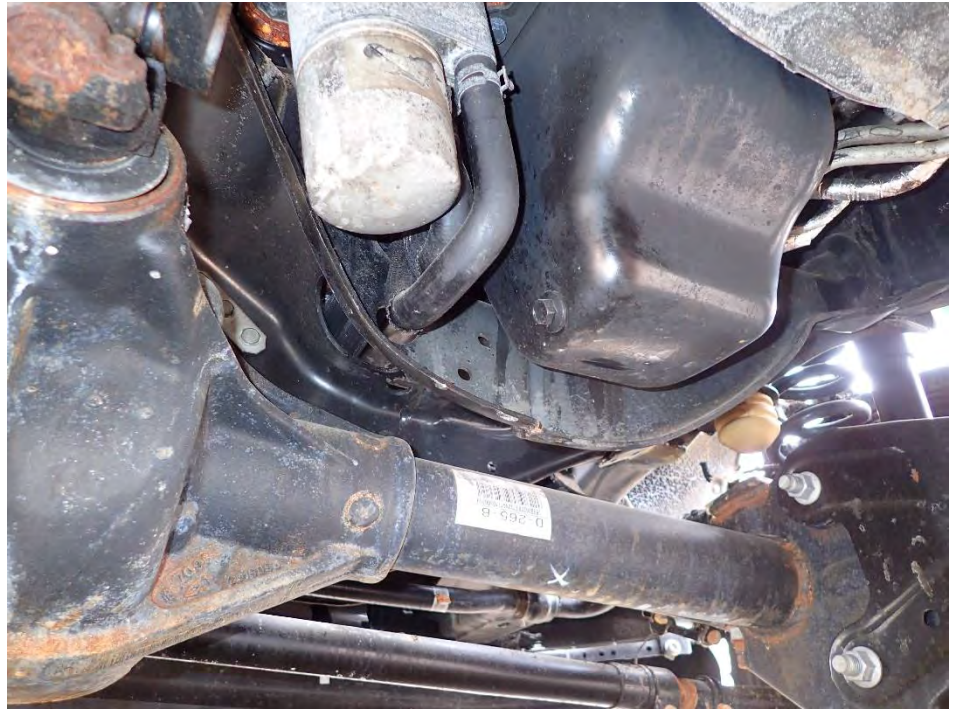
53

Closer view of the lower left side of the engine. There was no radiant heat exposure to the engine. There was no evidence of gasoline leaking from the rear of the engine.

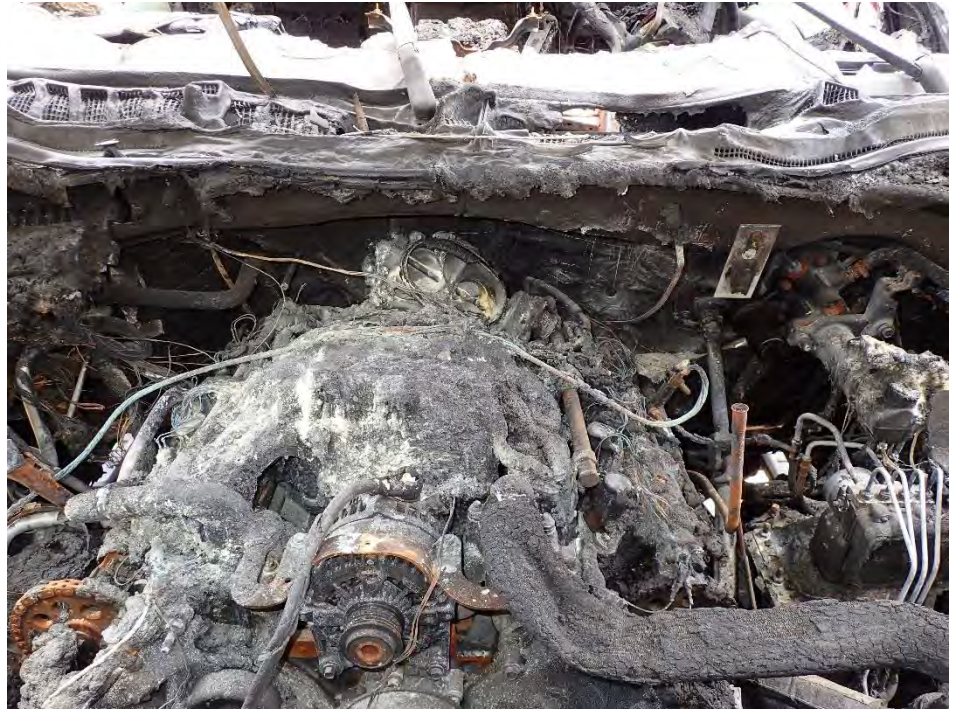
55

Everything located in the upper region of the engine compartment was damaged by heat contained underneath the hood.

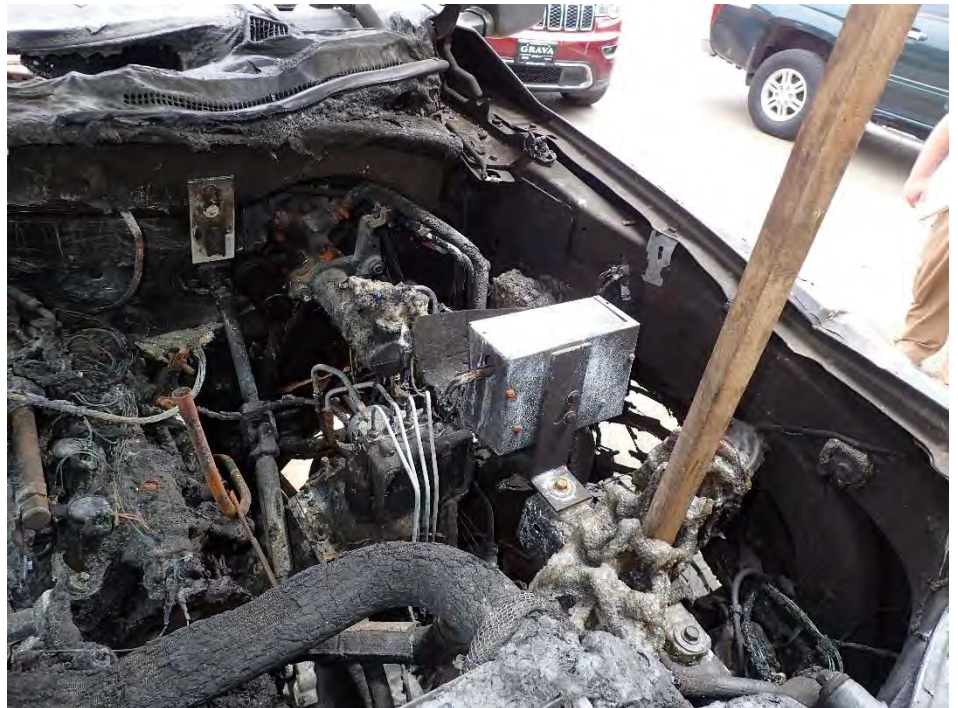
56

View of the left rear of the engine compartment. The aluminum brake master cylinder was intact but the plastic fluid reservoir was partially consumed.

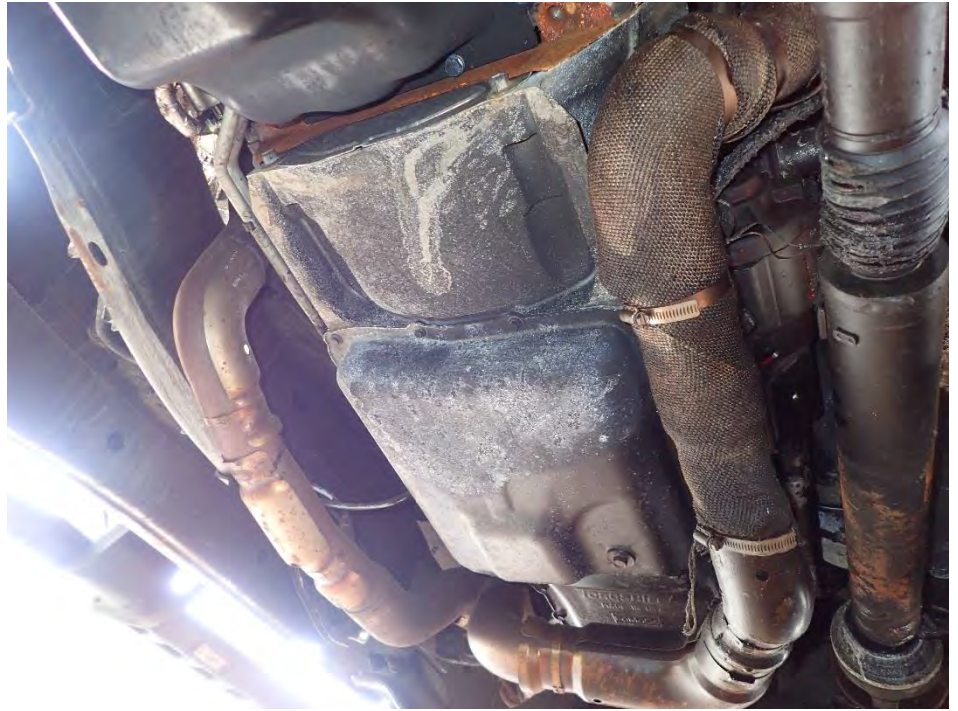
57

View of the underside of the automatic transmission as seen from the driver's side. The exhaust pipe had been wrapped with heat tape that was secured to the pipe using hose clamps. The exhaust pipe and surrounding area were wet with transmission fluid.

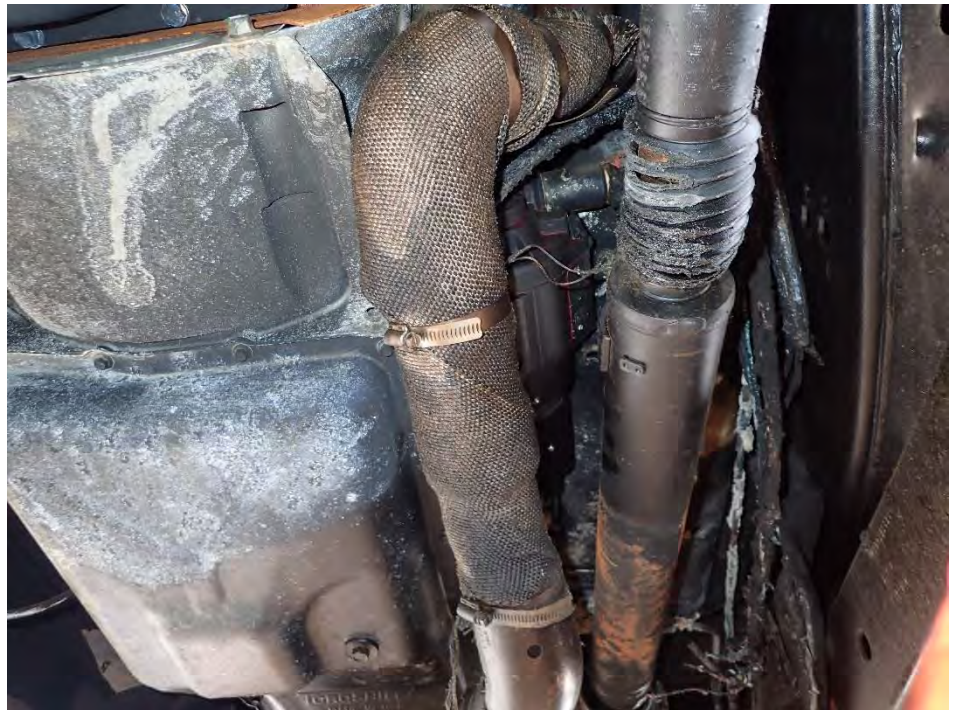
58

Closer view of the left side (driver's side) exhaust pipe where it extends down from the exhaust manifold and passes underneath the aftermarket PTO on the transmission.

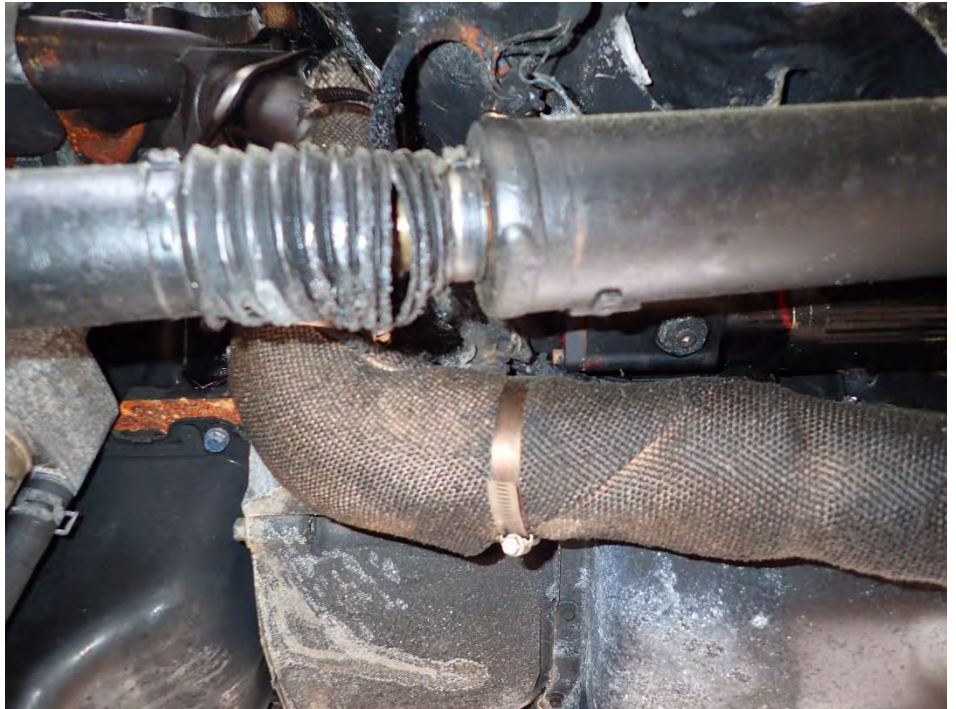
59

Closer view of the left side exhaust pipe. The PTO can be seen above the exhaust pipe.

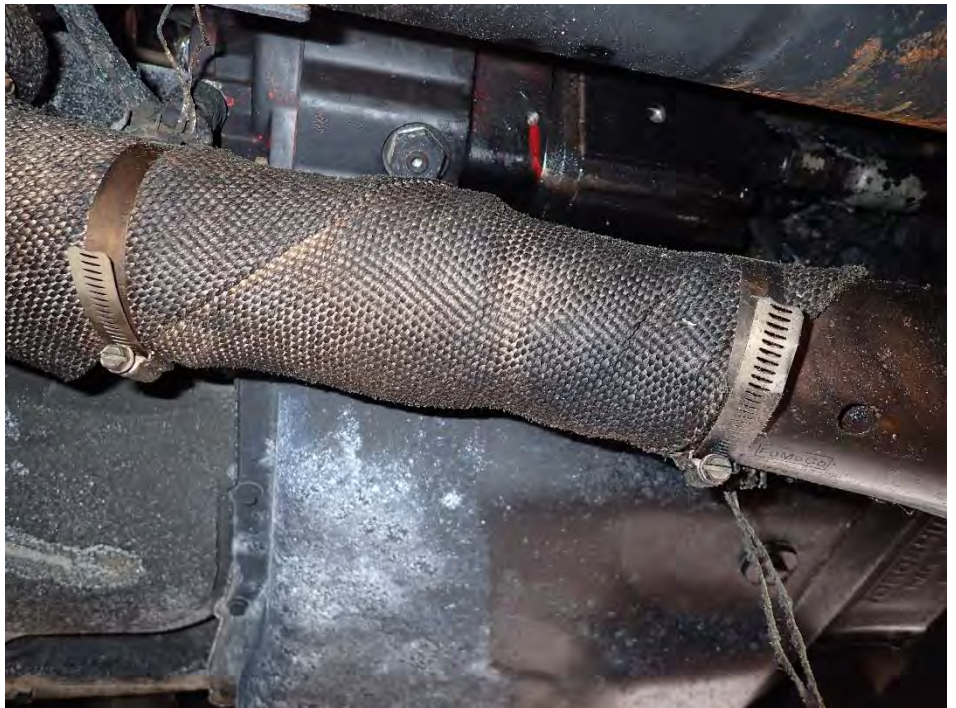
60

Closer view of the left side exhaust pipe. The PTO pump is located just above the heat wrap.

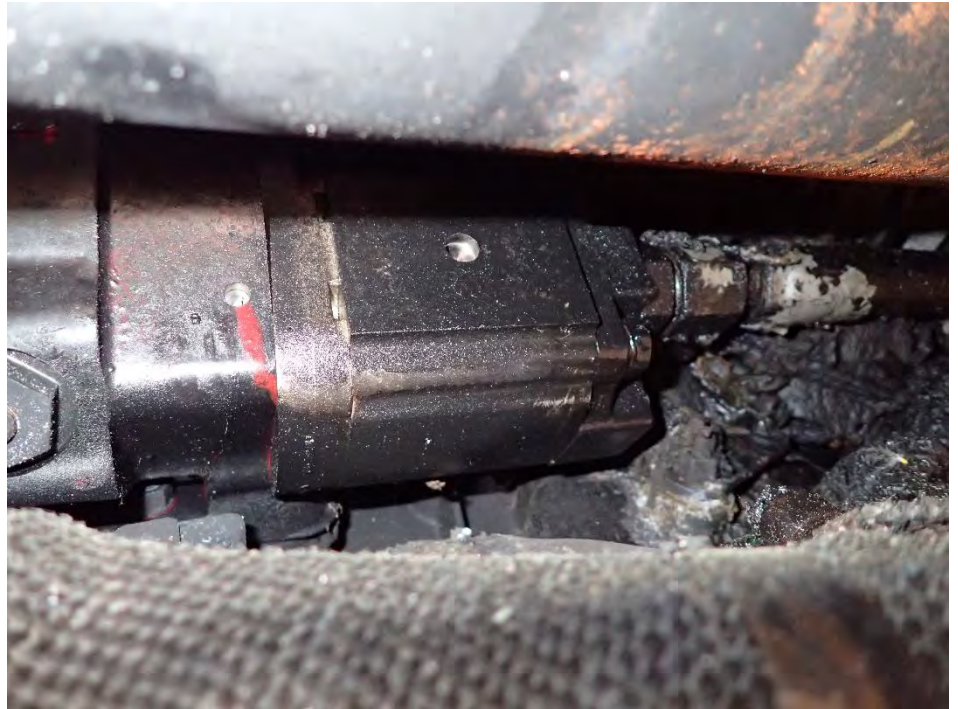
61

View of the PTO pump where it is bolted to the side of the transmission, near the bellhousing. The reservoir line can be seen at the back of the pump.

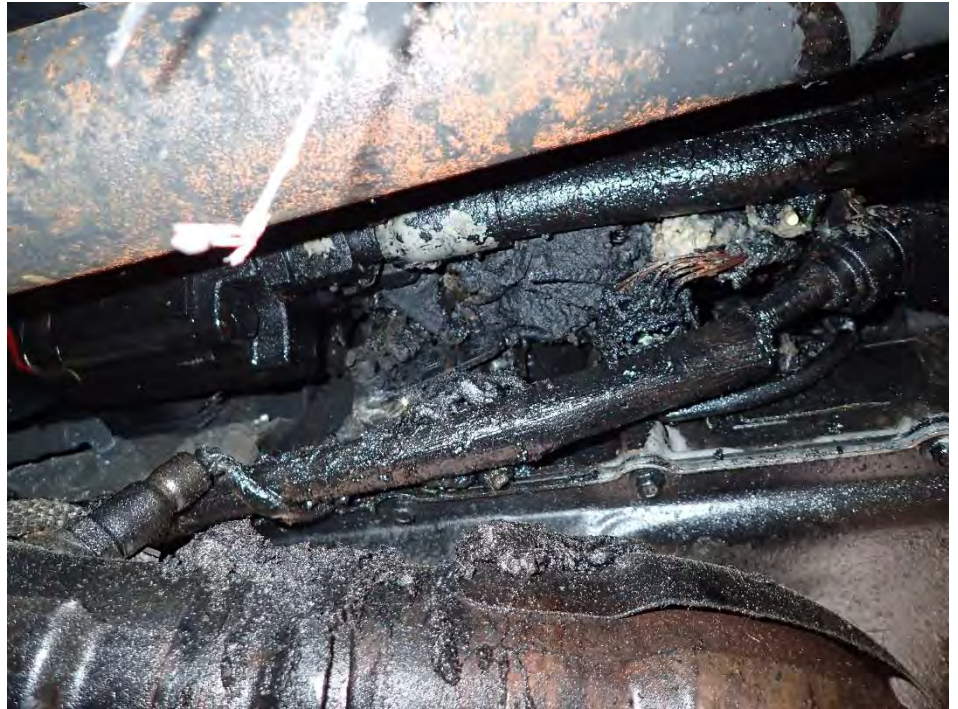
63

The bottom of the photograph shows the exhaust components. Directly above, the shift cable can be seen. The fire vented up through the 4 WD shifter opening in the floor, above the shift cable. The hydraulic PTO pump can be seen on the left side of the photo.

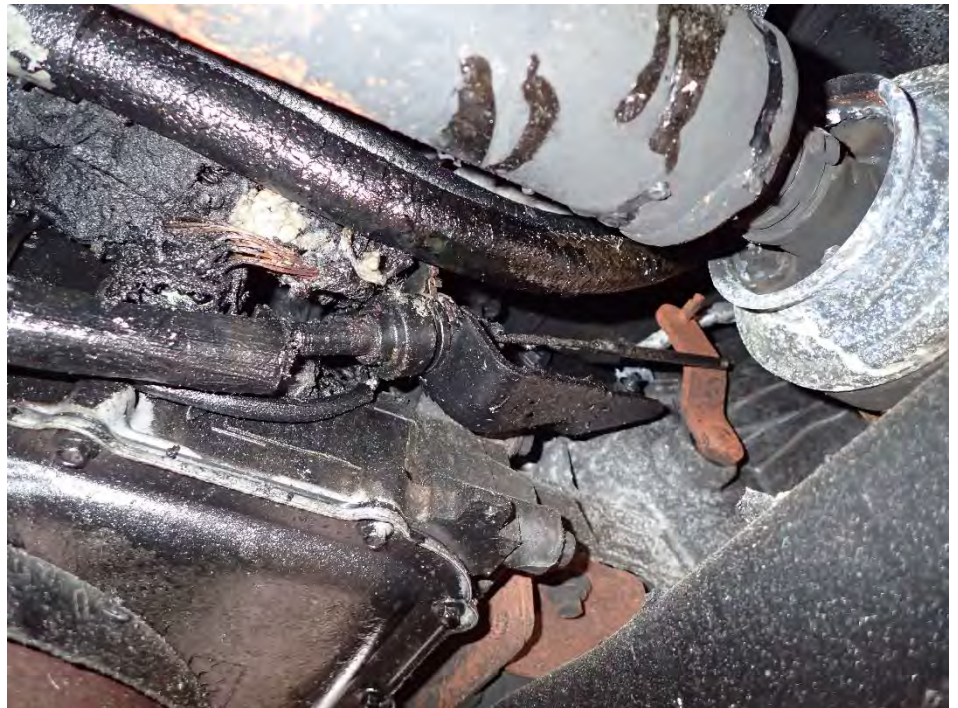
64

View of the automatic gearshift cable and the bracket at the rear of the transmission. The transmission wiring harness and connector can be seen just above the shift cable.

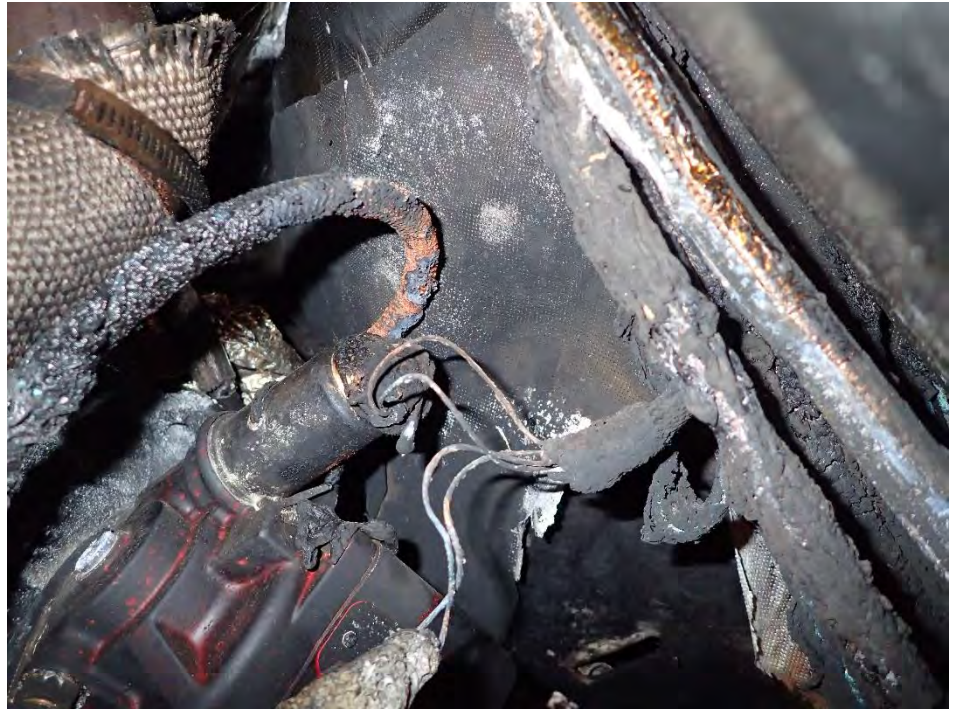
65

View of the PTO pump. The floor pan above the PTO pump was burned. The PTO integrated cartridge valve and pressure switch can be seen on the PTO housing. The transmission pressure line is located just above.

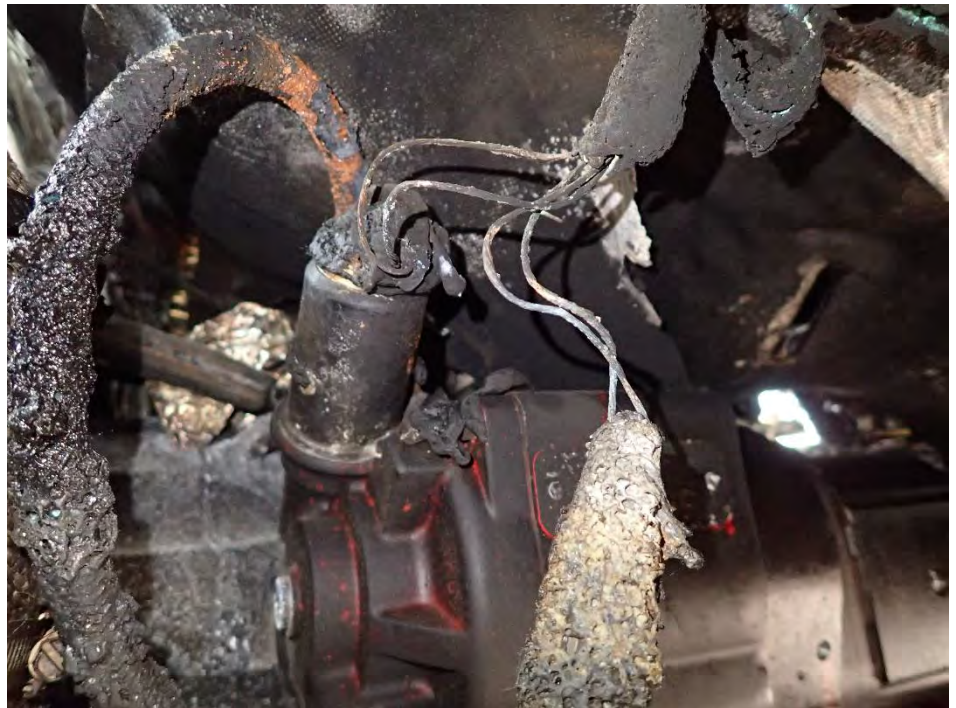
66

View of the pressure switch and the transmission line. The transmission line was rubbing against the bottom of the floor of the truck. The transmission moves independently of the floor of the truck when the engine is running.

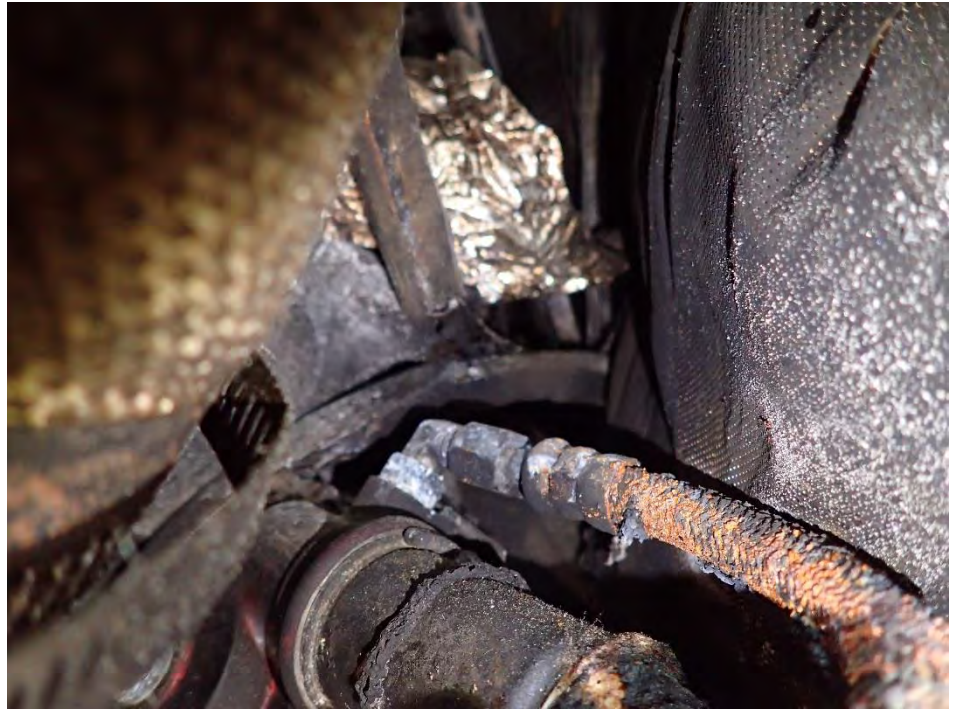
67

View of the transmission line where it connects to the integrated cartridge valve and pressure switch that controls the engagement of the PTO. This line is pressurized at all times when the engine is running.

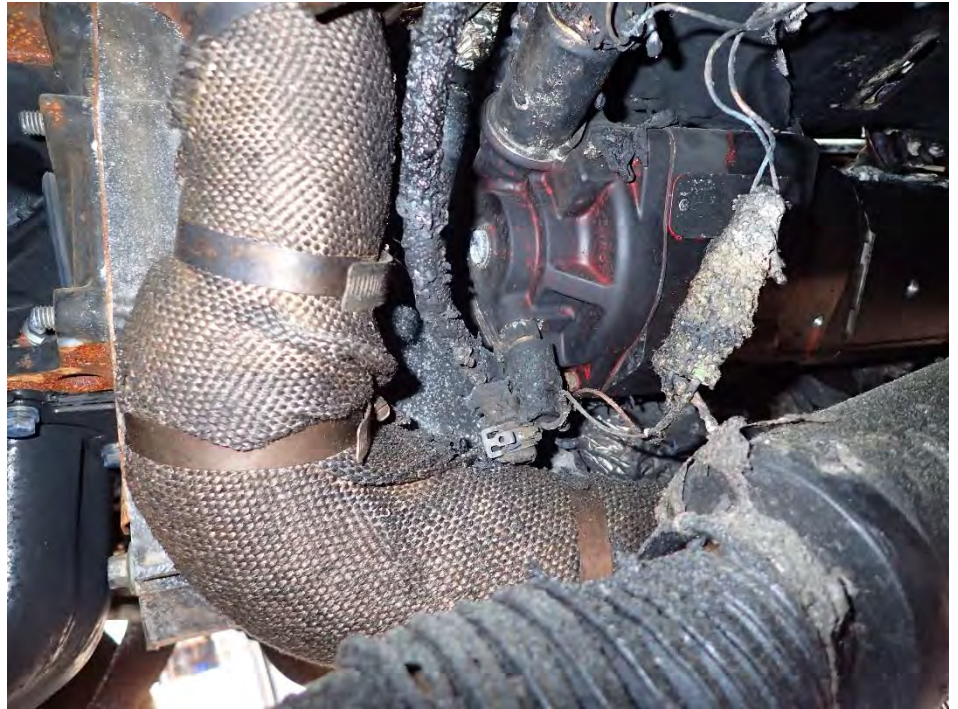
71

View showing the front of the PTO pump along with the activation switch. Note the position of the hydraulic transmission line in close proximity to the exhaust pipe.

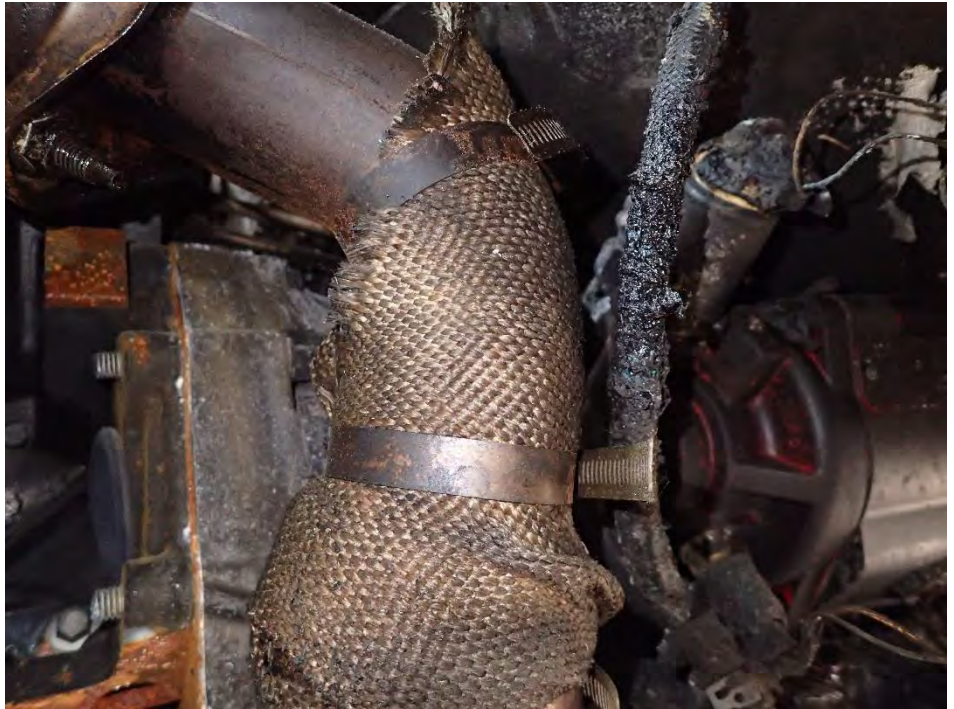
73

Close view of the exhaust pipe and transmission line. As noted, this transmission line is pressurized at all times when the engine is running. The engine RPM and the pressure increase when the operator in the bucket operates the PTO.

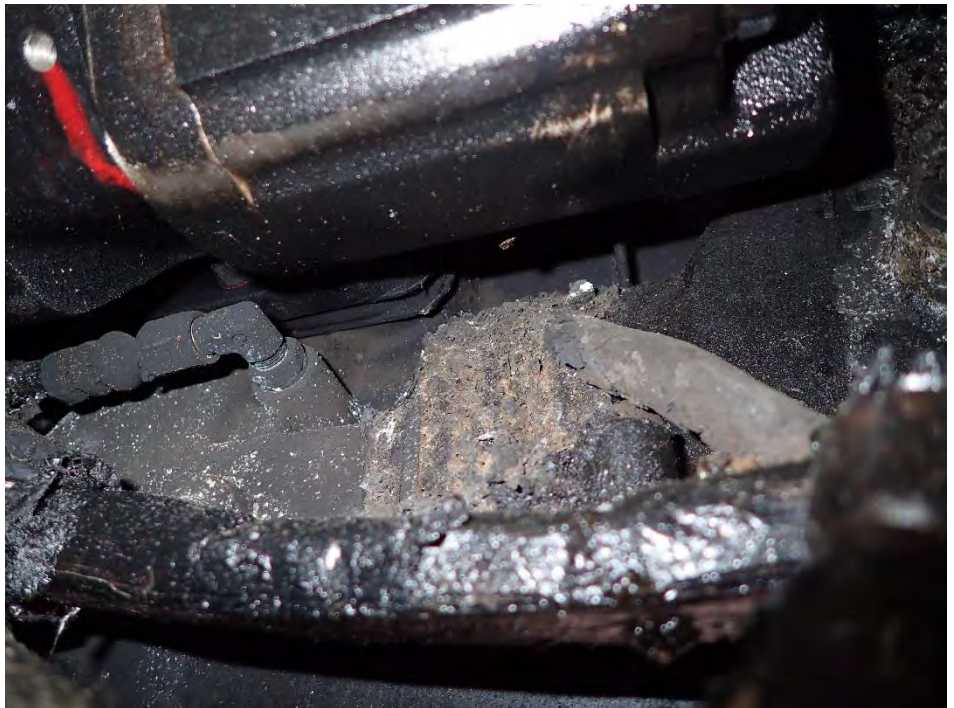
74

View of the test port on the side of the automatic transmission. The PTO used pressure from this port to provide hydraulic transmission fluid pressure to the activation switch of the PTO.

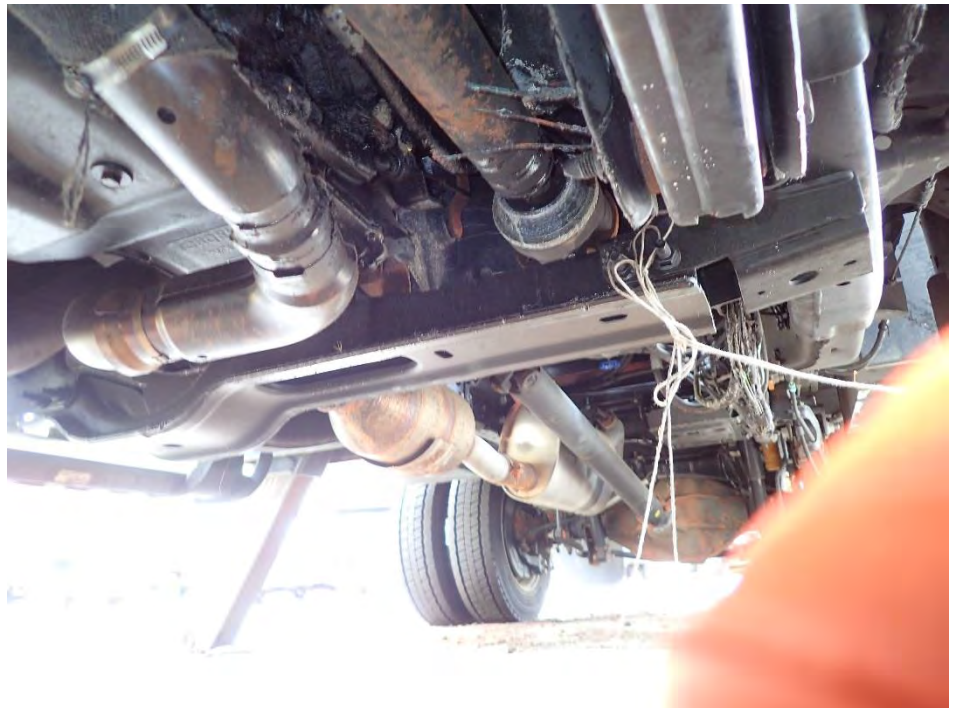
76

View looking toward the rear of the truck. The fire damaged area was on the left side of the transmission only.

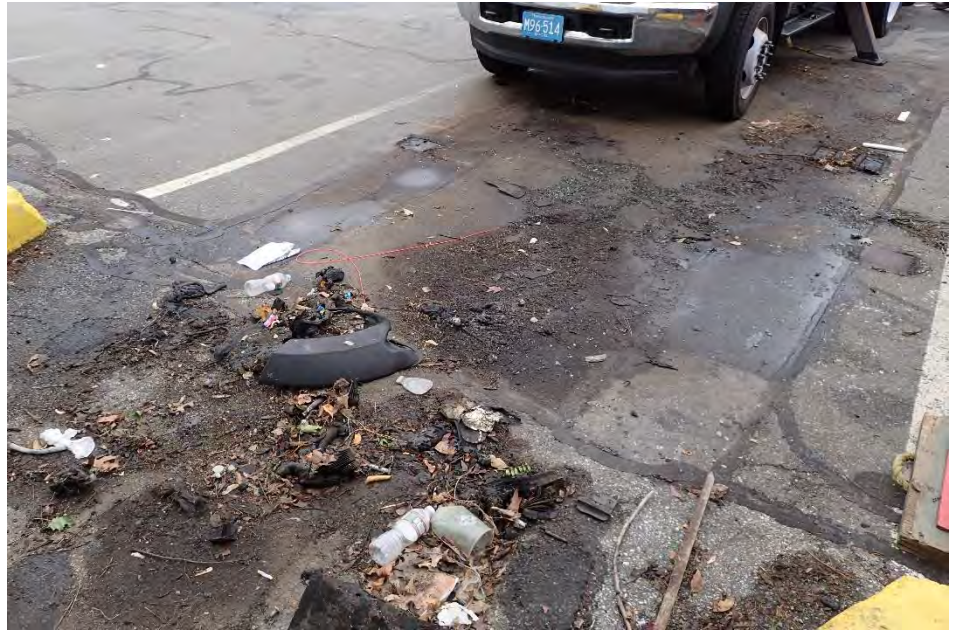
79

View of the pavement underneath the truck. The fire occurred in April 2018 and the photograph was taken in October 2018.

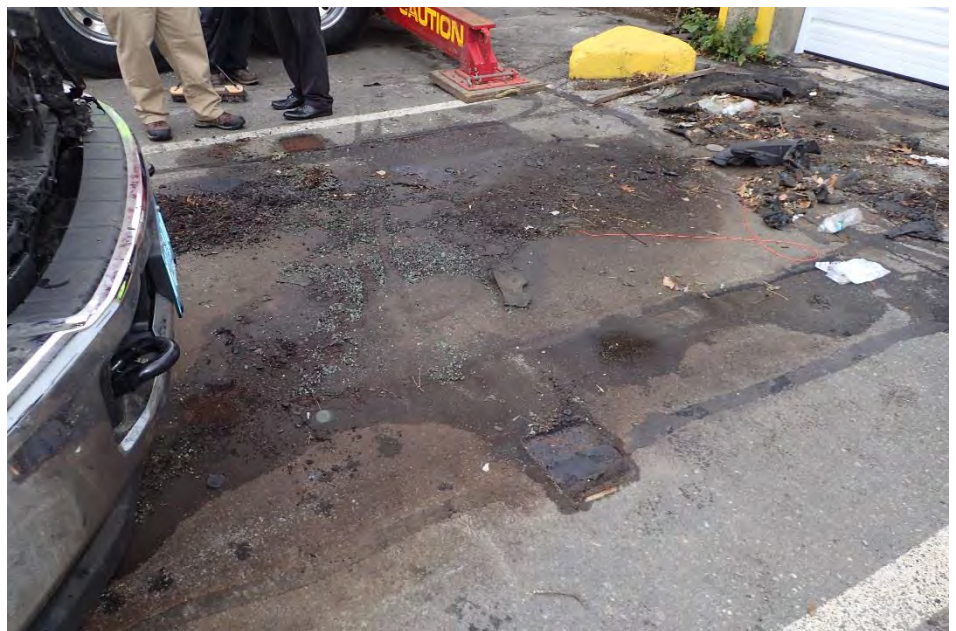
80

Another view of fluid stains on the pavement underneath the truck.

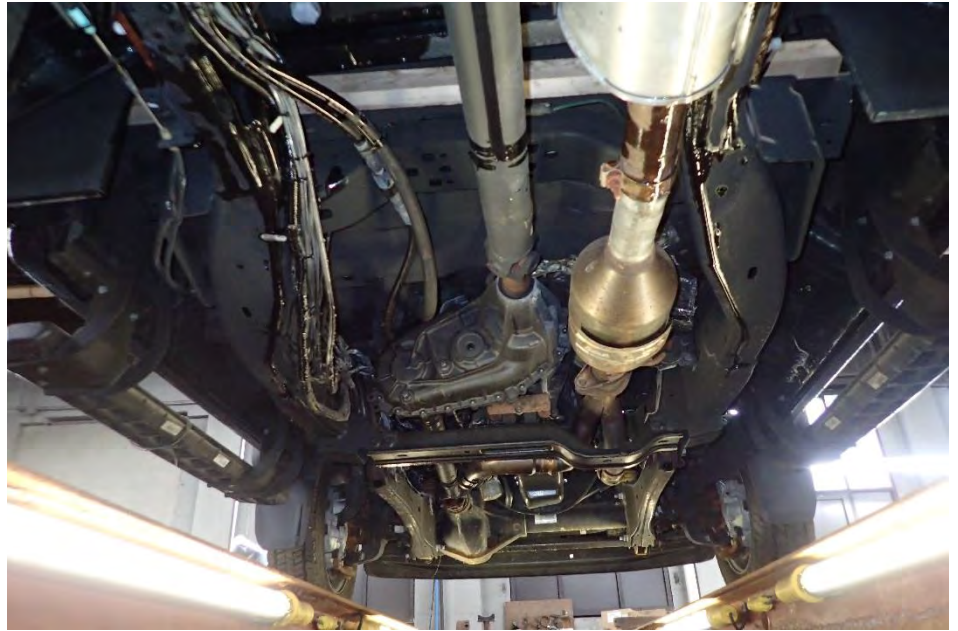
85

View looking toward the rear of the 4-wheel drive transfer case and the automatic transmission. The fire burned most intensely on the left side of the transmission, forward of the transfer case.

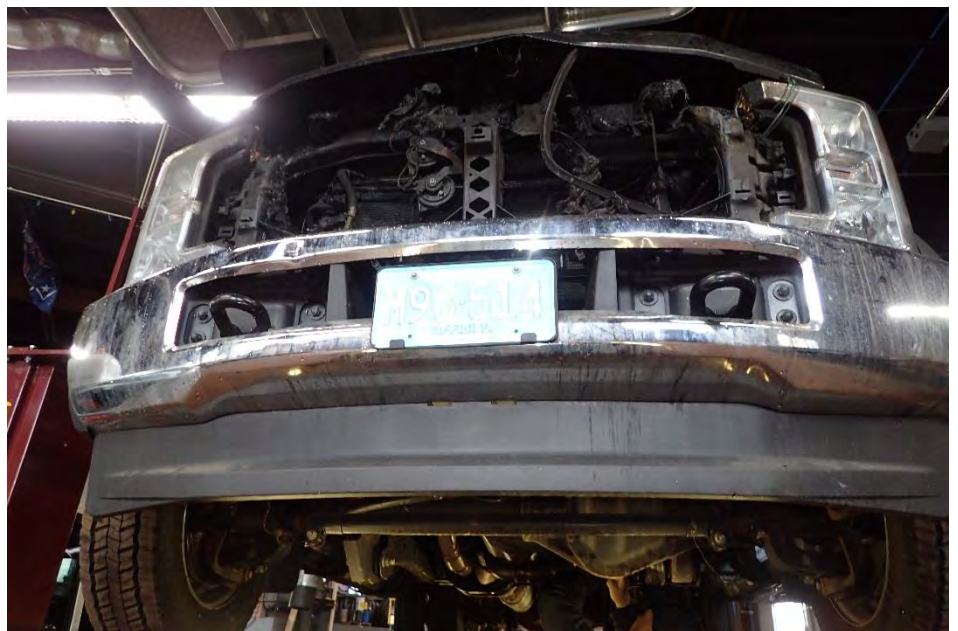
86

View of the front undercarriage. Nothing was burned.

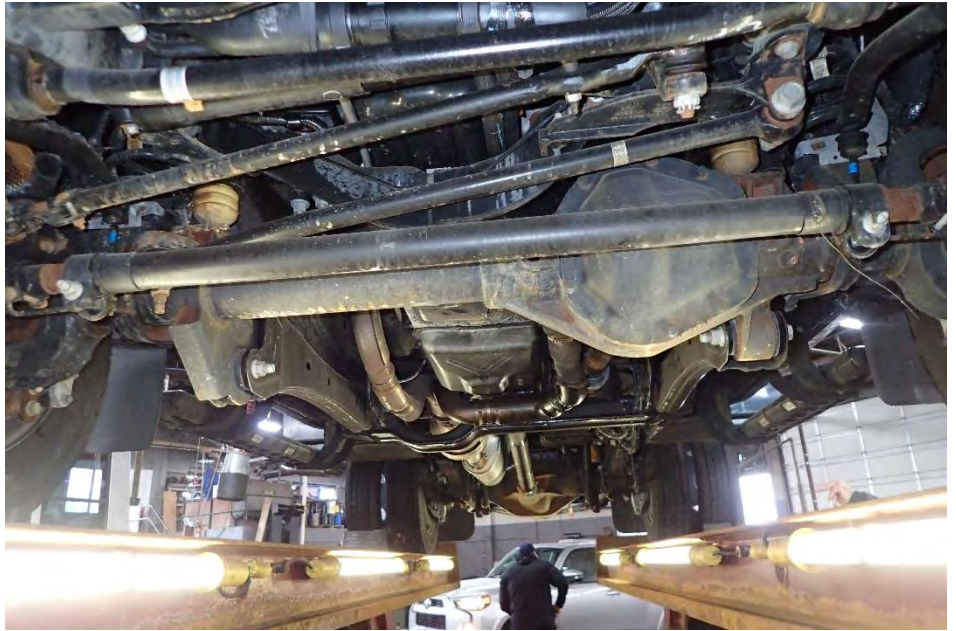
87

View of the front suspension. The fire did not extend into the front suspension.

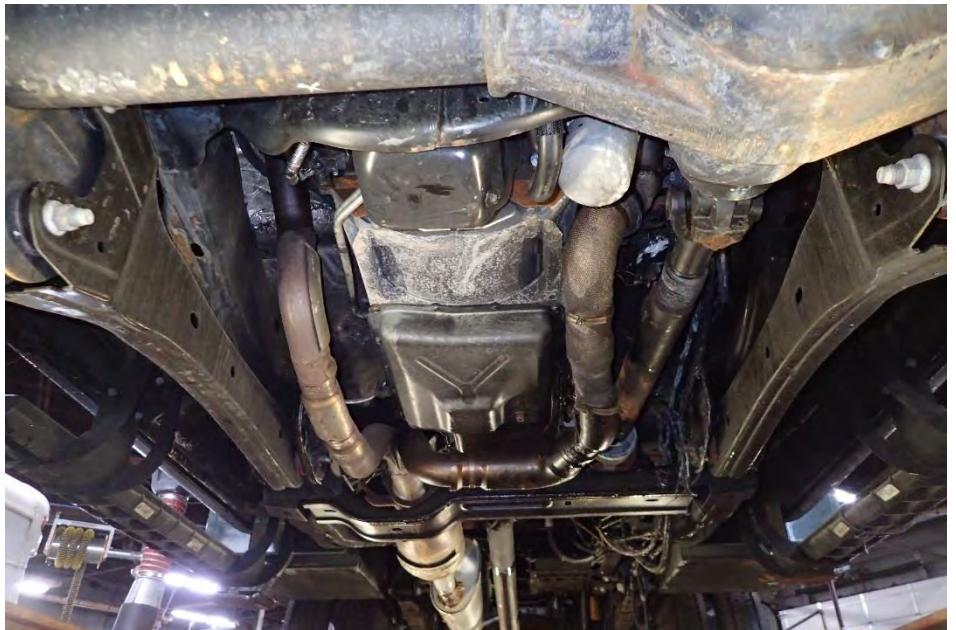
88

View looking toward the front of the transmission and crossmember. There was burned fluid on the left side (driver's) exhaust pipe.

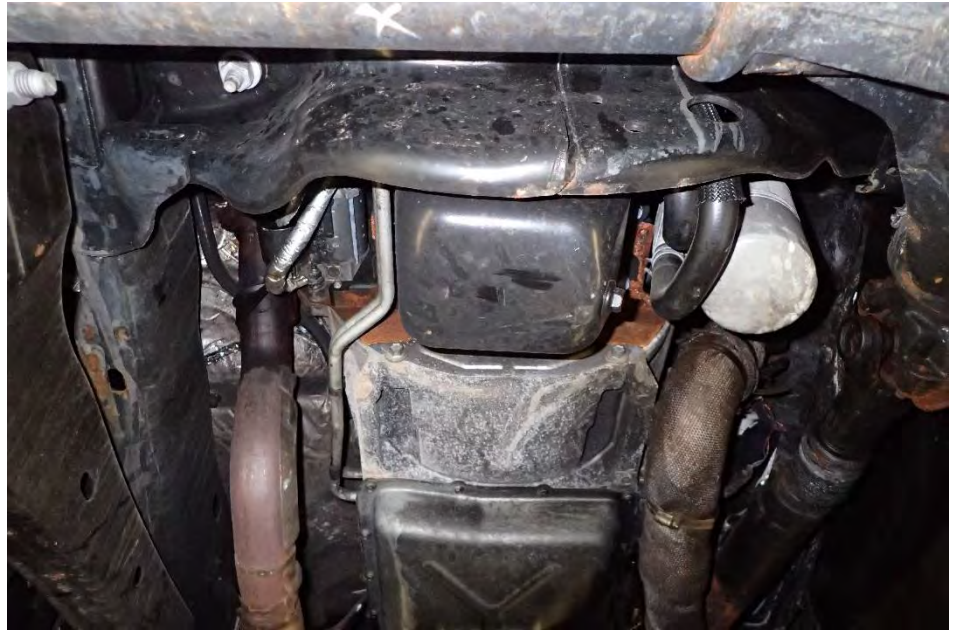
89

View of the underside of the engine oil pan and the transmission bellhousing. The underside of the engine was not burned.

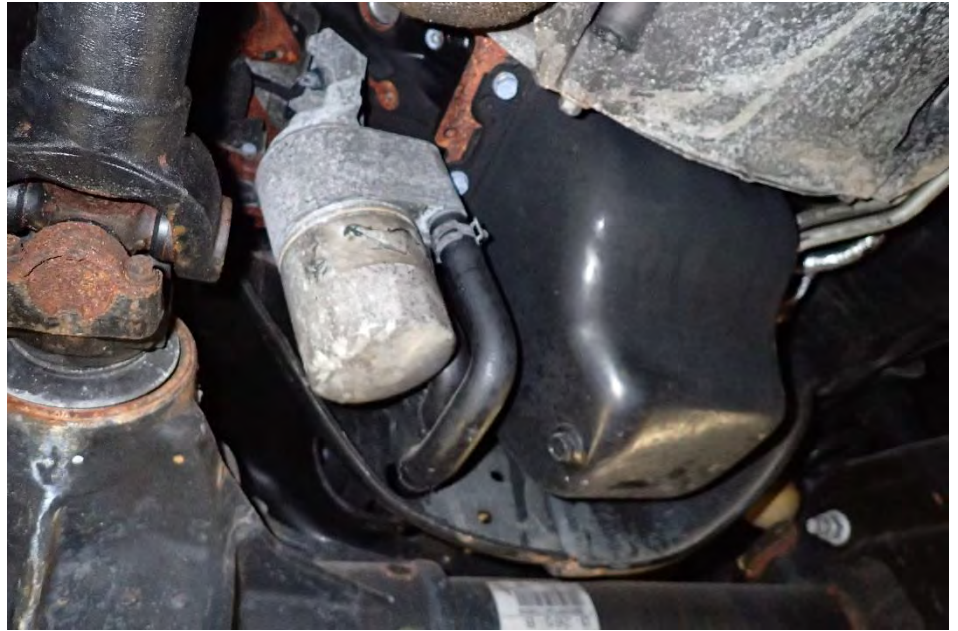
93

View of the left rear of the V10 gasoline engine. It was not burned.

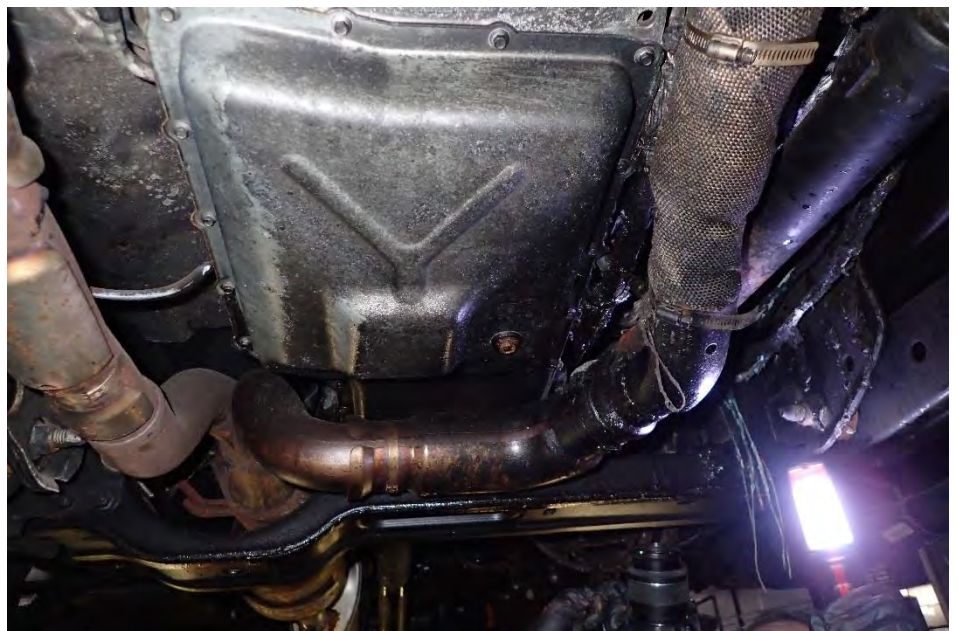
94

View looking at the front of the automatic transmission oil pan and the exhaust crossover pipe. The fire was intensified after it vented up through the large hole in the floor pan that accommodates the 4-wheel drive gearshift.

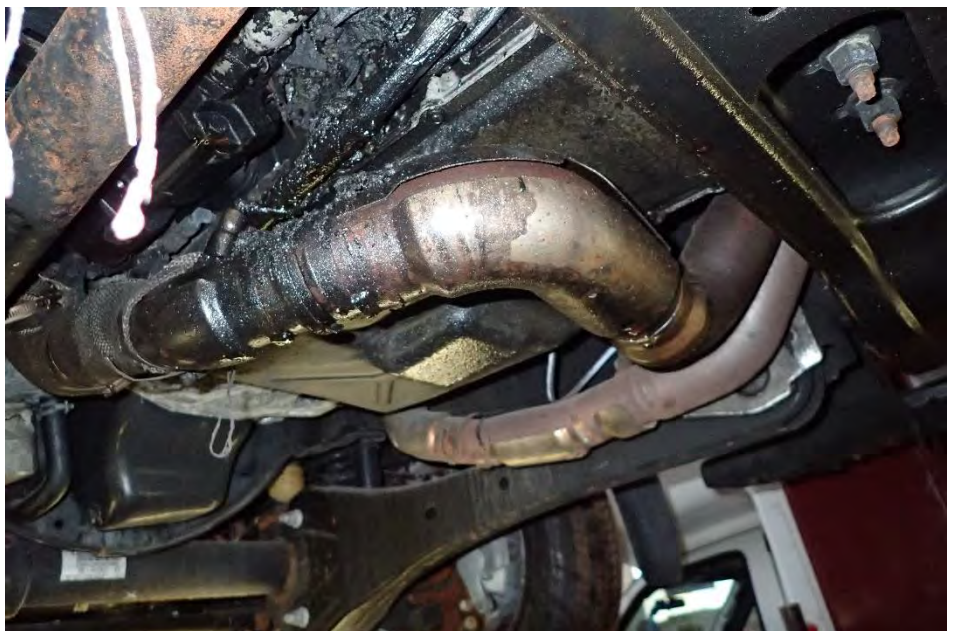
96

Closer view looking at the left rear of the automatic transmission. The opening in the floor is located directly above. This allowed the fire to vent freely up into the cab of the truck, which intensified the heat release at the left side of the transmission.

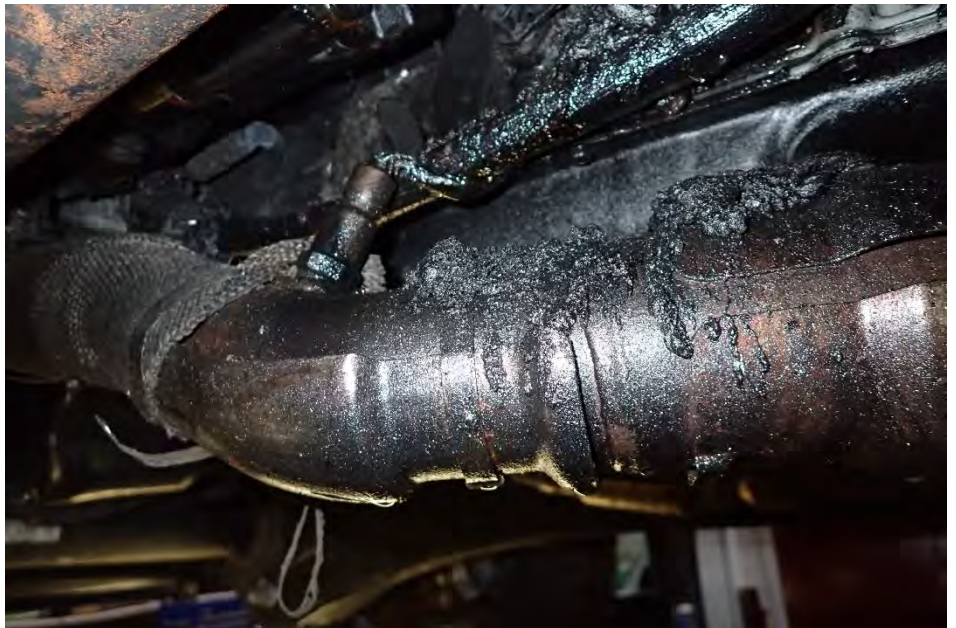
98

Close view of the exhaust pipe and an O2 sensor on the top of the pipe. The pipe was covered with burned transmission fluid.

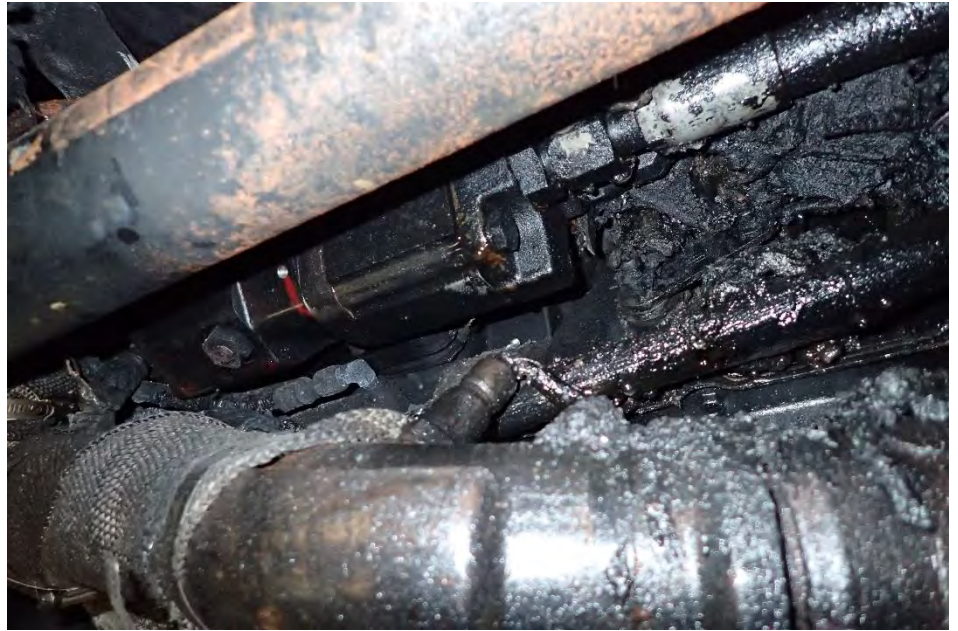
99

Another view showing the left side exhaust pipe. The PTO pump and the reservoir line can be seen above the exhaust pipe. The transmission test port and the pressure line to the PTO can be seen just below the PTO pump.

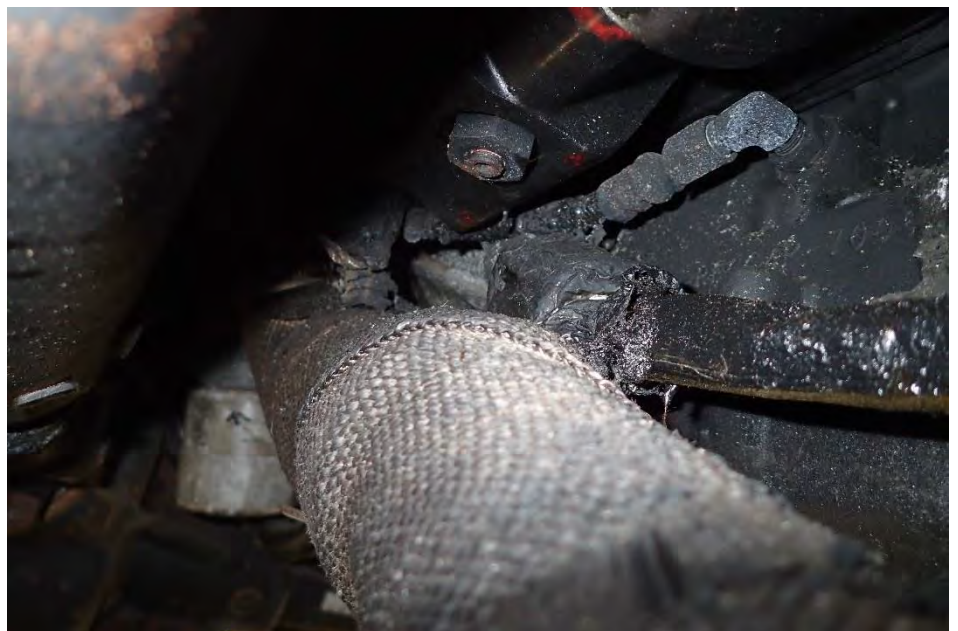
100

View of the transmission test port and the aftermarket transmission line extending to the PTO control switch.

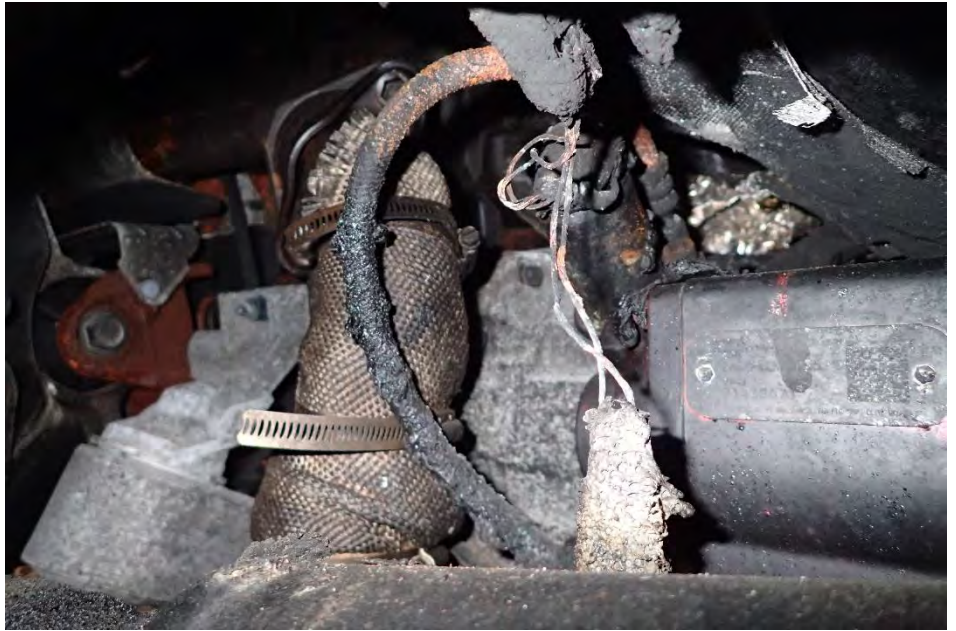
101

View of the left side of the PTO where it mounts to the side of the transmission. The pressurized transmission line can be seen looping around the front of the PTO where it connects to the switch on top of the PTO.

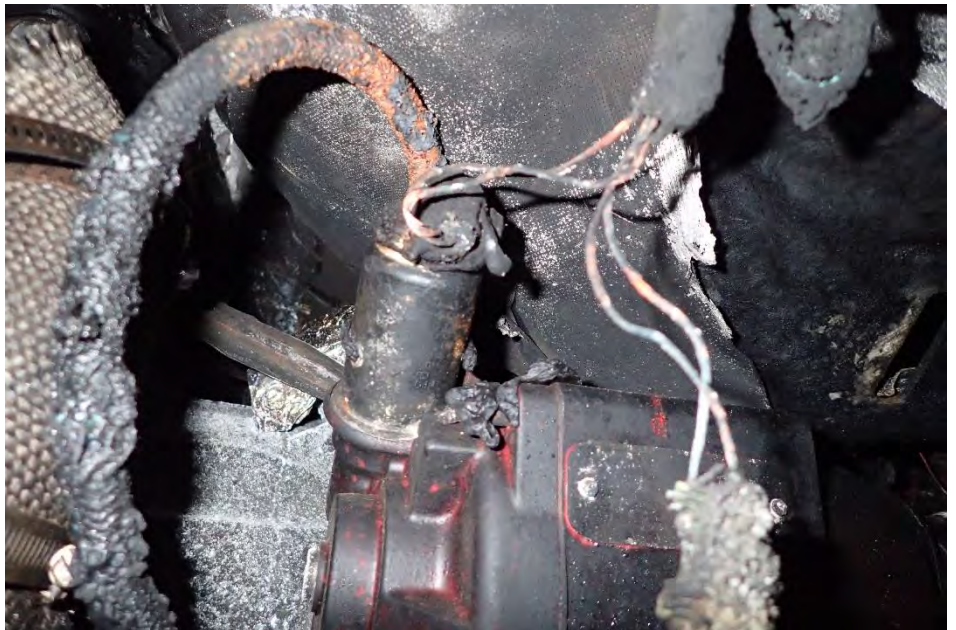
102

View of the integrated cartridge valve and pressure switch on the PTO pump housing. Note that the transmission line was rubbing the floor pan directly above.
