SD|LYONS

VEHICLE ANALYSIS – SDL# 10744.1

INSURED Somerville DPW
VEHICLE 2017 Ford F550 Super-Duty
VIN 1FDUF5HY1HED35804
ODOMETER Unknown
DATE OF LOSS April 13, 2018

Inspect the 2017 Ford F550 Super-Duty aerial bucket truck. Determine the origin and cause of the fire.

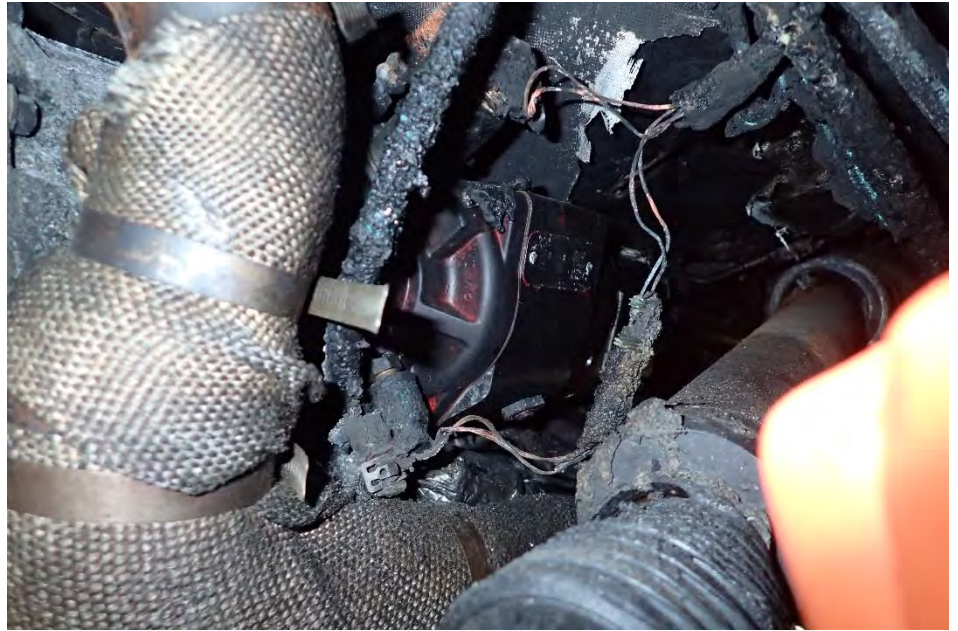
103

View of the front of the PTO pump and the transmission pressure line located in close proximity to the hot surface of the exhaust.

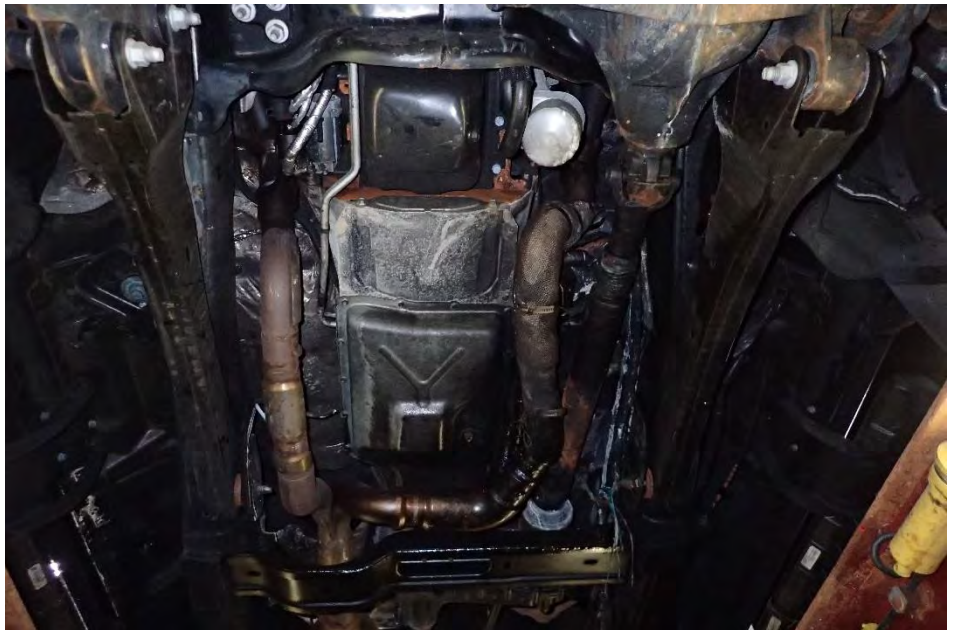
106

View of the underside of the engine and transmission before removing the exhaust pipes for inspection purposes.

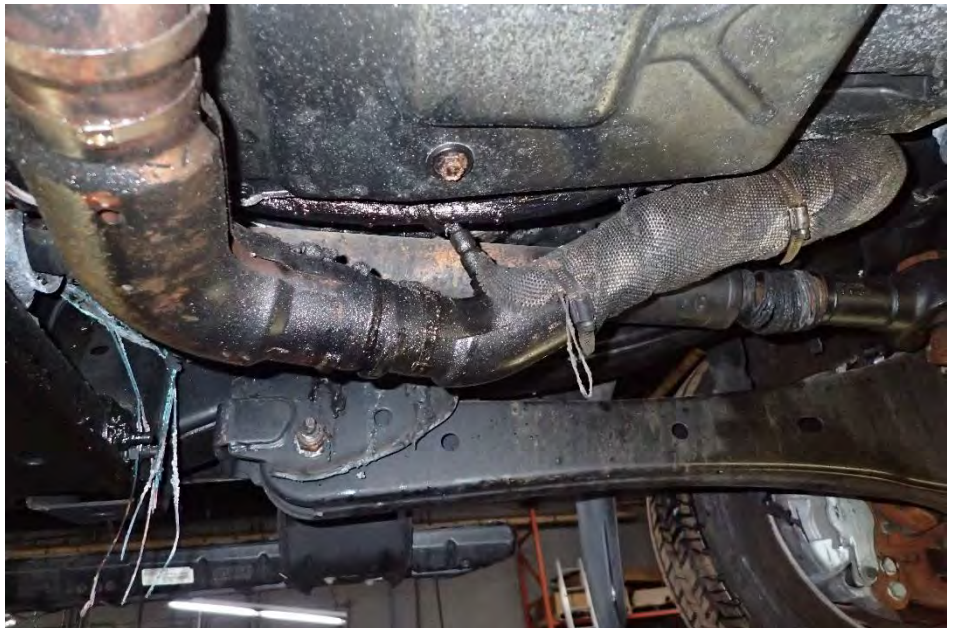
108

Closer view of the exhaust pipe located just below the PTO pump. This view was taken from the right side.

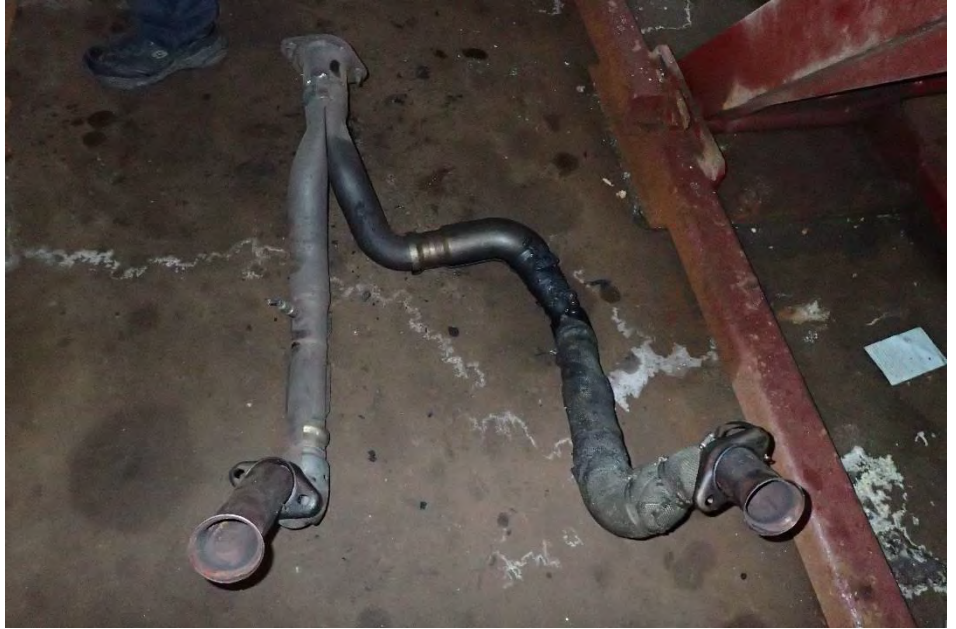
109

The exhaust pipes were unbolted from the exhaust manifolds and removed from the truck.

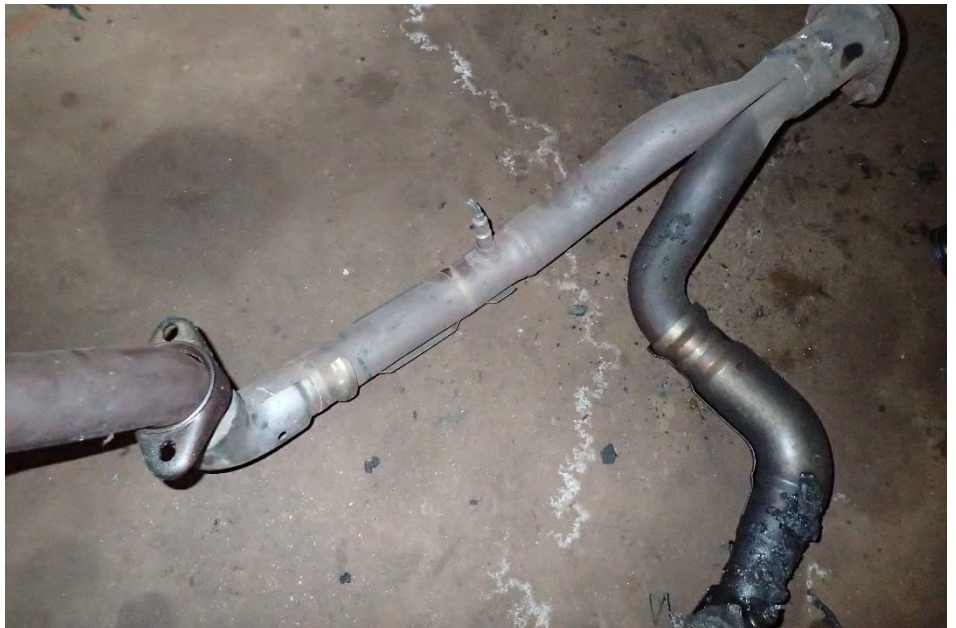
110

View of the right side exhaust pipe. There was no fluid on the right side pipe.

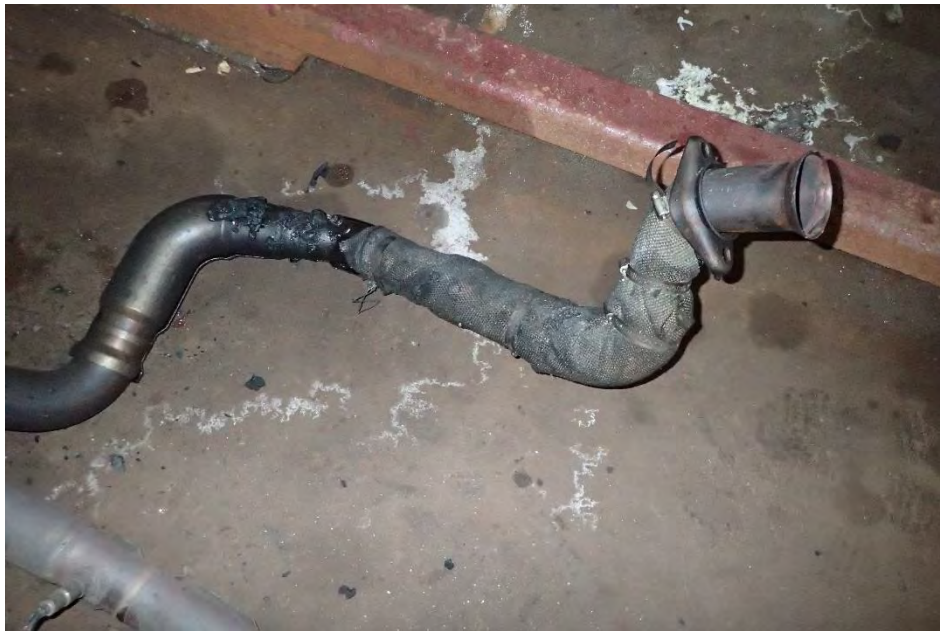
111

View of the left side exhaust pipe and the heat tape that someone had applied to the pipe.

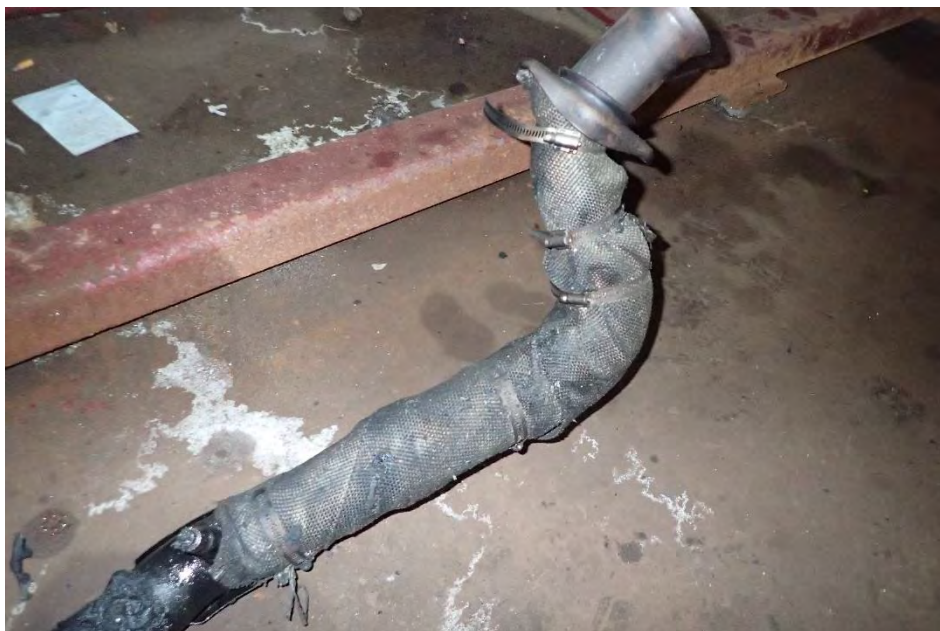
112

Another view of the left side pipe showing the heat tape and burned transmission fluid.

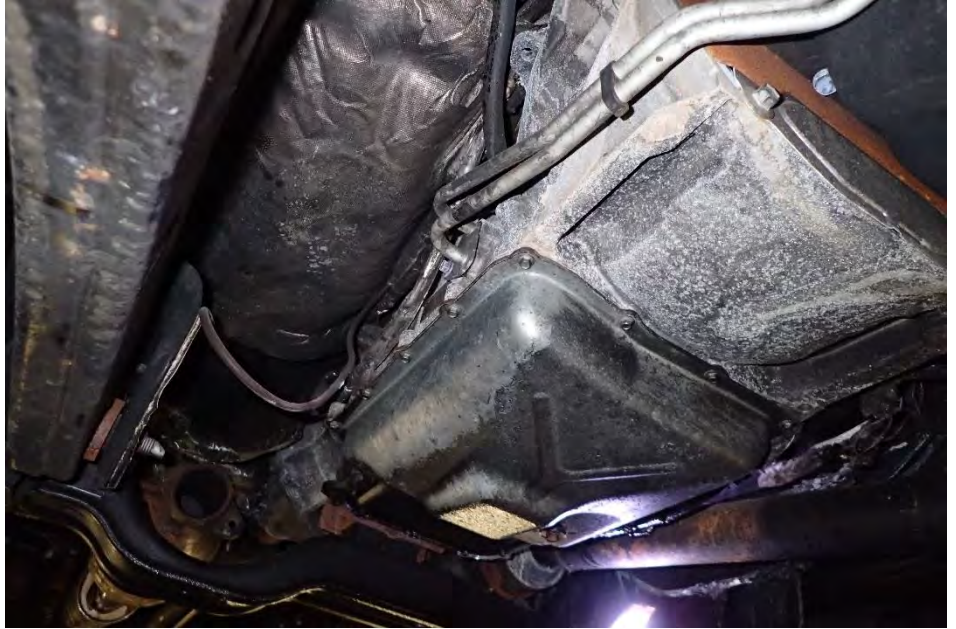
113

View of the right side of the transmission after removing the exhaust pipe. Nothing was burned.

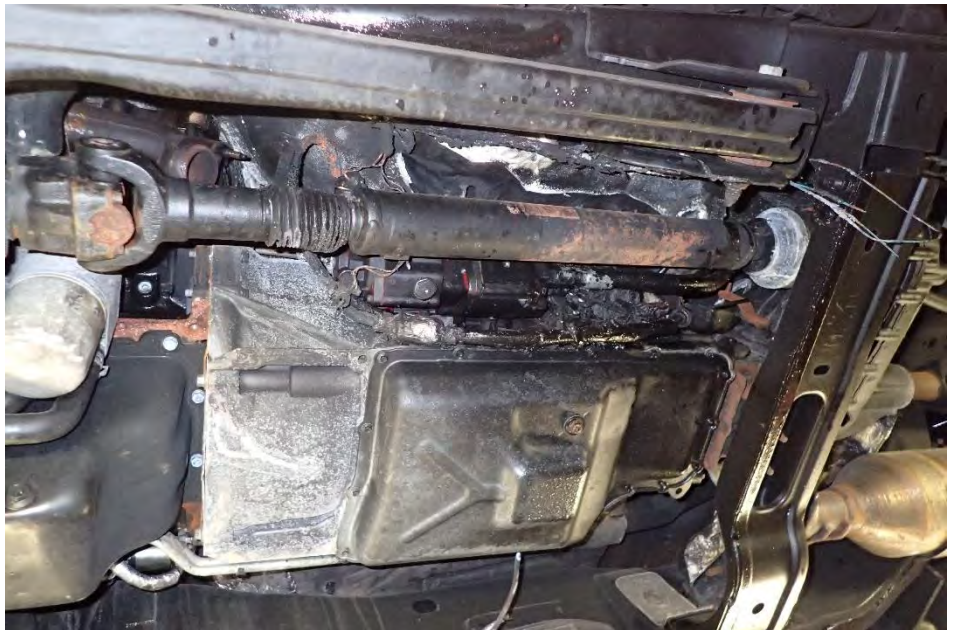
114

View of the left side of the transmission after removing the exhaust pipes. The PTO pump and the transmission pressure line can be seen.

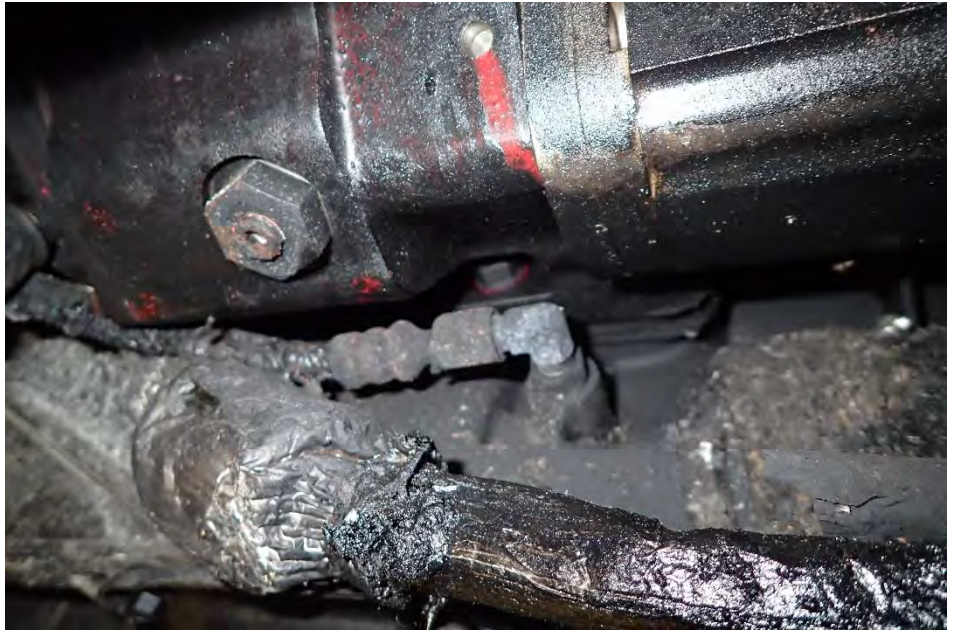
117

Closer view of the pressurized transmission test port and the aftermarket transmission line installed for the PTO pump activation.

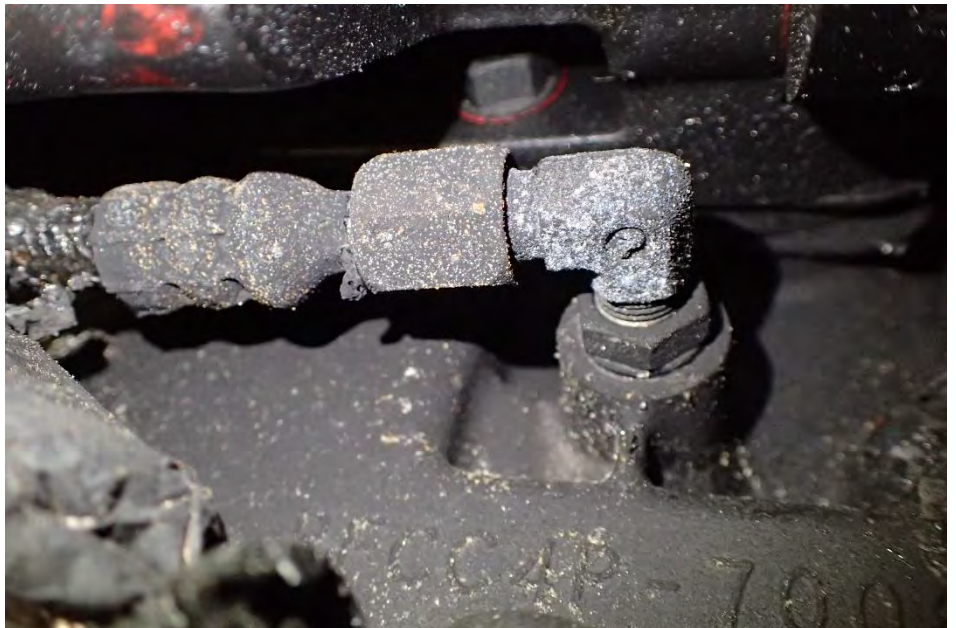
118

Close view of the aftermarket line connected to the transmission test port. This line is pressurized anytime the engine is running. When the PTO activates, the engine RPM and the pressure increase.

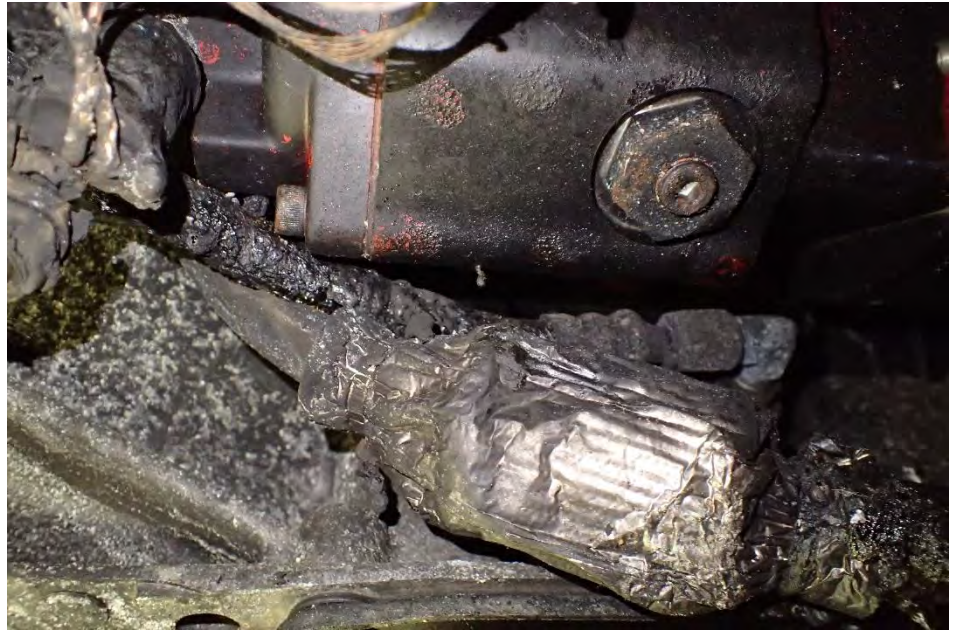
119

Close view of the transmission line where it passes in front of the PTO pump and in close proximity to the exhaust pipe and the shift cable.

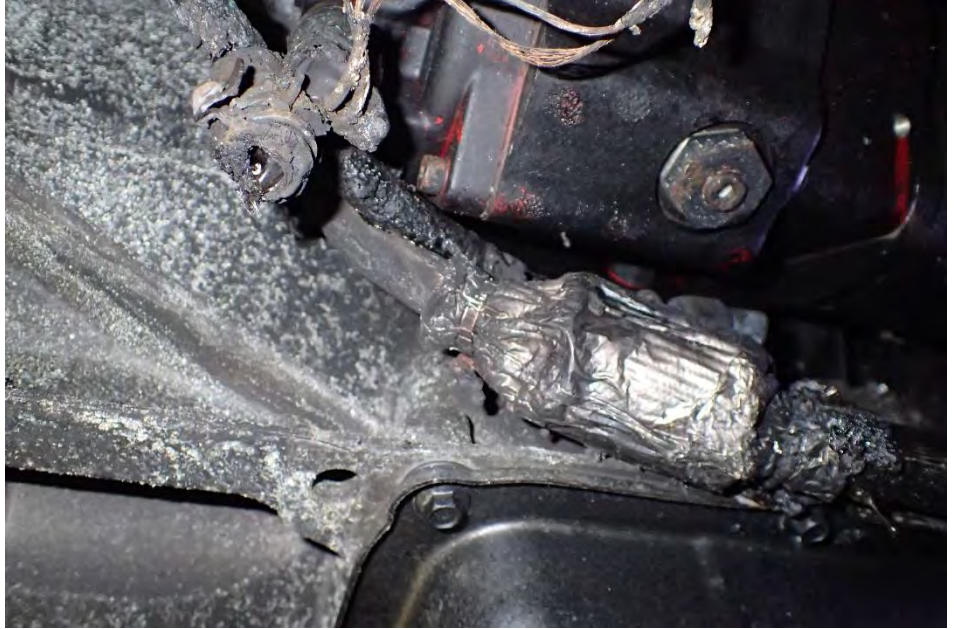
123

The transmission pressure line was fused together with the housing on the gearshift selector cable.

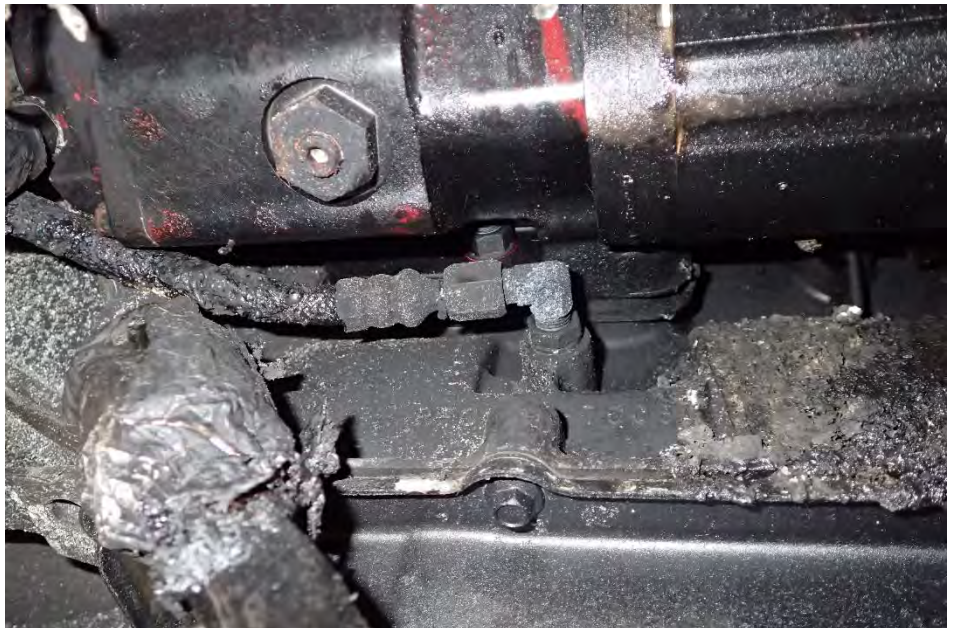
124

Another view showing the transmission line extending from the transmission test port to the PTO. The hose was up against the pump housing and the gearshift selector cable.

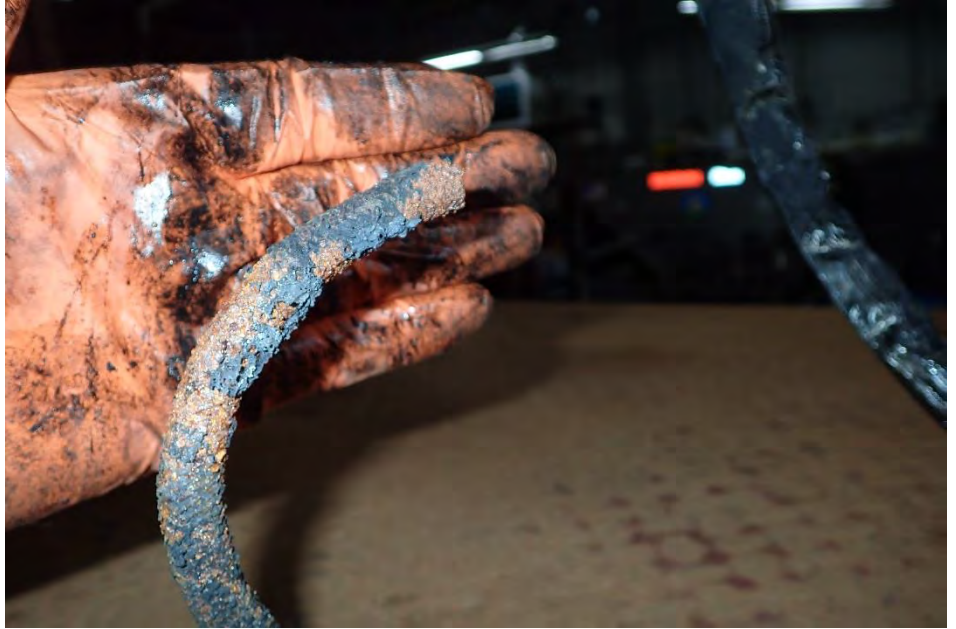
129

Closer view of the broken end of the transmission line.

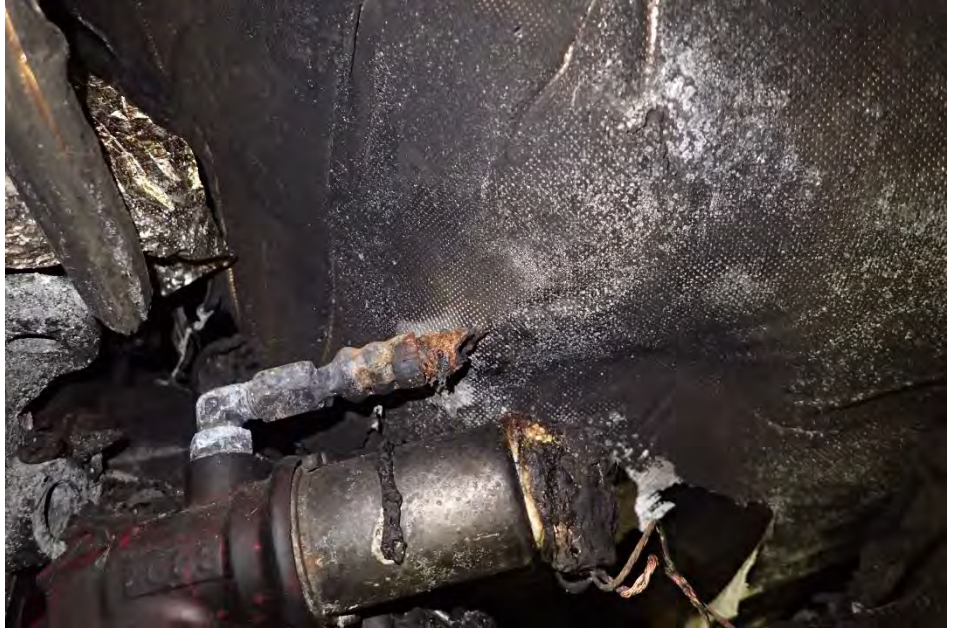
131

Closer view of the broken transmission line.

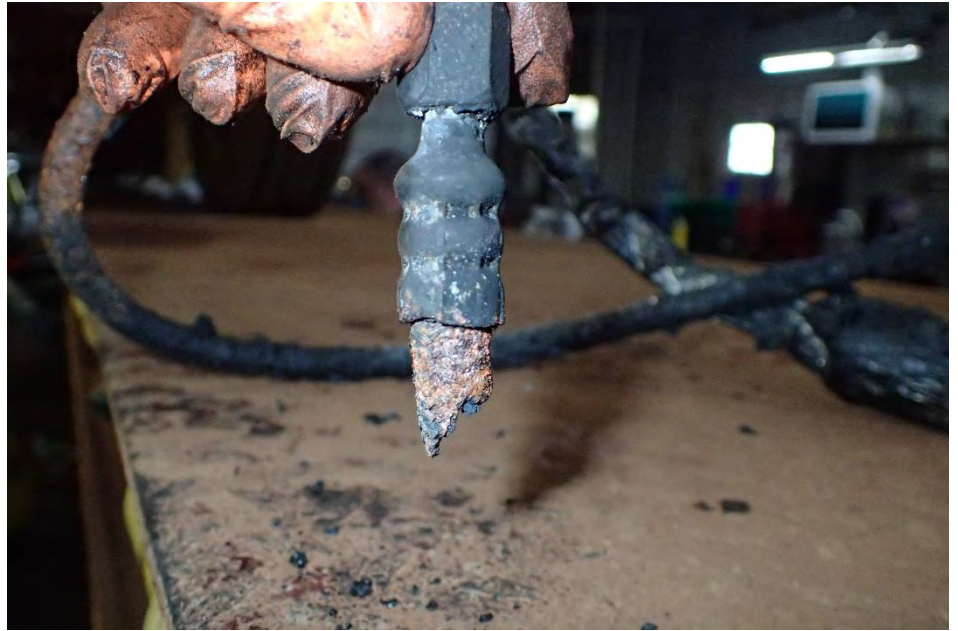
135

View of the burned and fractured end of the line.

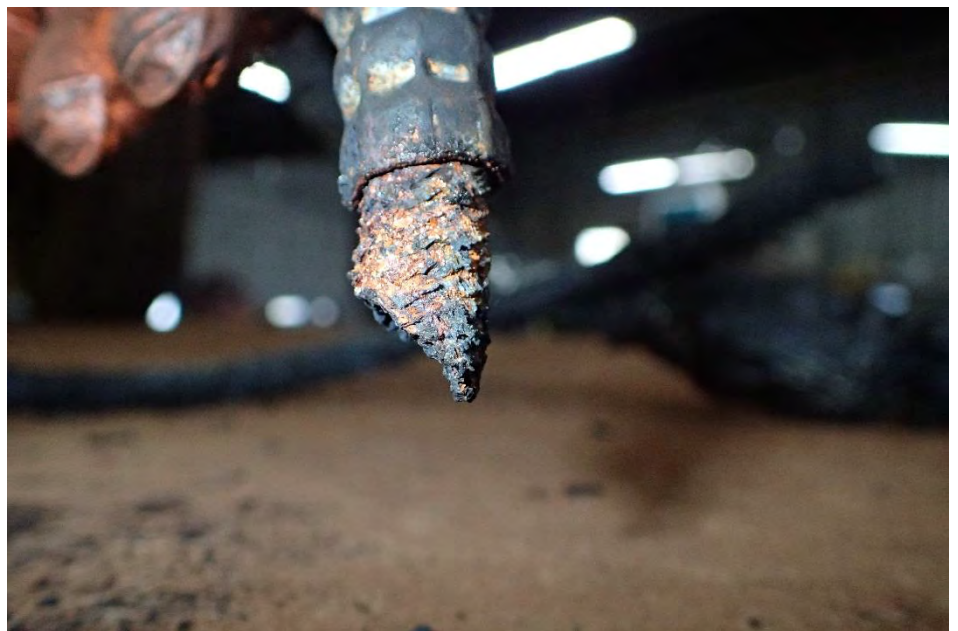
136

Another view of the fractured end of the line.

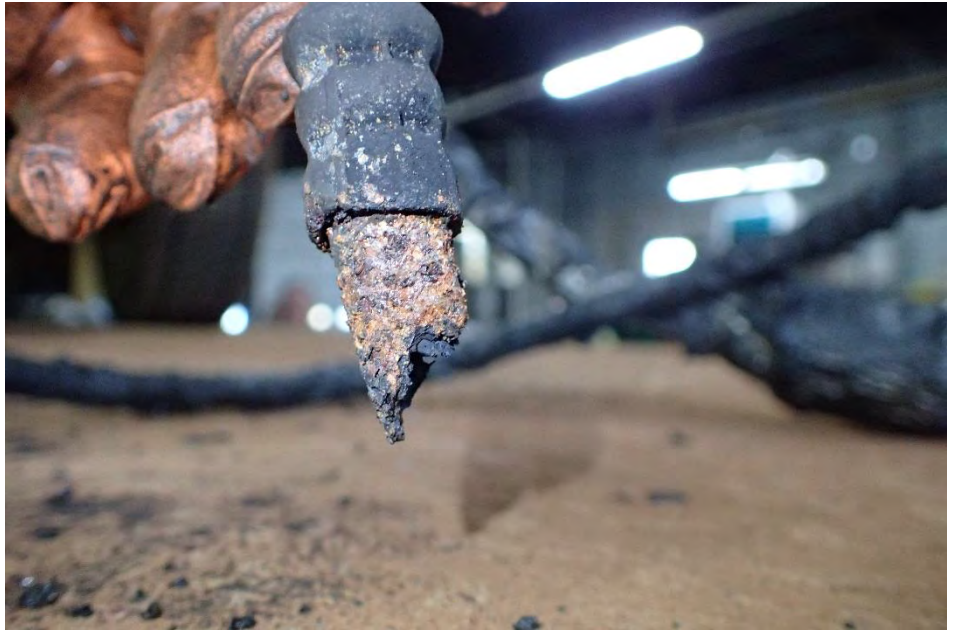
137

Another view of the fractured end of the line.

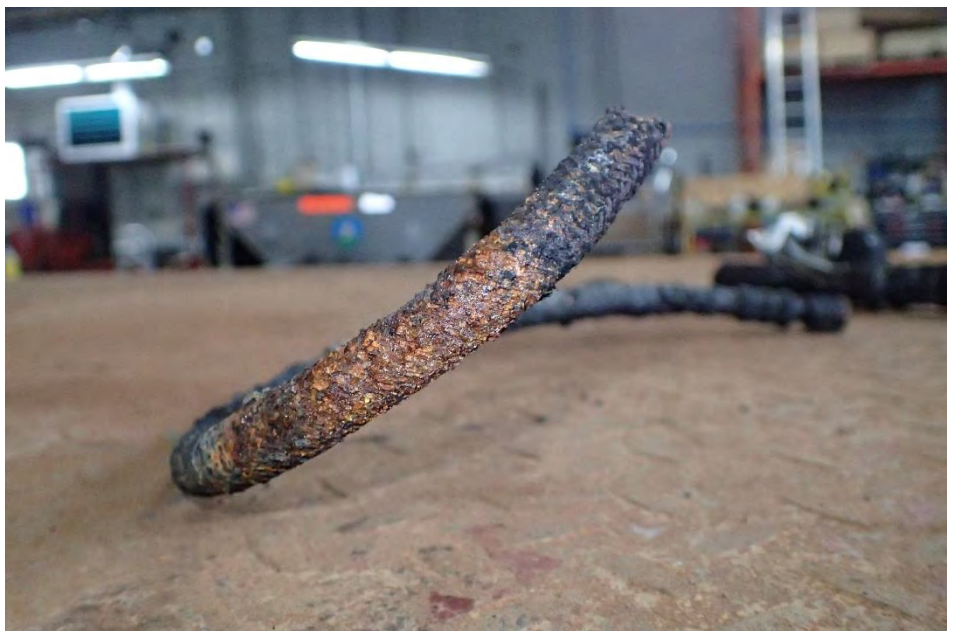
138

View of the upper end of the hose where it had been rubbing on the floor of the truck.

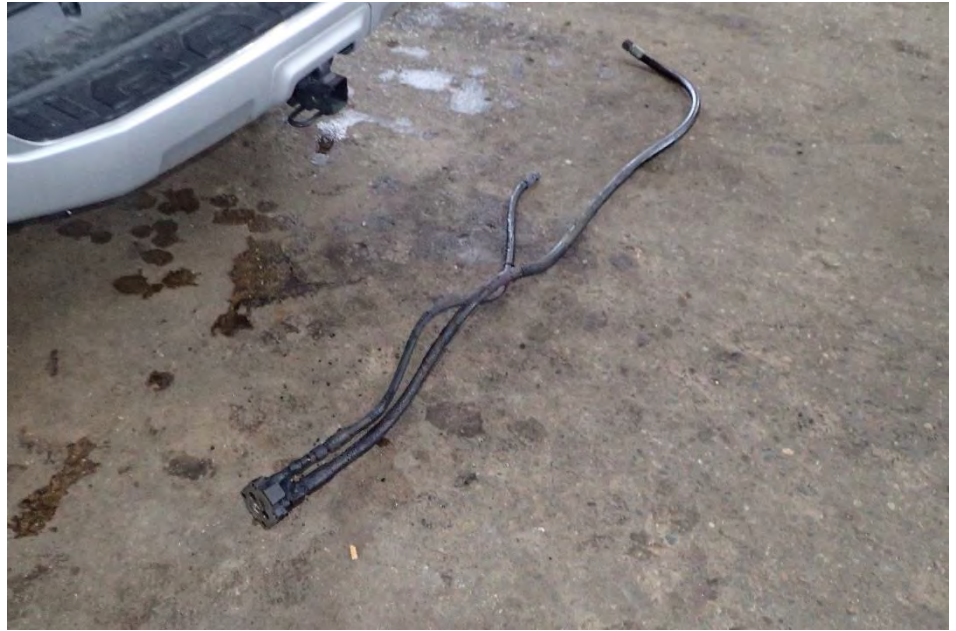
147

View of the reservoir line and the pressure line removed from the back of the PTO pump.

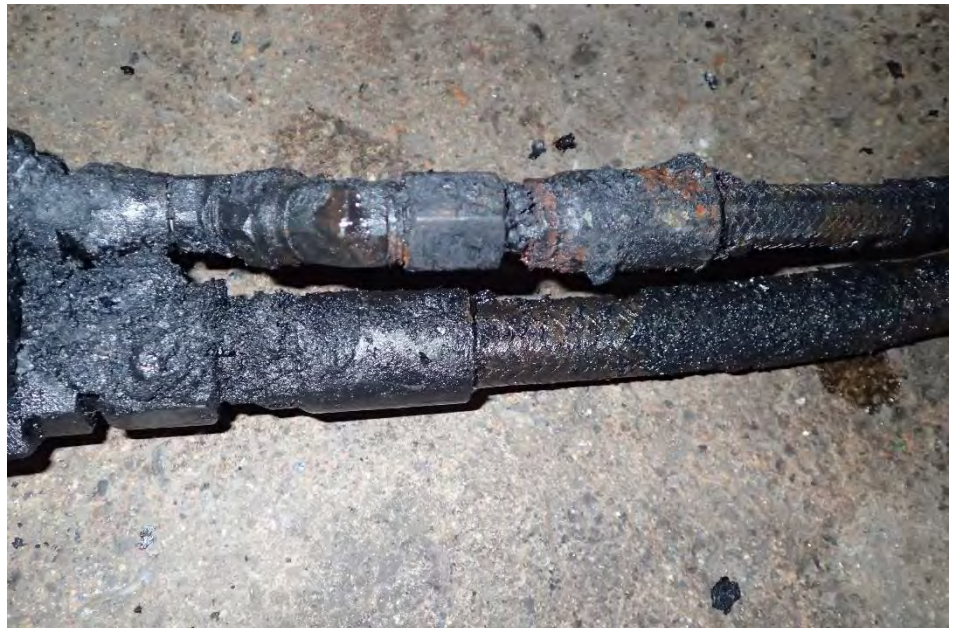
148

View of the reservoir line and the pressure line.

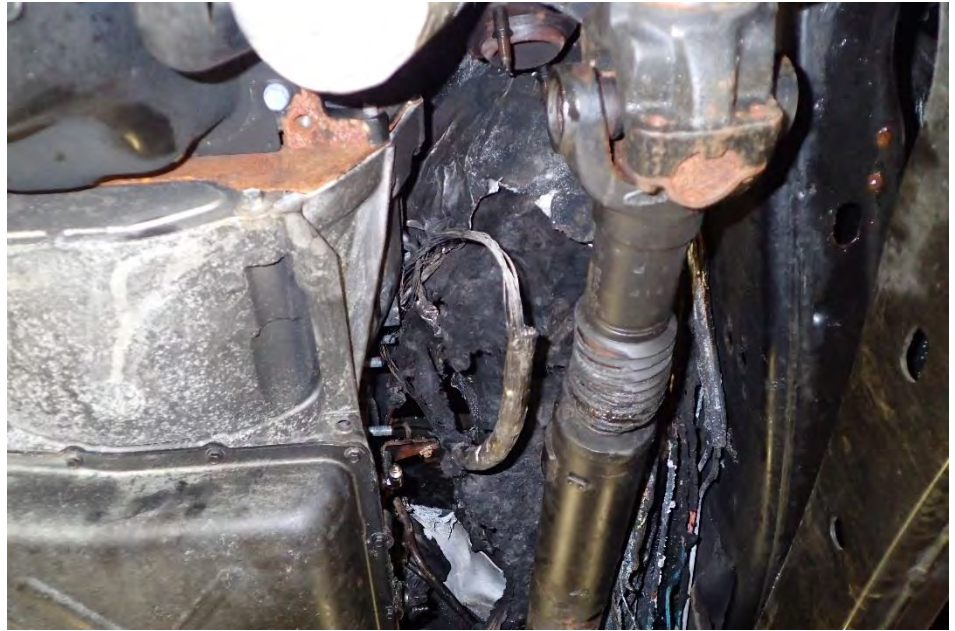
149

View of the left side of the floor pan after removing the pump. The remains of the shift cable were still in place.

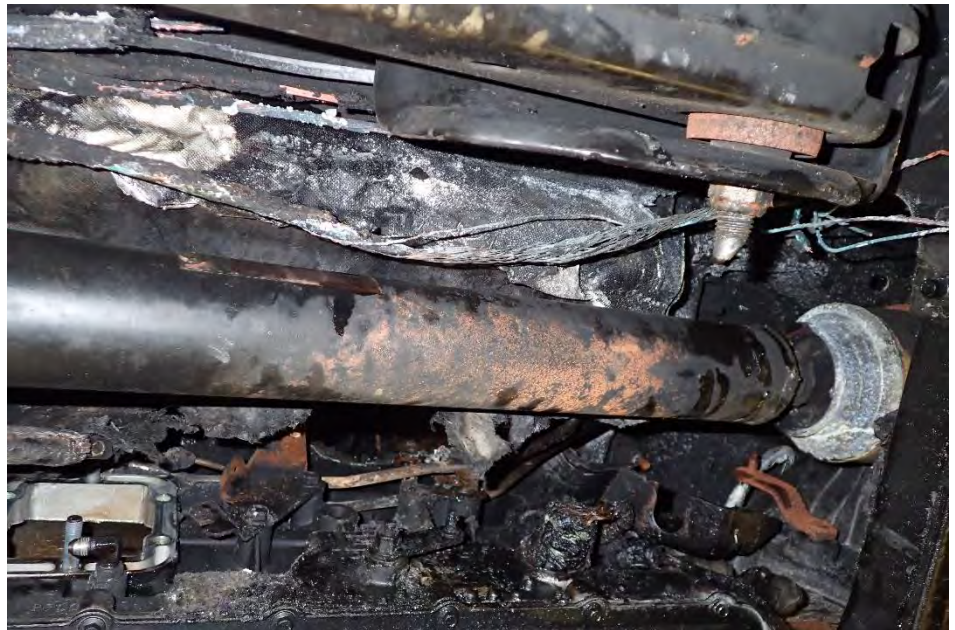
150

View of the opening in the floor above the left side of the transmission. This allowed the fire to vent up through the floor and created a high intensity fire pattern attributable to the ventilation and the presence of the fuel.

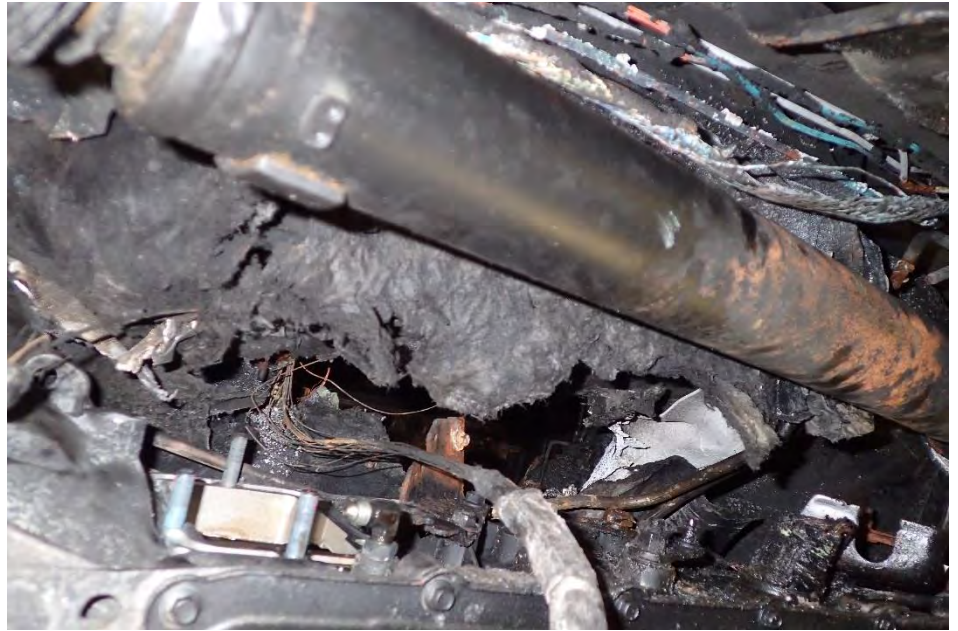
151

Another view of the relatively large opening in the floor above the left rear of the transmission.

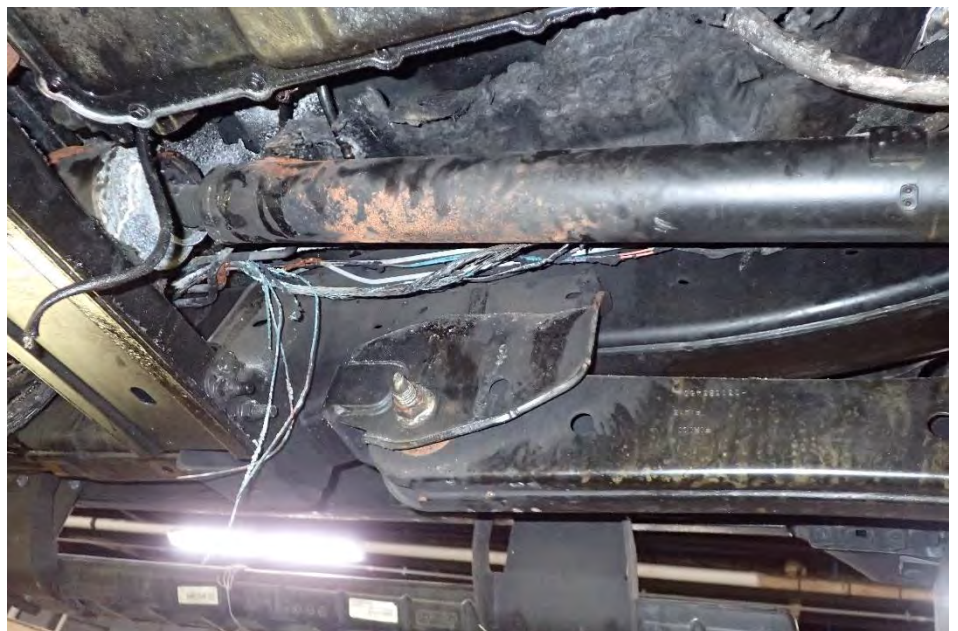
152

View of the left side framerail. The fuel lines are located further back on the framerail and they were not in the area of the fire. I examined the wiring harnesses remaining on the framerail.

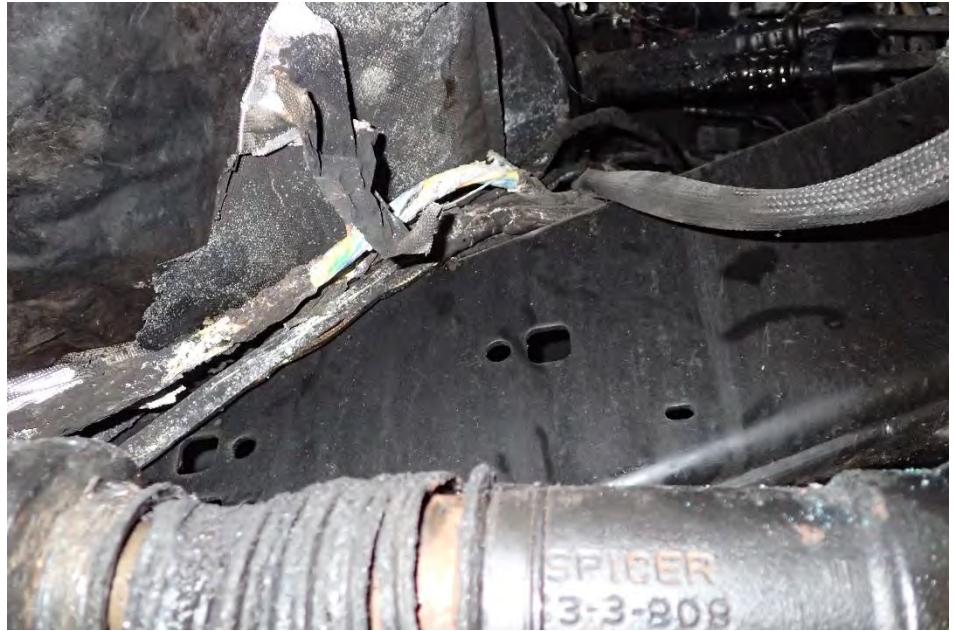
The insulation still remained on some of the wires along the left framerail. I found no evidence of electrical activity.
