Project Name: Structural Stabilization Project

Project Location: 277 Broadway, Somerville, MA 02145

Building Conditions Assessment

31 May 2019

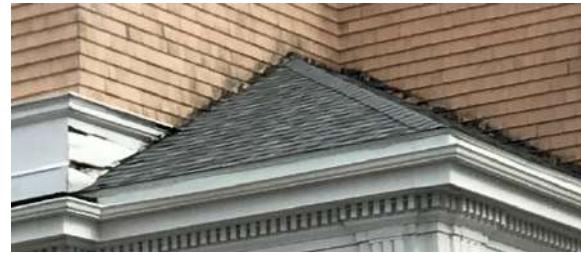
There appears to be active water infiltration where the low roof edges intersect the tower. This may be due to flashing not having been installed by the roofers, or other movement created by summer heat or winter ice. Damage from the water intrusion can be seen in the front stairs. See photos to the right.

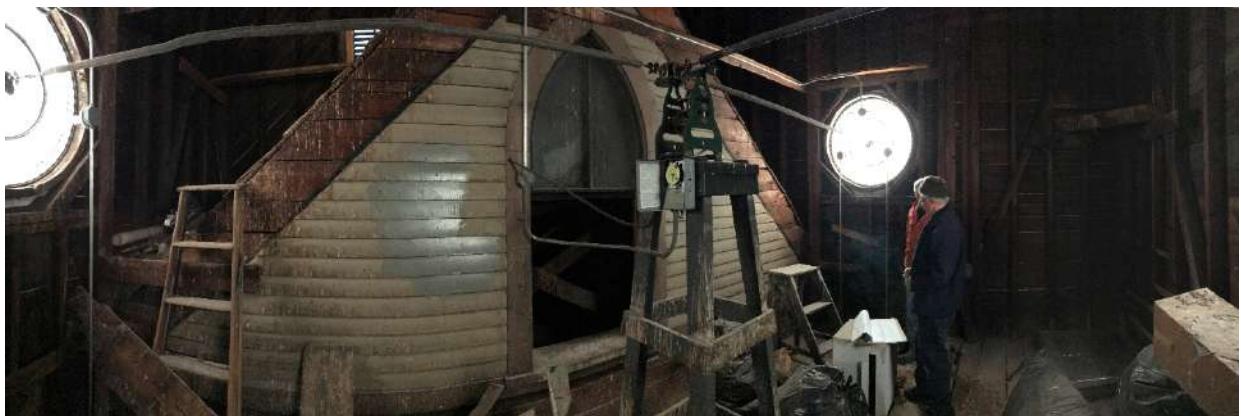
7 Panorama view of the interior of the clock tower showing the end gable of the original church. The geared mechanism to run the clocks is to the right of the ogee window. Note also the crossed-braced framing in the exterior walls.

- *Periodically monitor the tower to make sure that the hatch is closed and no birds get in.*
- *Dispose of the roofing waste stored in the tower.*
- *See also the structural report.*

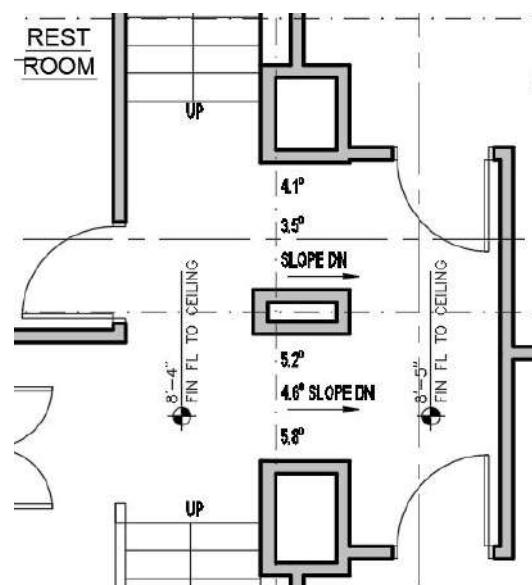
2Ground Floor Hallway

Ground Floor: The ground floor is accessible by an exterior concrete ramp and an internal ramp. It should be noted that the doorway entering the building between the ramps has insufficient push space on the latch side of the door. However, by Section 26.4, the doorway must have 12" of clearance on the push side of the door if the door has a latch and a closer. The latch on this door can be dogged in the open position when the ground floor area is open to the public, for example when the food pantry is open. The hallway between the daycare rooms and the restrooms has a sloped floor. The north side has a slope that varies between 3.5% and 4.1%, which falls within the parameters of a sloped walkway. The south side has a slope that varies between 4.6% and 5.8%, which is greater than the maximum slope for a walkway. See the image at right and drawing Ex1-1.

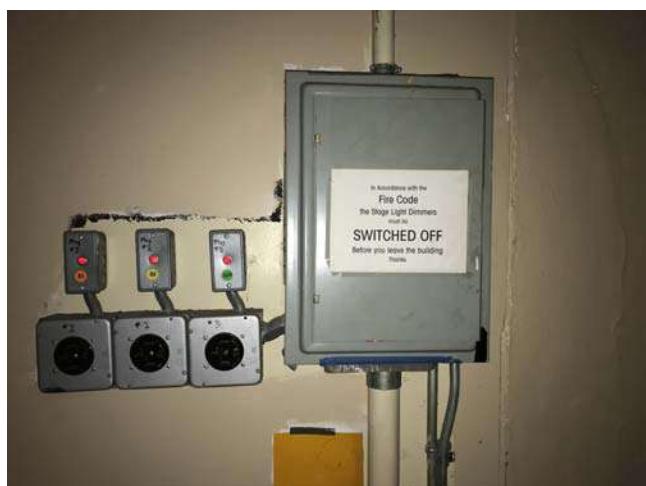
Photo #3

There are two other load centers within the facility. There is one on the second floor located on the stairs leading to the mezzanine and another one at the mezzanine level. The load center on the second floor is recessed in the wall of the stairs and is a 12 circuit load center with 4 spaces for future circuit breakers. The load center at the mezzanine level is 20 circuit load center and primarily serves the theatre lighting and equipment. These load centers are showing signs of wear and should be upgraded if renovations are being considered. See Photos #2 & #3.

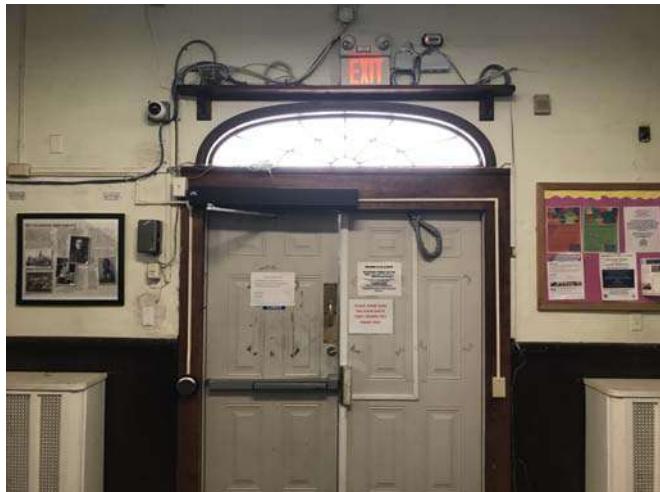
cable and wiremold with building wire within it. All of these are acceptable wiring methods and appeared to be installed throughout the building. In some cases the "NM" and "MC" cables need to be supported more frequently than they are currently. The NEC requires supports for this type of cable to be every 6'-0" on center from the building structure and should be done in a neat and workmanlike manner. See Photo #4

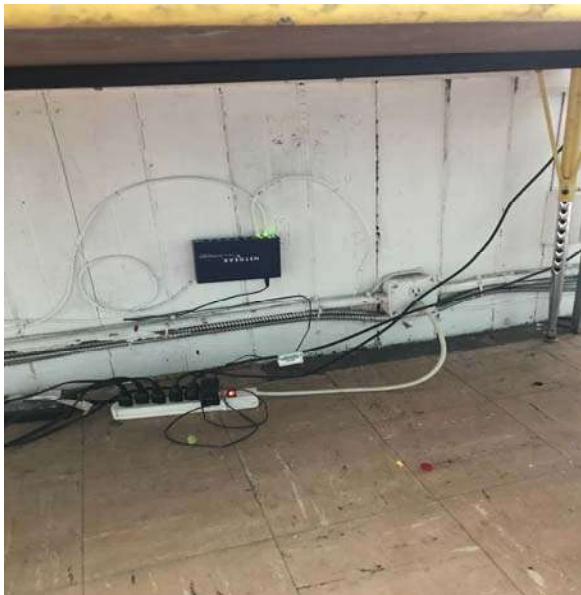
It was noticed that in a number of locations plug strips and extension cords were being used to provide for additional items to be plugged in or circuit to be extended to user locations. Plug strips should be used as a last resort to provide power to equipment or appliances. If renovations are being considered additional branch circuits with new outlets should be added where power is required. See Photo #5

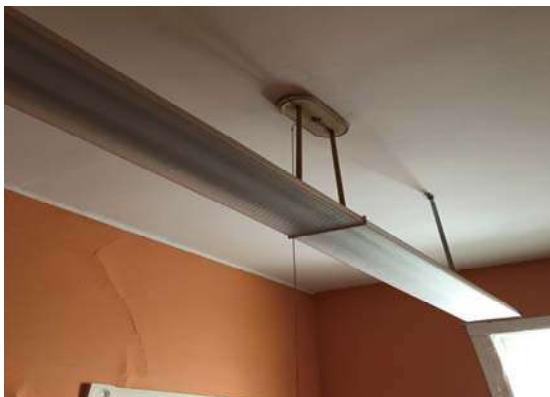
Photo #6

Lighting throughout the building consists predominantly of pendant mounted fluorescent wraparound type light fixtures. These light fixtures are very old and some had broken lens and were equipped with T8 fluorescent lamps. A number of the rooms on the first floor had light fixtures with pull chains in lieu of switches. See Photo #6.

The balance of the lighting within the building should be replaced with new LED energy efficient light fixtures. New LED lighting would save energy and don't require lamp replacement. Most LED light fixtures today have a 50,000 hour life expectancy and there could be rebate money available from Eversource to help defray the cost of replacement. All the lighting should be controlled with Vacancy sensors within each area or room. These devices are also eligible for rebate money.

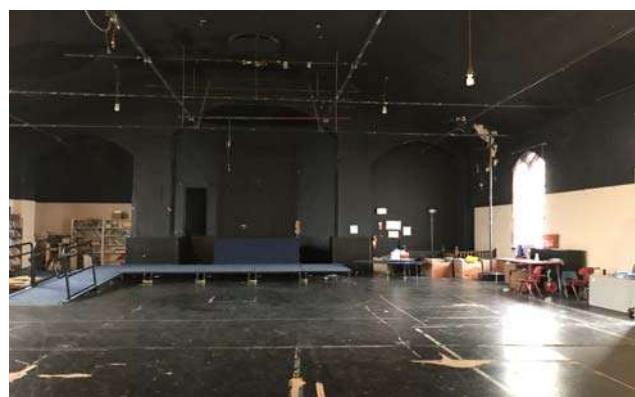
Photo #7

The auditorium area lighting had screw-in compact fluorescent lamps installed in what appeared to be the original chandelier sockets. These fixtures appear to be original with the building. This same condition was found in the front stairs leading to the auditorium. See Photo #7.

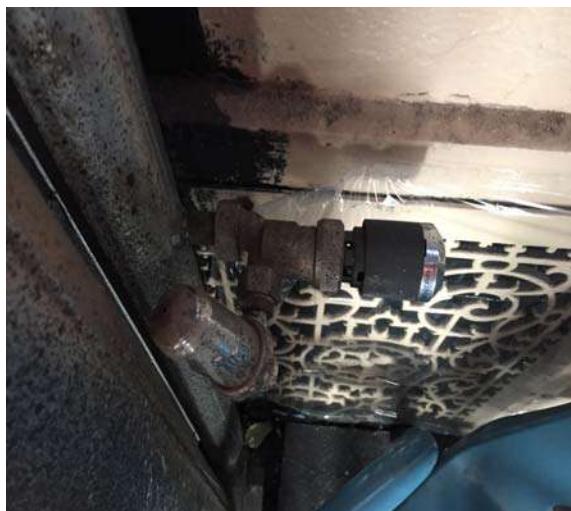
Photo #1

The existing heating system is a one pipe gravity steam system with cast iron radiators scattered throughout various rooms, not all spaces. The radiators are controlled from non-electric self-contained control valves mounted right on the radiator (see photo #1). Most of the steam piping was not insulated. The parts that were insulated with foam type Armaflex type insulation but none of the fittings were insulated. Each radiator is enclosed in a perforated metal enclosure (see photo #2). There was one radiator in the attic that did not have an enclosure (see photo #3). In several cases there was some kind of furniture up against the enclosure disrupting the inflow of air to the radiator making it very inefficient (see photo #4). Each cast iron section appeared to show wear and tear, the silver paint wearing off looking like rust spots (see photo #5).

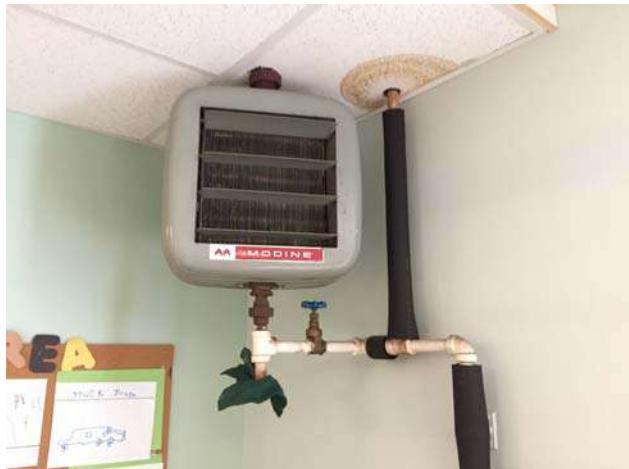
Photo #6

The basement was heated from a steam horizontal unit heater model 3HS33S01, 33 mbh heating capacity, and 1/125 motor (see photo #6). Not all rooms in the basement were directly heated. It depended upon the heat from the unit heater to migrate throughout the basement. There were many hot and cool spots.

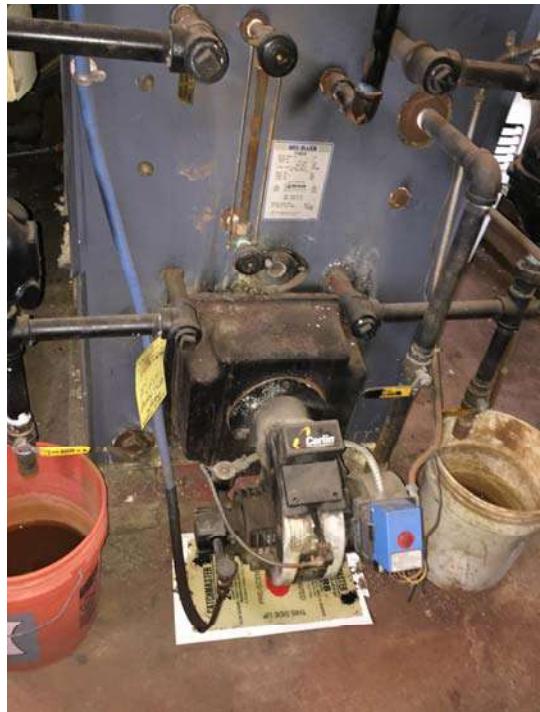
Photo #7

The boiler room was located in the basement. There was debris everywhere. There was one oil fired boiler producing steam to all the cast iron radiators (see photo #7). The boiler is a Weil McLain model #678 with an input of 5.50 gph, 789 mbh gas input rating, 643 mbh gross output, 559 mbh net rating and 15 psi steam working pressure. The boiler looked like it has exceeded its life expectancy. The oil burner appeared rusty but was operating. Again none of the piping in the boiler room was insulated. There were plastic pails under the McDonnell Miller controls to collect the condensate for blowdown (see photo #7). The controls were McDonnell Miller model # 247-2 mechanical water feeder and low water cut-off and McDonnell Miller model #2M switch with manual reset. A floor drain would be more appropriate for this use. It appeared the boiler controls were adequate and working. There were two adjacent 275 gallon fuel oil tanks in the boiler room vented to outside (see photo #8). The oil tanks were all rusted. There did not appear to be adequate ventilation for combustion in the boiler room. The flue from the boiler connected to the masonry chimney on the opposite side of the water heater flue. The boiler flue did not appear to be type "B" double wall (see photo #9). There were ceiling exhaust fans in each bathroom. Not all worked and some that did were noisy. There were abandoned exhaust fans in the basement bathroom walls (see photo #10).

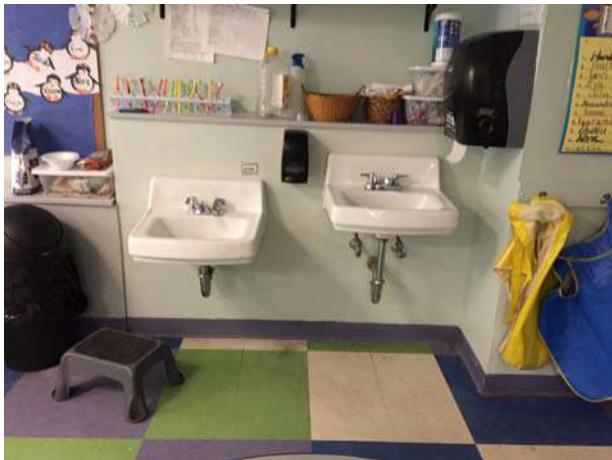
Photo #11

Each bathroom had a water closet and a lavatory. Some were suited for handicap use and some were suited for children's use with the low mount water closets. Not all the handicapped lavatory drains and hot water pipes were insulated to protect a handicap person on a wheel chair from burning themselves (see photo #11). All drains and hot water piping to handicapped fixtures must be insulated.

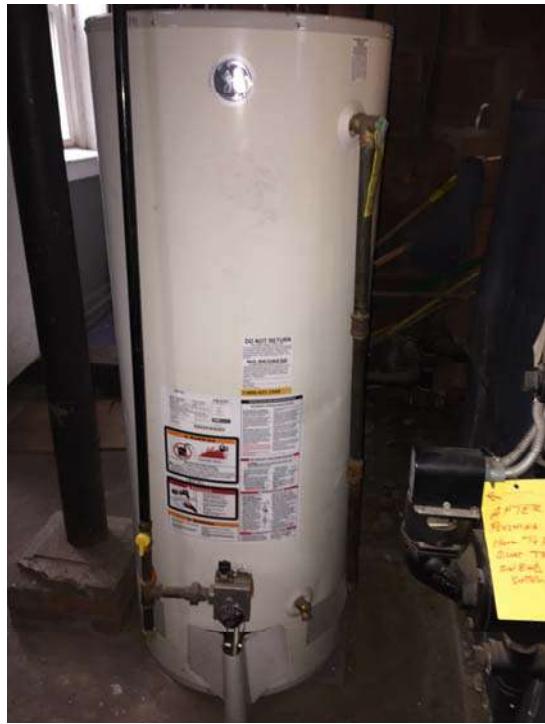
Photo #12

There was a gas fired domestic water heater with storage (see photo #12). It was a Rheem model #SG50T12AVGOO, 40 mbh input and 50 gallon storage capacity. The water heater appeared to be in good condition. None of the piping to and from the water heater was insulated (see photo #13). All the hot and cold domestic water piping including fittings should be insulated. We did not see a recirculation line. We could not find the water meter or where the cold water service entered the building. There was a gravity vented flue pipe connected to the water heater and connected to the brick chimney. The connection at the chimney could use a new or tighter thimble. The chimney appeared to require some major pointing. The grout appeared to be missing in many spots.
