CITY OF SOMERVILLE, MASSACHUSETTS
DEPARTMENT of ENGINEERING
JOSEPH A. CURTATONE
MAYOR

**BOARD ORDER #203947 - ELMWOOD FLOODING
ENGINEER'S REPORT**

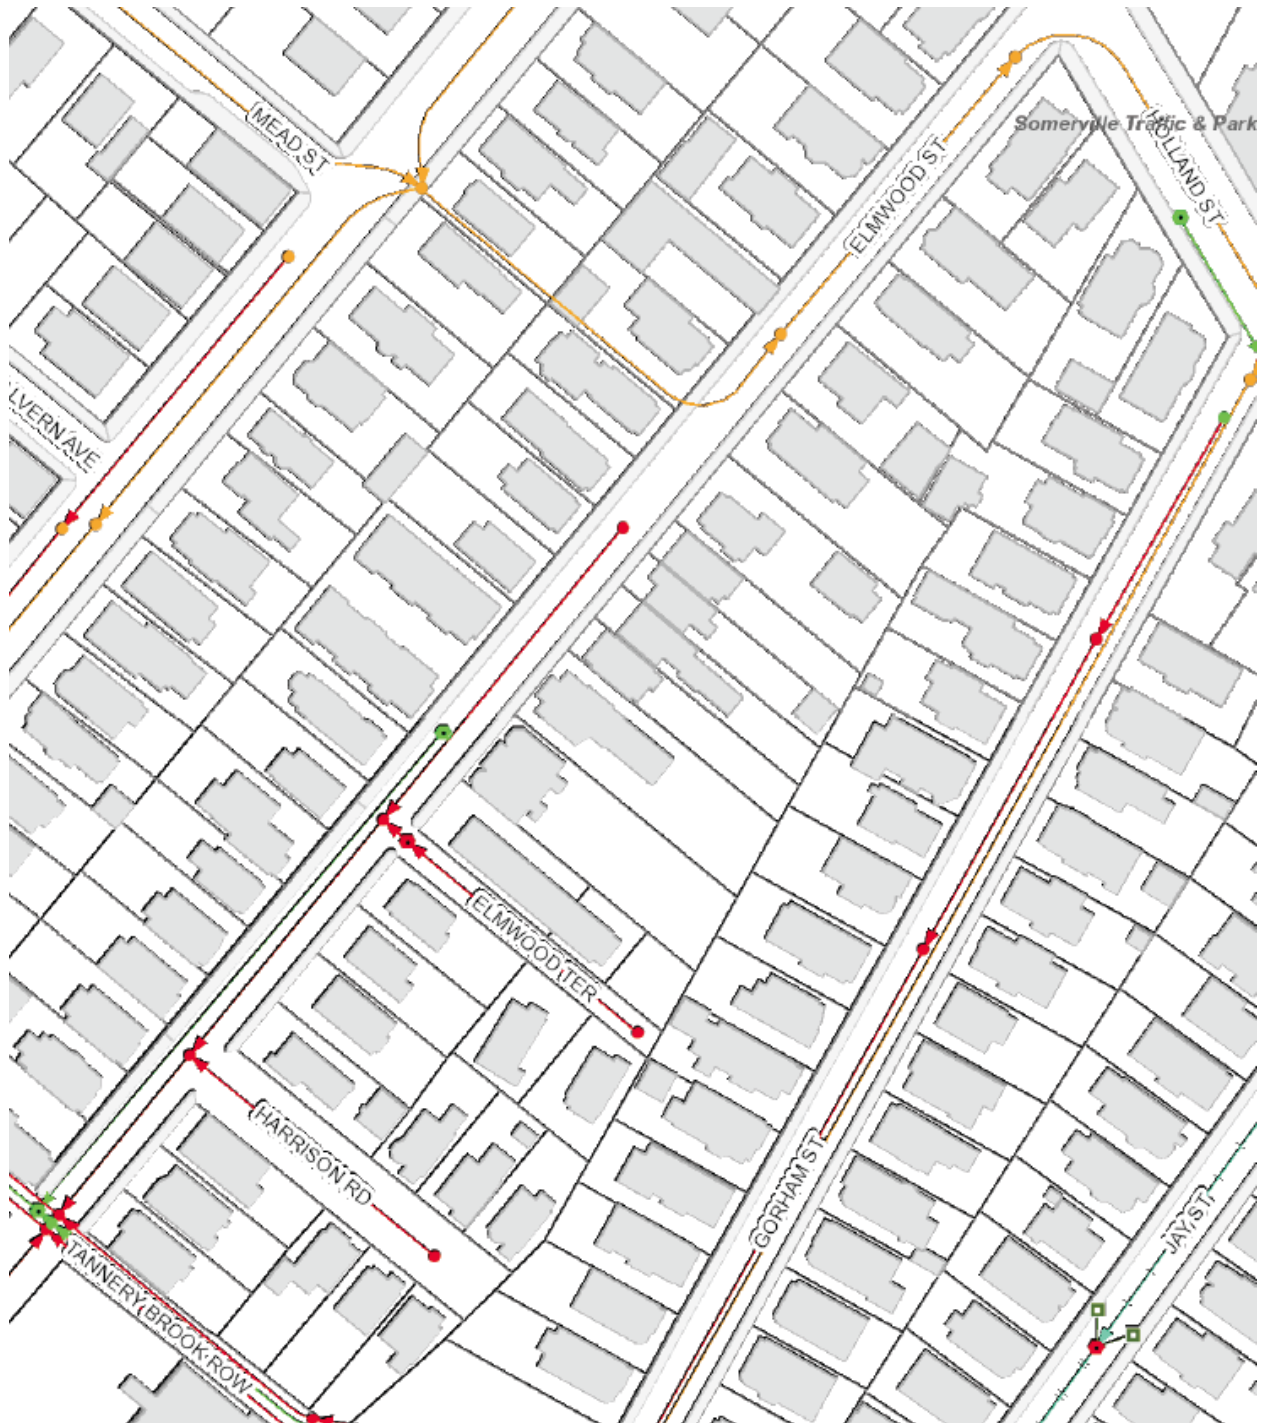
Elmwood Street is a public right-of-way to the south of Holland Street. It has not been paved by the city in the past 5 years, and it is not on the city's 5-year paving plan; however, that plan is revised annually based on pavement condition survey. Elmwood Street is served by an 8" water main. A 30" brick combined sewer constructed in 1879 that serves a large area to the south of Teele Square crosses between 25 and 21 Elmwood from Cameron Avenue and flow north to Holland Street. Sanitary and normal storm flows from that area, including 21 to 5 Elmwood, are conveyed southward on Holland Street and ultimately to the Somerville Avenue Combined system. During large storm events, the Holland Street subsystem overflows to the Tannery Brook system. Sanitary and storm flows from the southern end of Elmwood Street are directly connected to the Tannery Brook system. An 8" sanitary sewer constructed in 1896 starts at 29 Elmwood and flows south. In 1919, a 12" storm drain was constructed over and sharing manholes with the sanitary sewer starting at 44 Elmwood and flowing south. Both of those pipes connect to the Tannery Brook system.

Figure 1 Area Infrastructure
